**CITY OF CAMBRIDGE**  
**BOARD OF SURVEY**

Re: Board of Survey Report Pursuant to G.L. c.  
143, § 8 Re: Address: 221 Mount Auburn  
Street, Cambridge, MA.

## RIVERVIEW CONDOMINIUMS – SUPPLEMENT TO 27 JUNE 2025 SGH LETTER

Re: Board of Survey Report  
221 Mount Auburn Street, Cambridge, MA

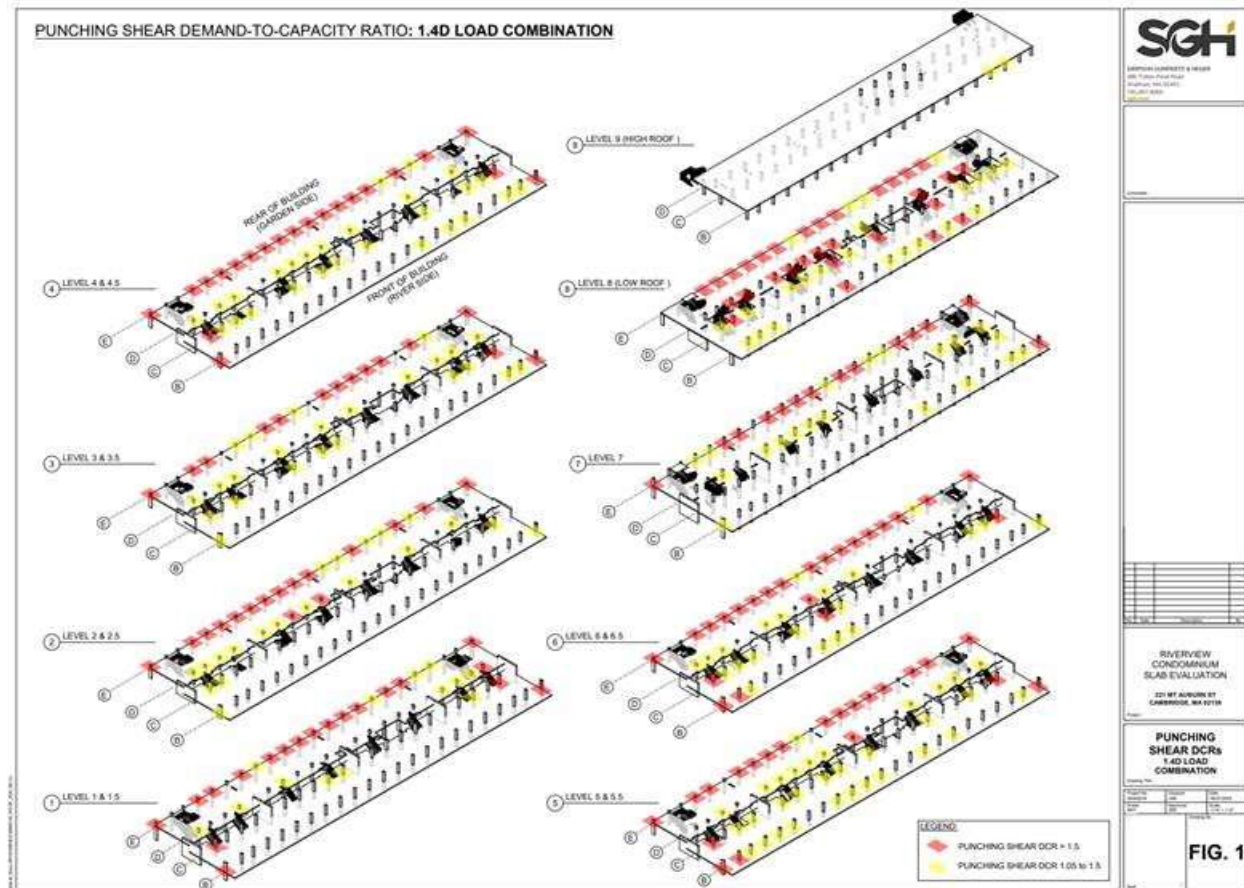
This June 27, 2025 Supplemental Letter prepared by SGH shared additional information requested by the City including **analysis of the building with dead load only (no snow load)**. The analysis shows a **significant number of slab-column connections** that are **potentially dangerous** (Demand to Capacity Ratios (“DCR”)  $>1.5$ , per American Concrete Institute (ACI) Code 562), **even without any snow load**. Figure 1 (1.4D load combination) shows that many column-slab connections have punching shear DCRs greater than 1.5 under dead-load only (i.e., the self-weight of the structure). Similarly, Figure 2 (1.2D + 1.6S load combination) also shows many locations with DCRs greater than 1.5, in particular at the High Roof and Low Roof slabs, due to snow loads. ACI 562 Commentary states that “the demand-to-capacity ratio for unsafe conditions was developed consistent with the performance-based procedures” contained in American Society of Civil Engineers and Structural Engineering Institutes – Minimum Design Loads and Associated Criteria for Buildings and Other Structures (ASCE/SEI 7-16)<sup>1</sup> and that “a demand-to-capacity ratio greater than 1.5...represents a condition with limited to no margin of safety against failure for ASCE/SEI loads.”

The Riverview Condominiums - Count of Slab-Column Connections by DCR report dated July 1, 2025 further examined the **magnitude of the number of potentially dangerous slab-column connections, both with and without snow load.**
