The Ragon Institute of MGH, MIT and Harvard
Proposed Demolition of 624 Main Street
10 September 2020

SUBJECT: Existing Conditions Summary
624 Main Street, Cambridge, Massachusetts

Subject 624 Main Street – Structural Engineering Report

624 MAIN STREET
REVIEW OF BUILDING CONDITION
AUGUST 18, 2020

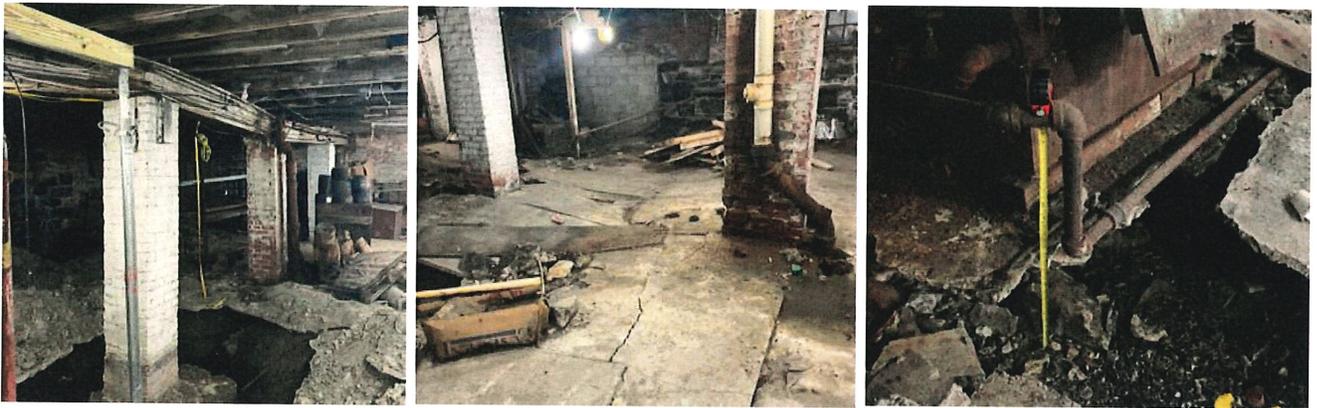
The building's exposure to water and weather over time has caused deterioration of the building's materials. This combined with the magnitude of total and differential settlements it has undergone, have resulted in failure of building's structural systems.

- Wood piles rot and compress causing total and differential settlement resulting in foundation walls that are cracked, bowed, and not plumb or level.
- Weather exposure and presence of water promote deterioration and loss of compressive strength of interior wood structure, and cracking, spalling or masonry walls.
- Ground floor slab and interior foundations settle due to a combination of improper design and construction, and incomplete removal of compressible Organic Deposits.
