CAMBRIDGE HISTORICAL COMMISSION HEARING APPLICATION

Updated Materials for October 9, 2025 public hearing

15 MT AUBURN STREET PROJECT

HARVARD UNIVERSITY NATIVE AMERICAN PROGRAM

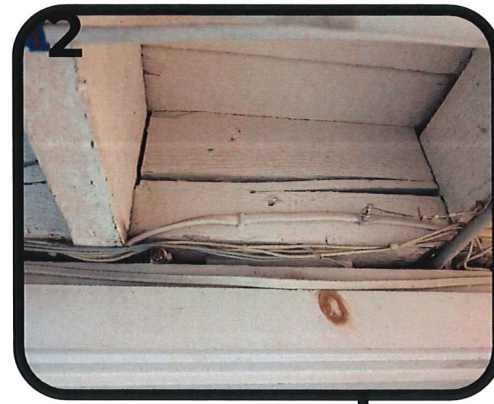
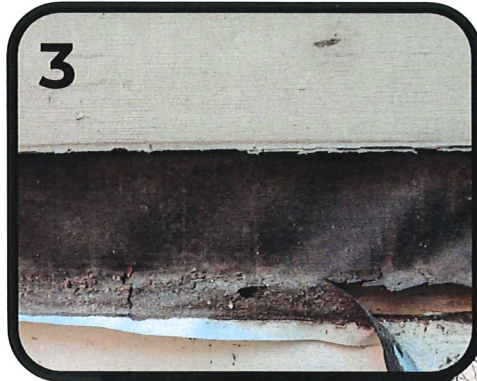
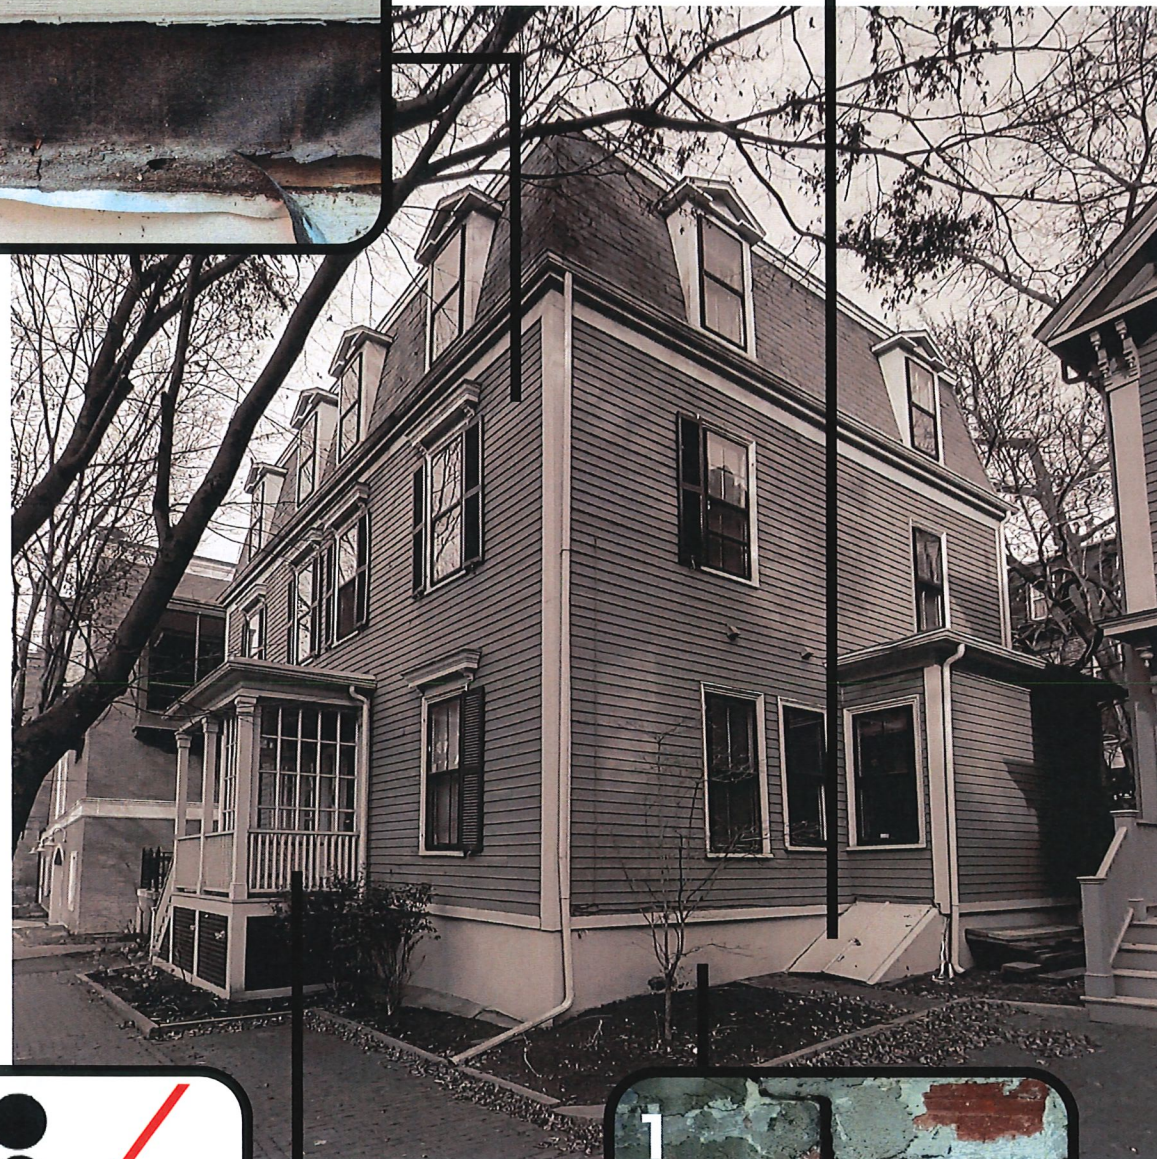
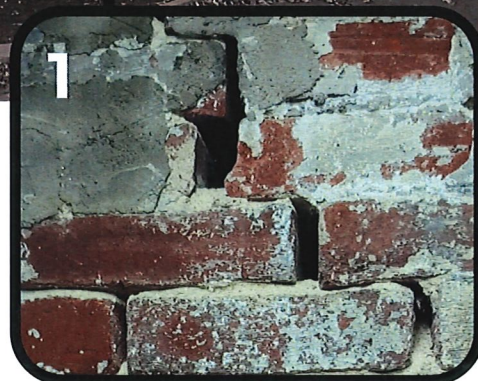
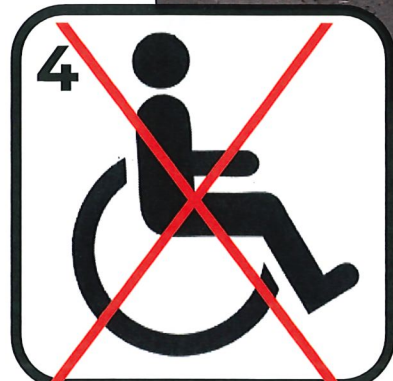
- Basement
 - Ceiling height does **not meet building code** (6'-3" to 7'-0")
 - **Water infiltration** on slab observed
- Existing foundation walls
 - Bricks over rubble stone
 - **Poor to fair conditions**
 - Shallow
 - SE and NE corner settled, with existing underpinning and shoring to remediate
 - East foundation wall bowing

EXISTING FOUNDATION CRACKS/ BILLOWING

WATER INFILTRATION AT SLAB

DETERIORATED MASONRY AT FOUNDATION WALL

PREVIOUS UNDERPINNING/ REPAIR AT SE CORNER

- Would need extensive work of **foundation underpinning** to make basement functional in a challenging tight site **6' away** from the residential abutter

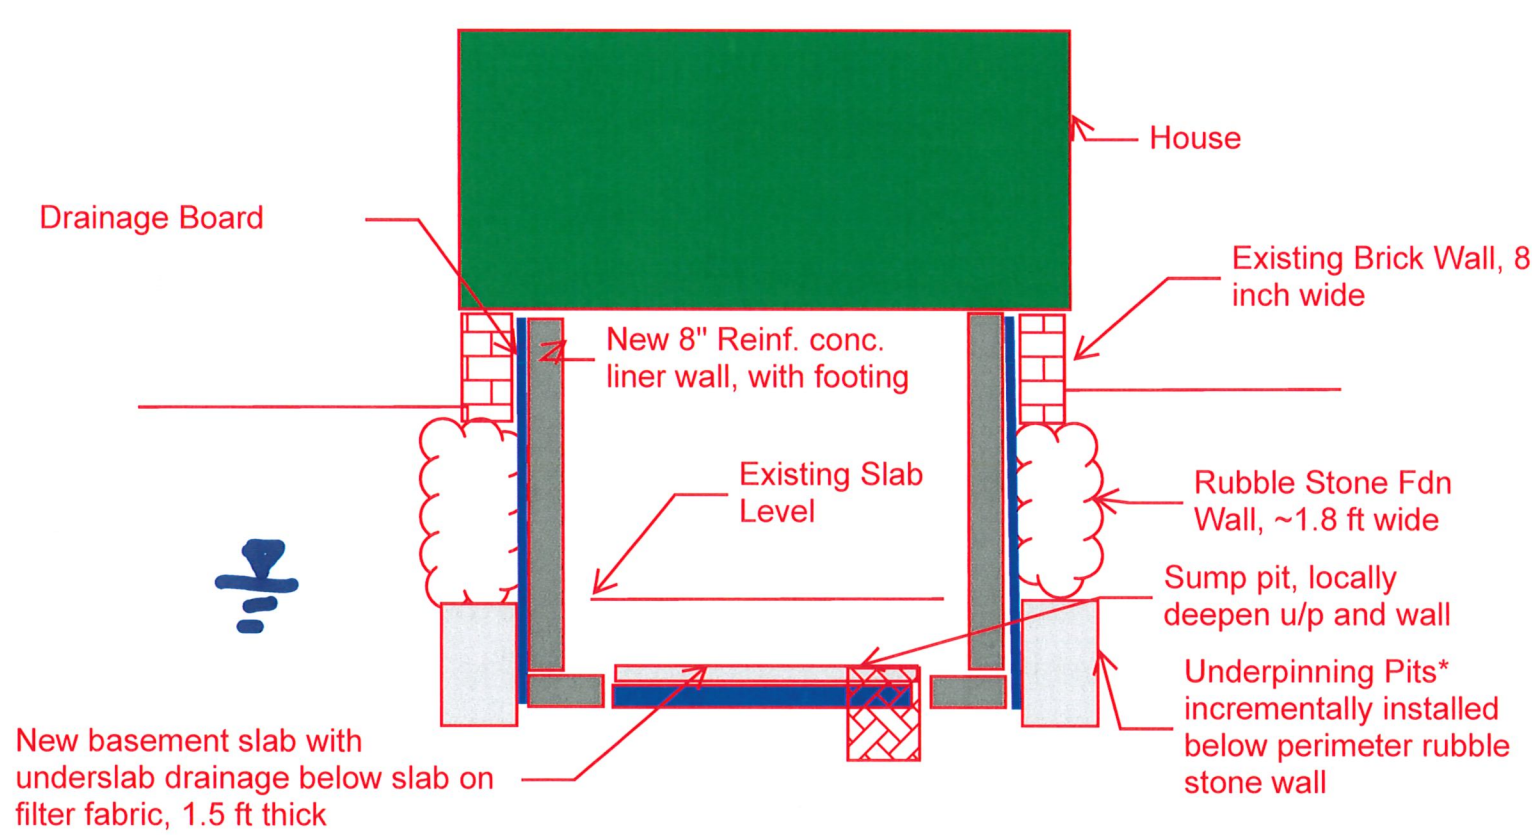
STRATEGY 1 - FOUNDATION REPAIR + UNDERPINNING

Two foundation repair strategies were investigated to understand the feasibility of addressing the structural deficiencies, water infiltration, and to bring the existing foundation and basement space up to current code.

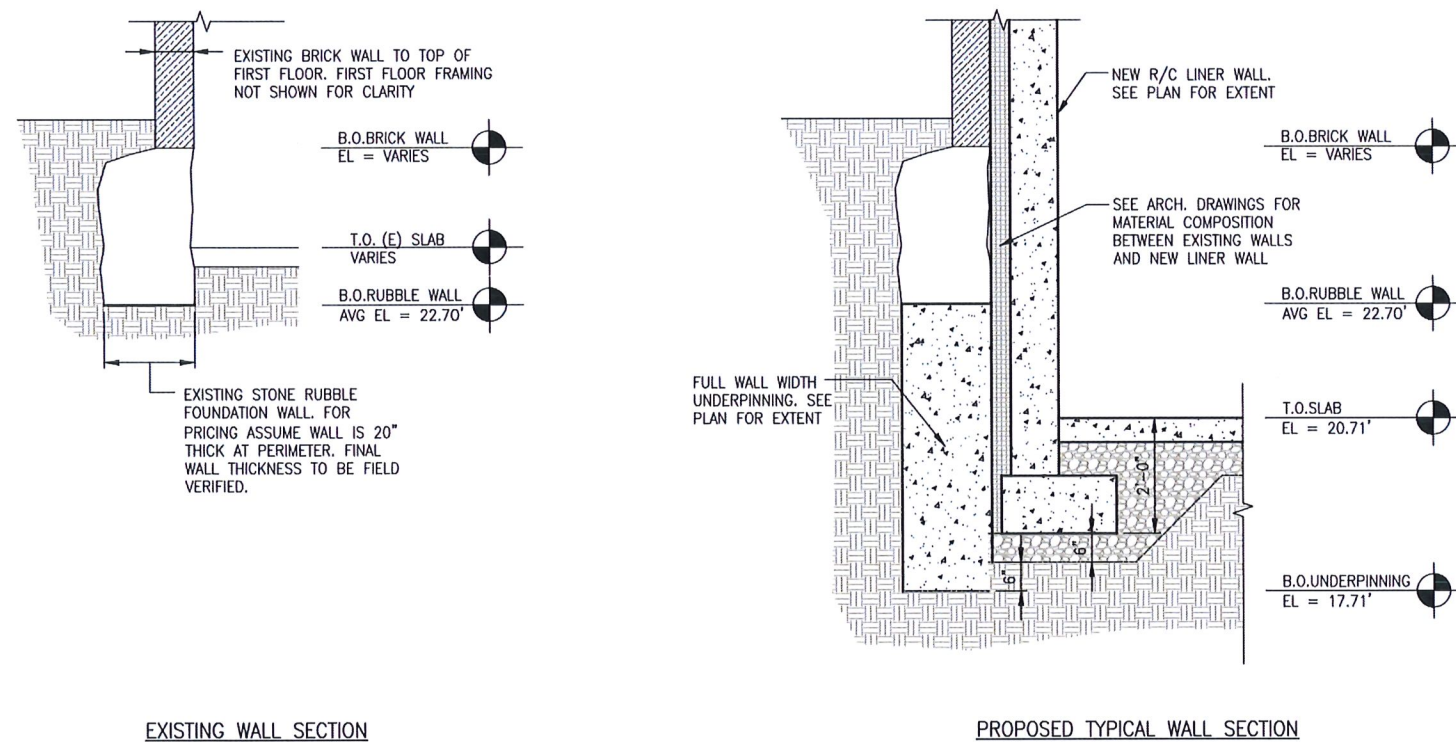
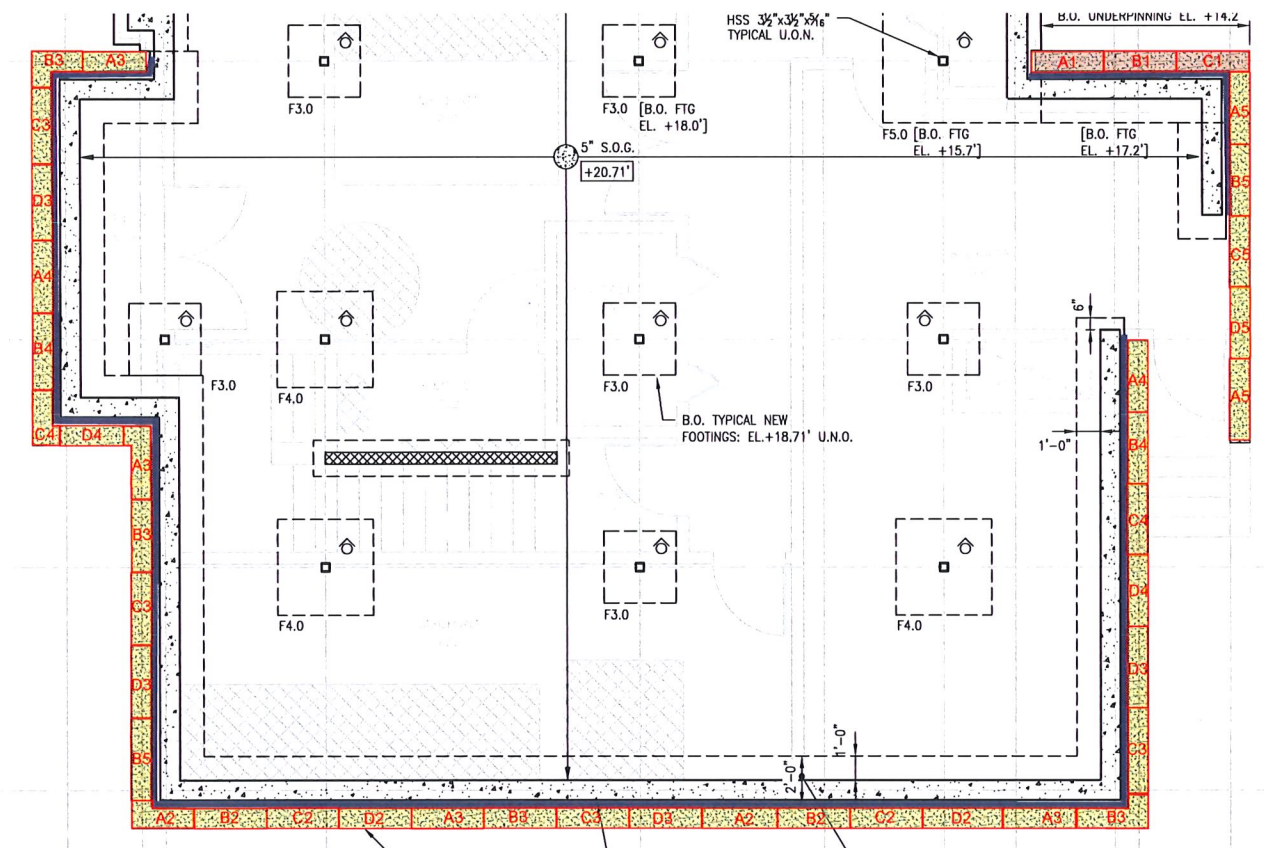
FOUNDATION - UNDERPINNING AND NEW LINER WALL

While it was the more feasible option, the site constraints would make this task extremely challenging.

After evaluating the feasibility of the two repair/replacement strategies, it was determined that the more feasible option would be to repair the existing foundation with underpinning and construct an additional 10" thick structural concrete liner and slab inside the existing foundation to meet current structural code.

To accomplish this, underpinning would need to be performed in 4' segments beneath the existing foundation walls. A new 10" thick concrete linear wall would need to be constructed with blind-side waterproofing and drainage system as part of the foundation design. The basement slab would need to be a reinforced concrete slab-on-grade with an underslab drainage system.

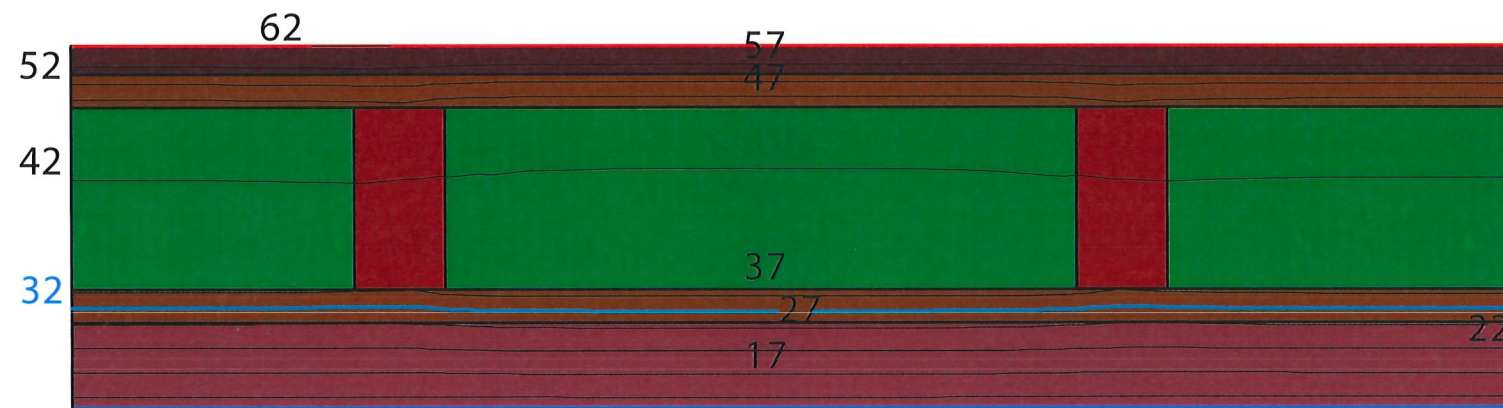
ISOTHERMS DIAGRAM @ EXISTING FACADE (TOP OF WALL)

As observed with the existing conditions on site and anticipated with the age and type of the facade materials used, we have concerns of the integrity and performance of the existing weather restive barrier (building paper) at the 3 existing façades that are to remain per the historic easement.

Air, water and moisture pass through the deteriorated barrier and reach the wood plank sheathing and other elements. Water and moisture can only dry out towards the exterior with the presence of a new vapor barrier installed on the warm side of insulation (interior side). As the façades are to be much better insulated and sealed, very little amount of heat is expected to escape the interior to dry out the moisture. Condensation would occur at the inside of the facade built-up, as shown on the isotherms diagrams on the left.

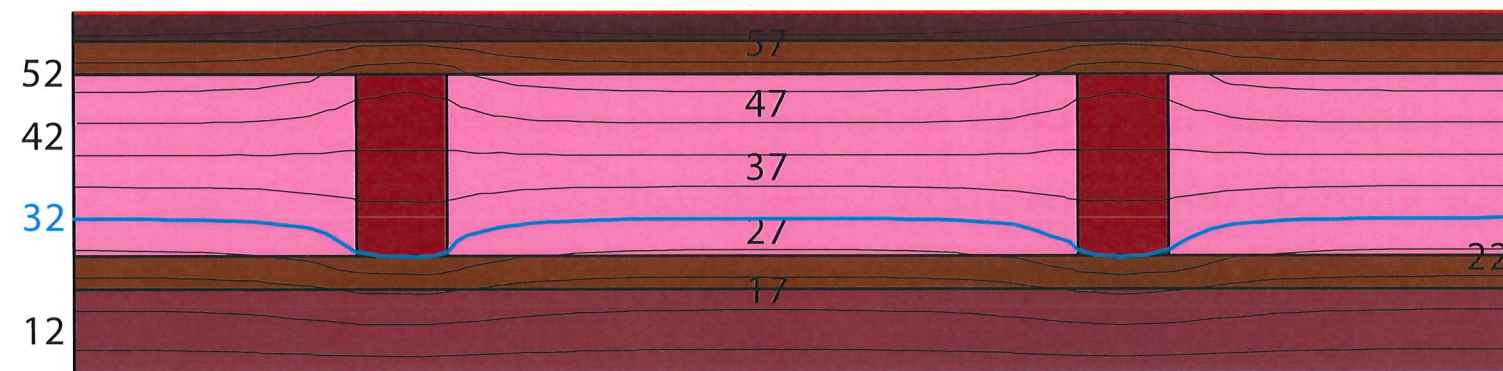
ISOTHERMS DIAGRAM @ EXISTING FACADE (BOTTOM OF WALL)

Adding new insulation to meet code will increase freeze-thaw cycles within the facade substrate and increase risk of further deterioration

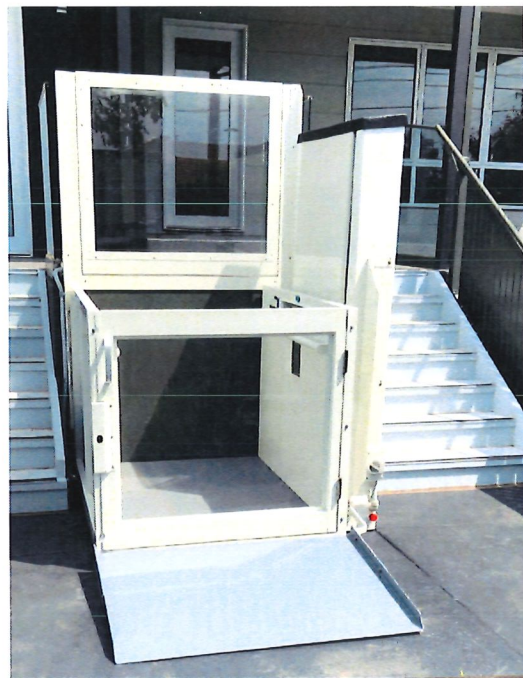
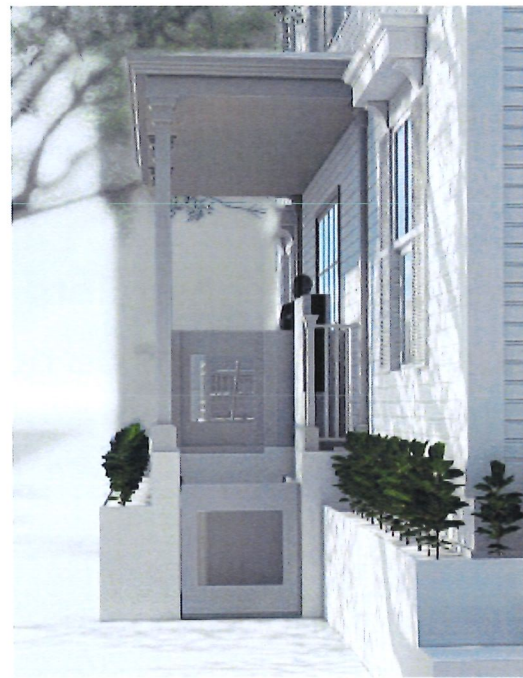
Building code 521 CMR 20.11.1 requires the interior spaces to be served by two accessible means of egress.

Multiple options were investigated to provide accessible front entrance. Adding an accessible ramp would not be possible due to site constraints. The only possible solution would be to add a vertical platform lift. The porch would need to be widened by 60" to maintain code required door clearance and to fit the lift equipment.

The back entrance would achieve accessibility via a ramp.
