# MEMORANDUM

DATE:February 23, 2016TO:CAM 004 Project FileFROM:Dennis Carr, MWHCC:Catherine Woodbury, Cambridge DPW; Richard Burns, MWRASUBJECT:Summary of Critical Tasks Involved in Separating the CAM 004 CSO RegulatorPROJECT:Concord Ave (Contract 9) Sewer Separation and Surface Improvements<br/>Project

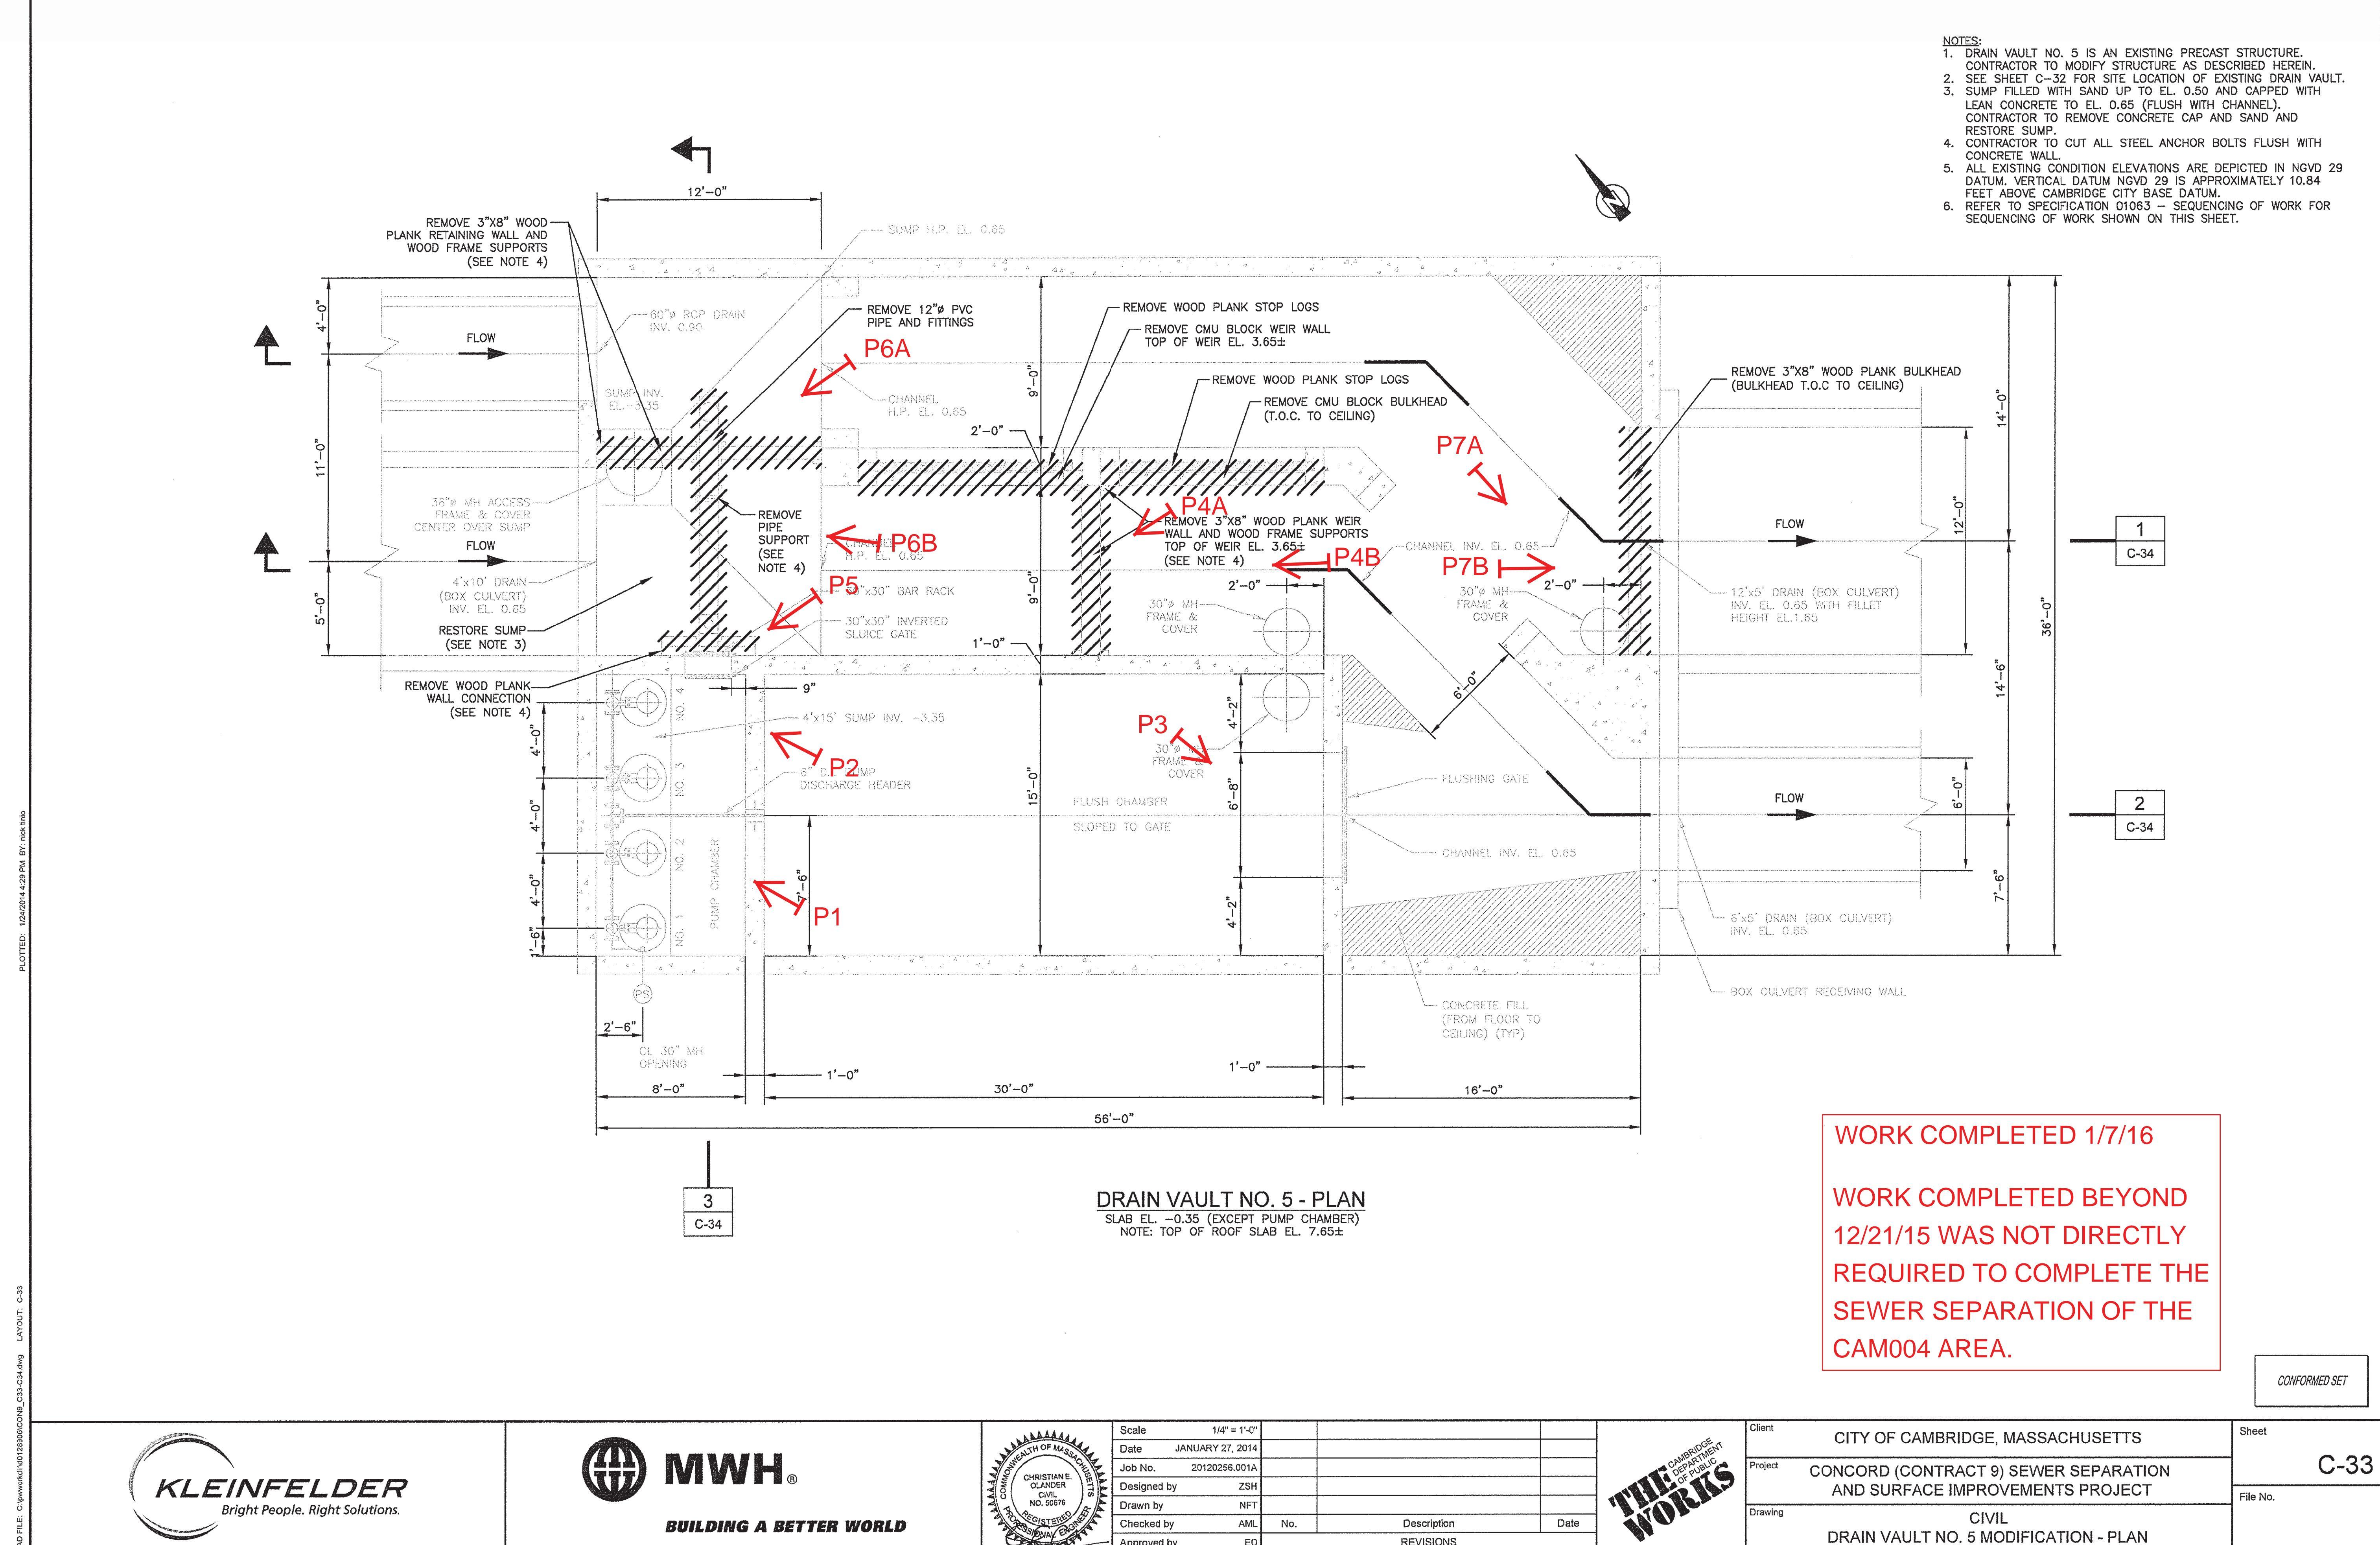
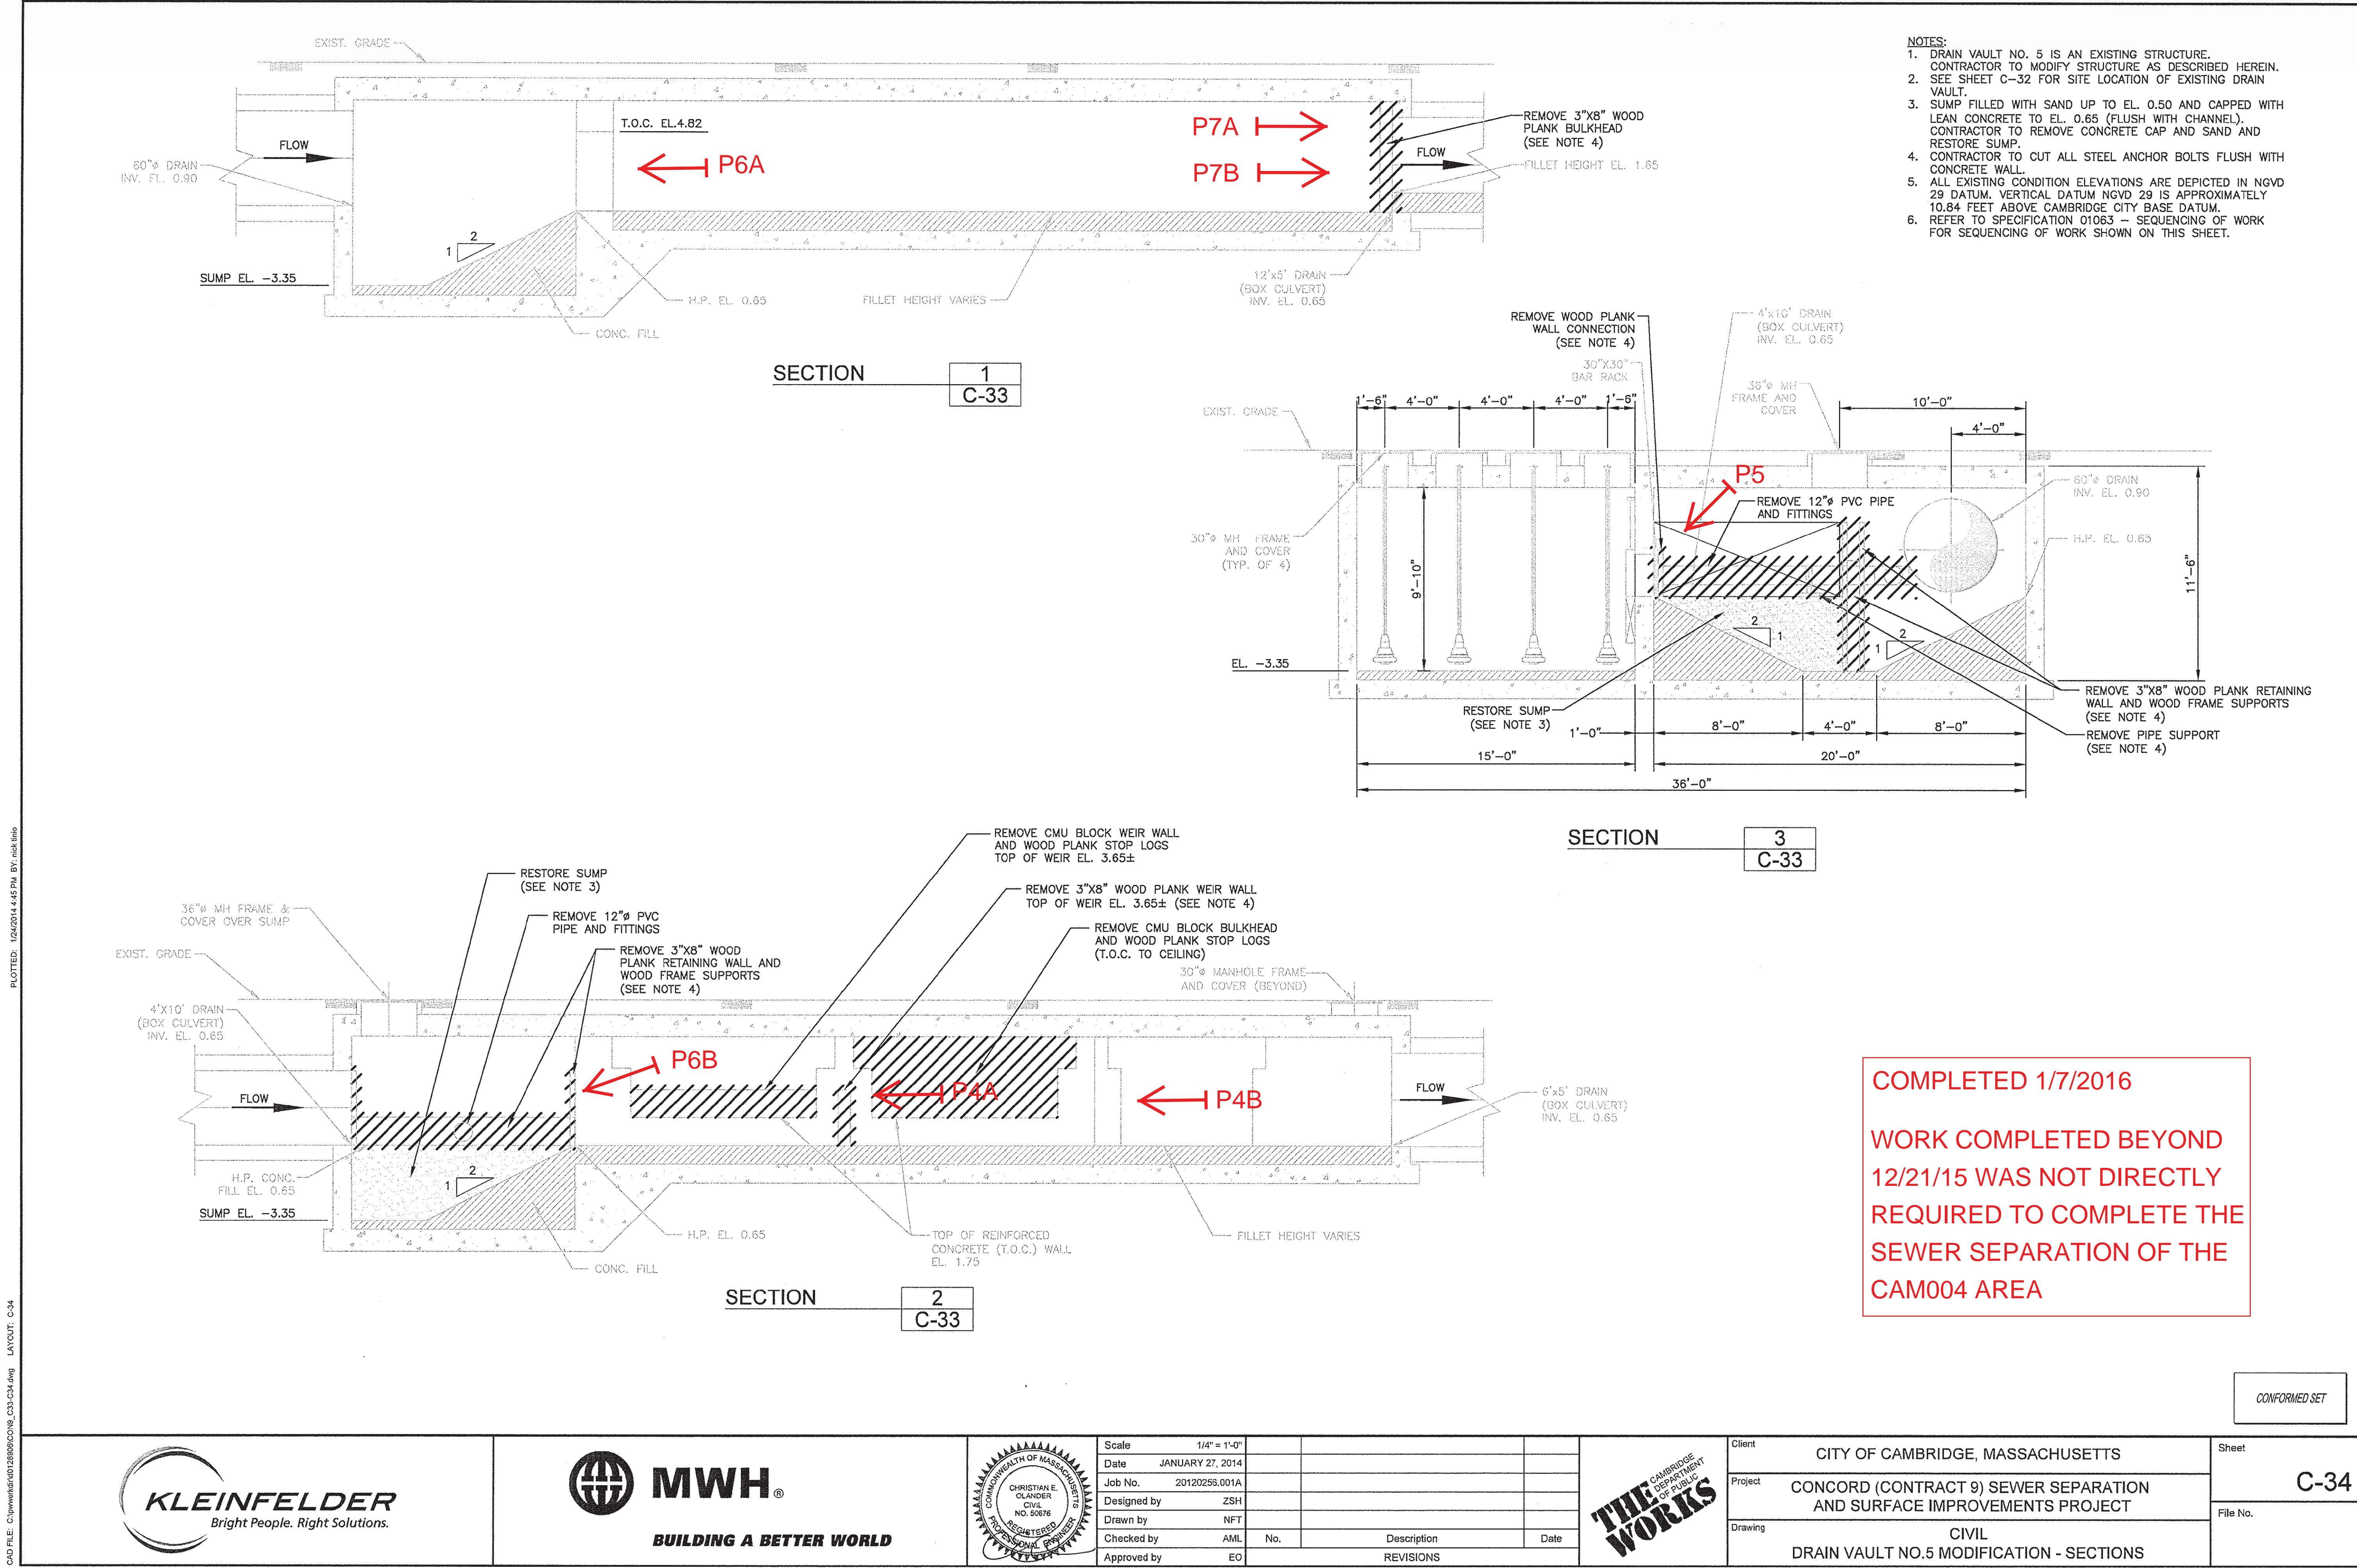
AT TACHMENT  $\mathbf{O}$ \_

4'x12' box culvert reduces upstream flooding and diverts storm flows to the newly created stormwater wetland. The location and results of these modifications are illustrated by Photographs P4 through P7 in Attachments C- 1, C-2, C-4 and C-5.

The work included the removal of two wooden overflow weirs, removal of two sections of masonry block walls, the reactivation of the grit pit by removing the gravel fill and 15" diversion pipe, and the removal of the wooden bulkhead leading to the 4'x12' box culvert. Opening the

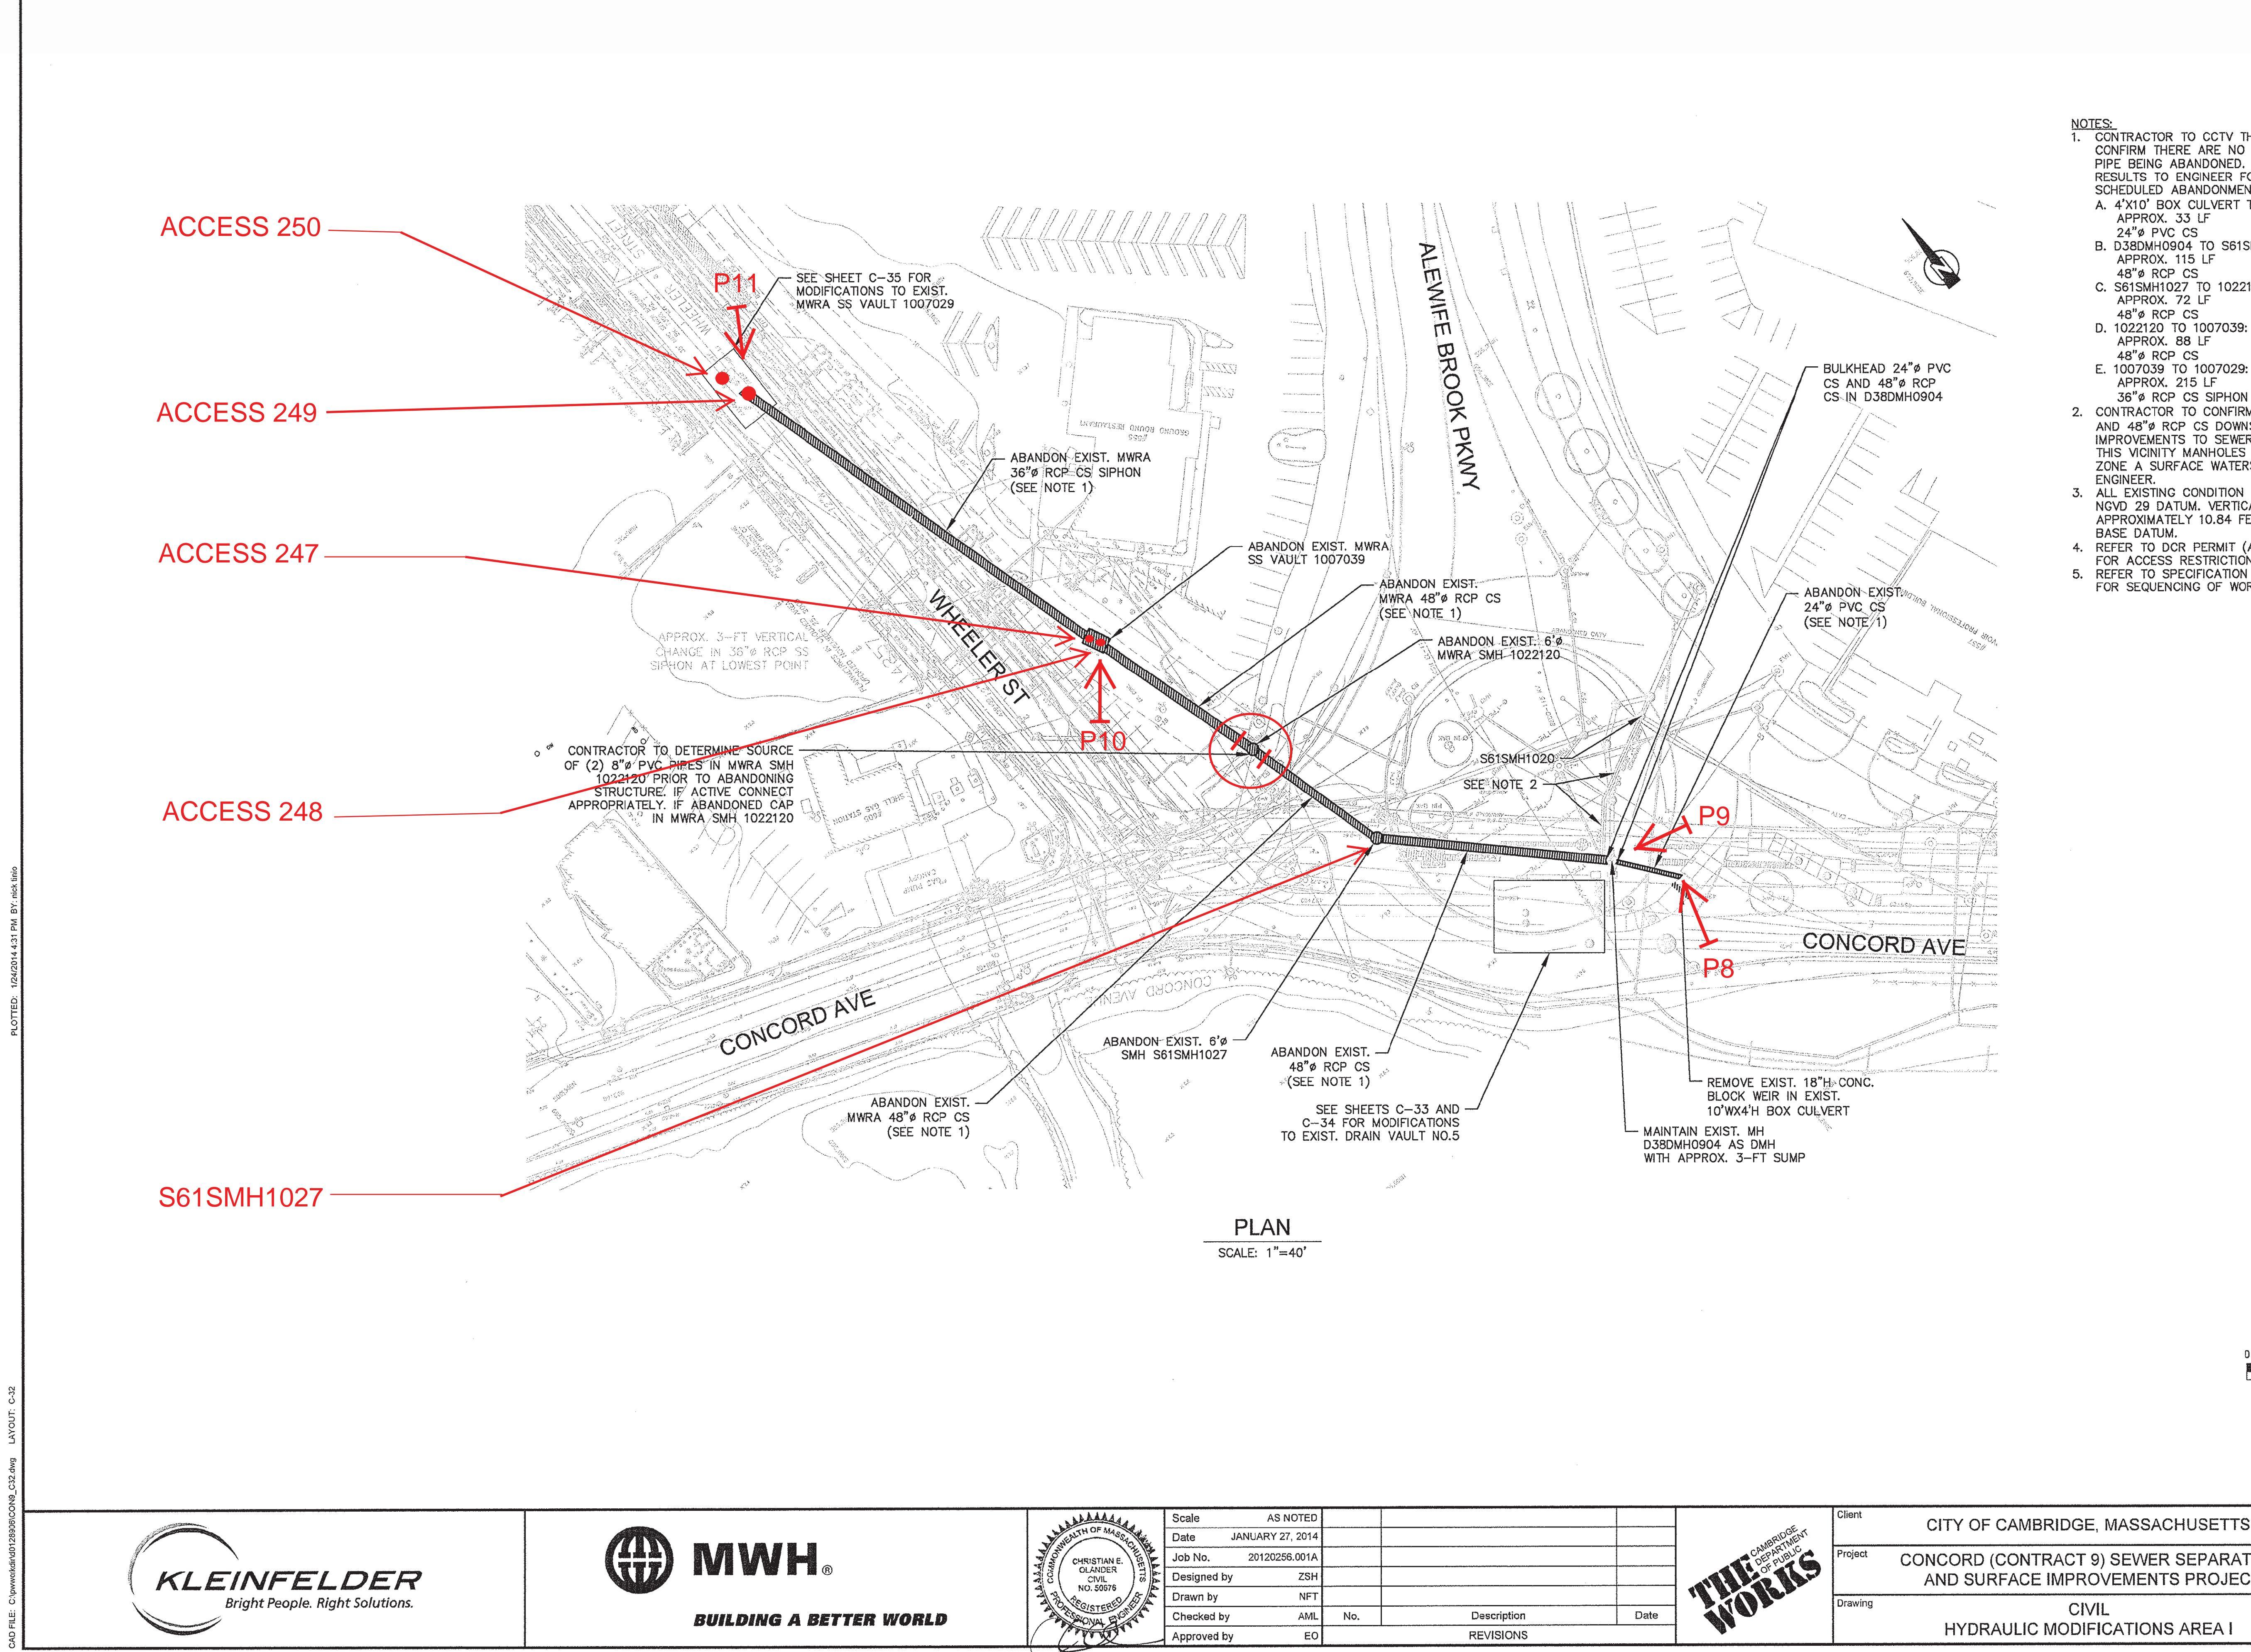
ient	CITY OF CAMBRIDGE, MASSACHUSETTS	Sheet
oject	CONCORD (CONTRACT 9) SEWER SEPARATION AND SURFACE IMPROVEMENTS PROJECT	C-32
rawing	CIVIL HYDRAULIC MODIFICATIONS AREA I

Sampling and testing of dry weather flow in the major storm drains tributary to the CSO Regulator located at Drain Vault 5 were performed according to EPA's guidelines. Sand bags were installed samples were collected within the vault and immediately upstream. Samples were analyzed by field kits or sent to the laboratory for analysis. The results met water quality standards for separated storm drain allowing the 24" dry weather connection between the City's 4'x10' box drain and MWRA's 48" sewer to be abandoned.

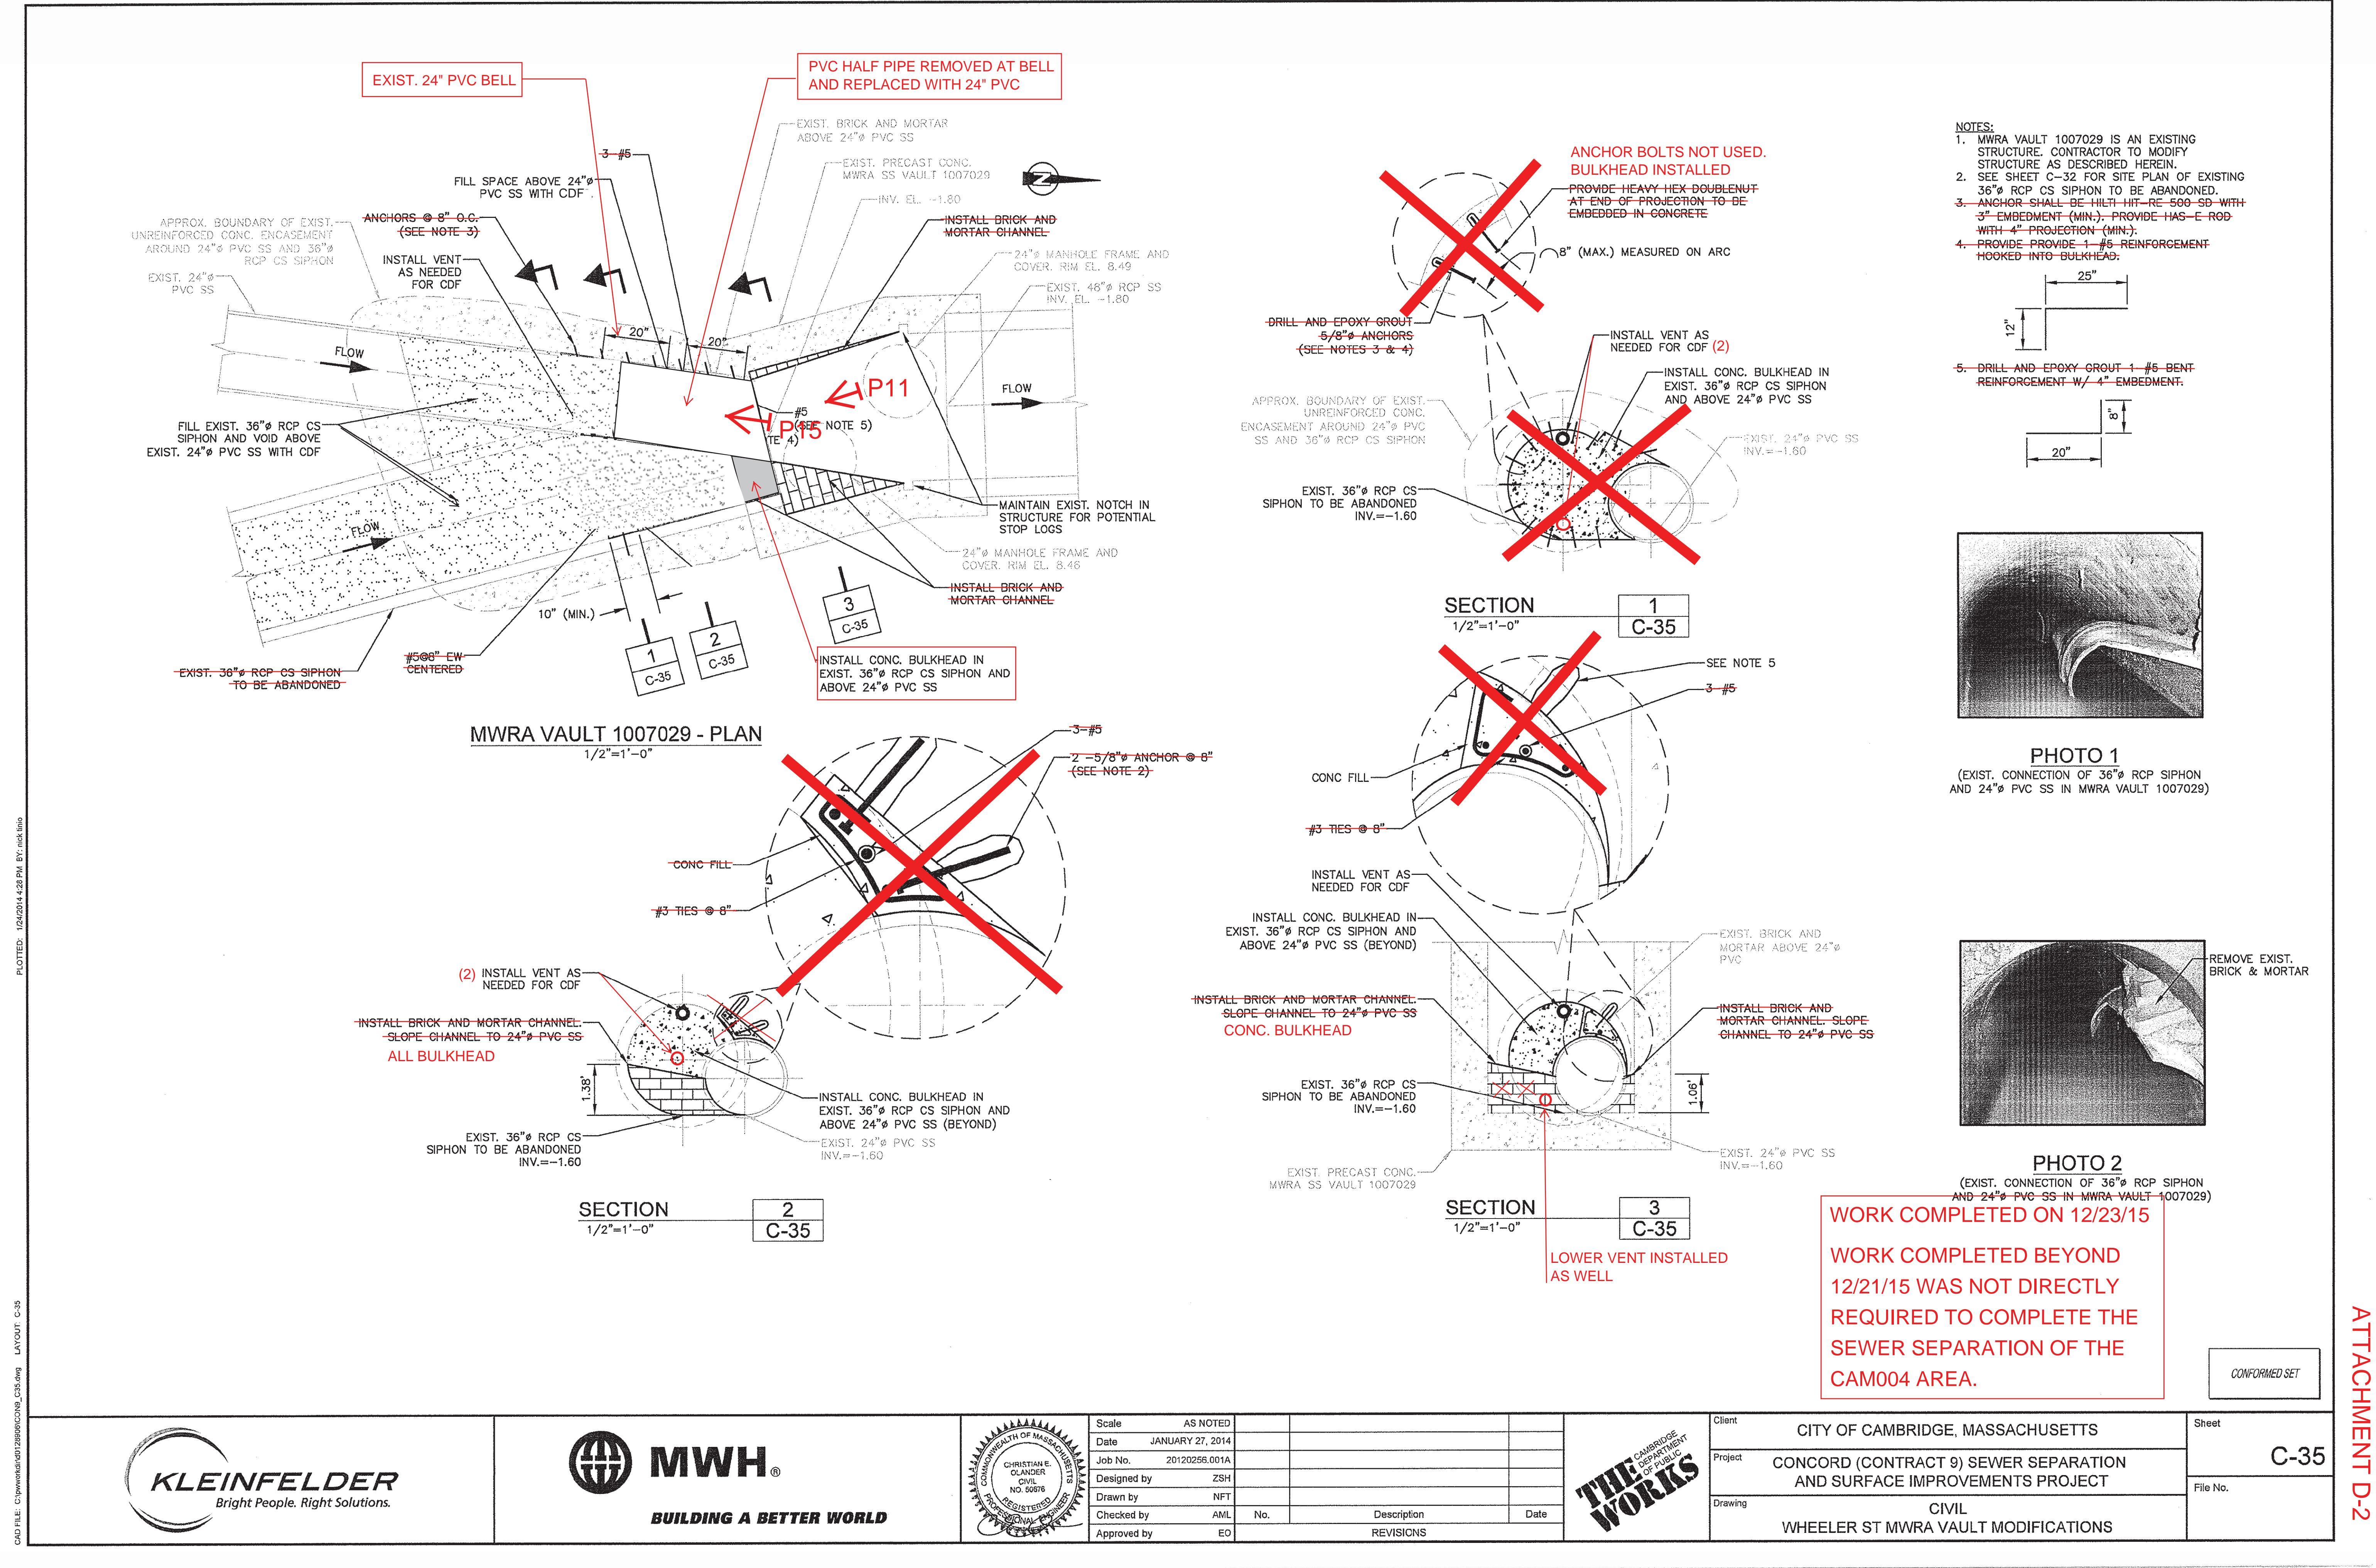
**TACHMENT D-1**

Plugging the connection between the 4'x10' box culvert (drain) and MWRA's sewer required masonry bulkheads at two locations. One is located in the 24" RCP dry weather lateral connection within the box culvert and the other is at the upper end of the MWRA sewer located adjacent to Drain Vault #5. The work also included bulkheading and flow filling the section of MWRA sewer (known as the Alewife Brook Conduit) between the rotary and Wheeler Street. The locations and photographs of these modifications are illustrated in Photographs P8 through P11 on Attachments D-1, D-2 and D-3. MWRA vault #1007029 now serves as the upstream terminal manhole for the MWRA's sewer in this area.

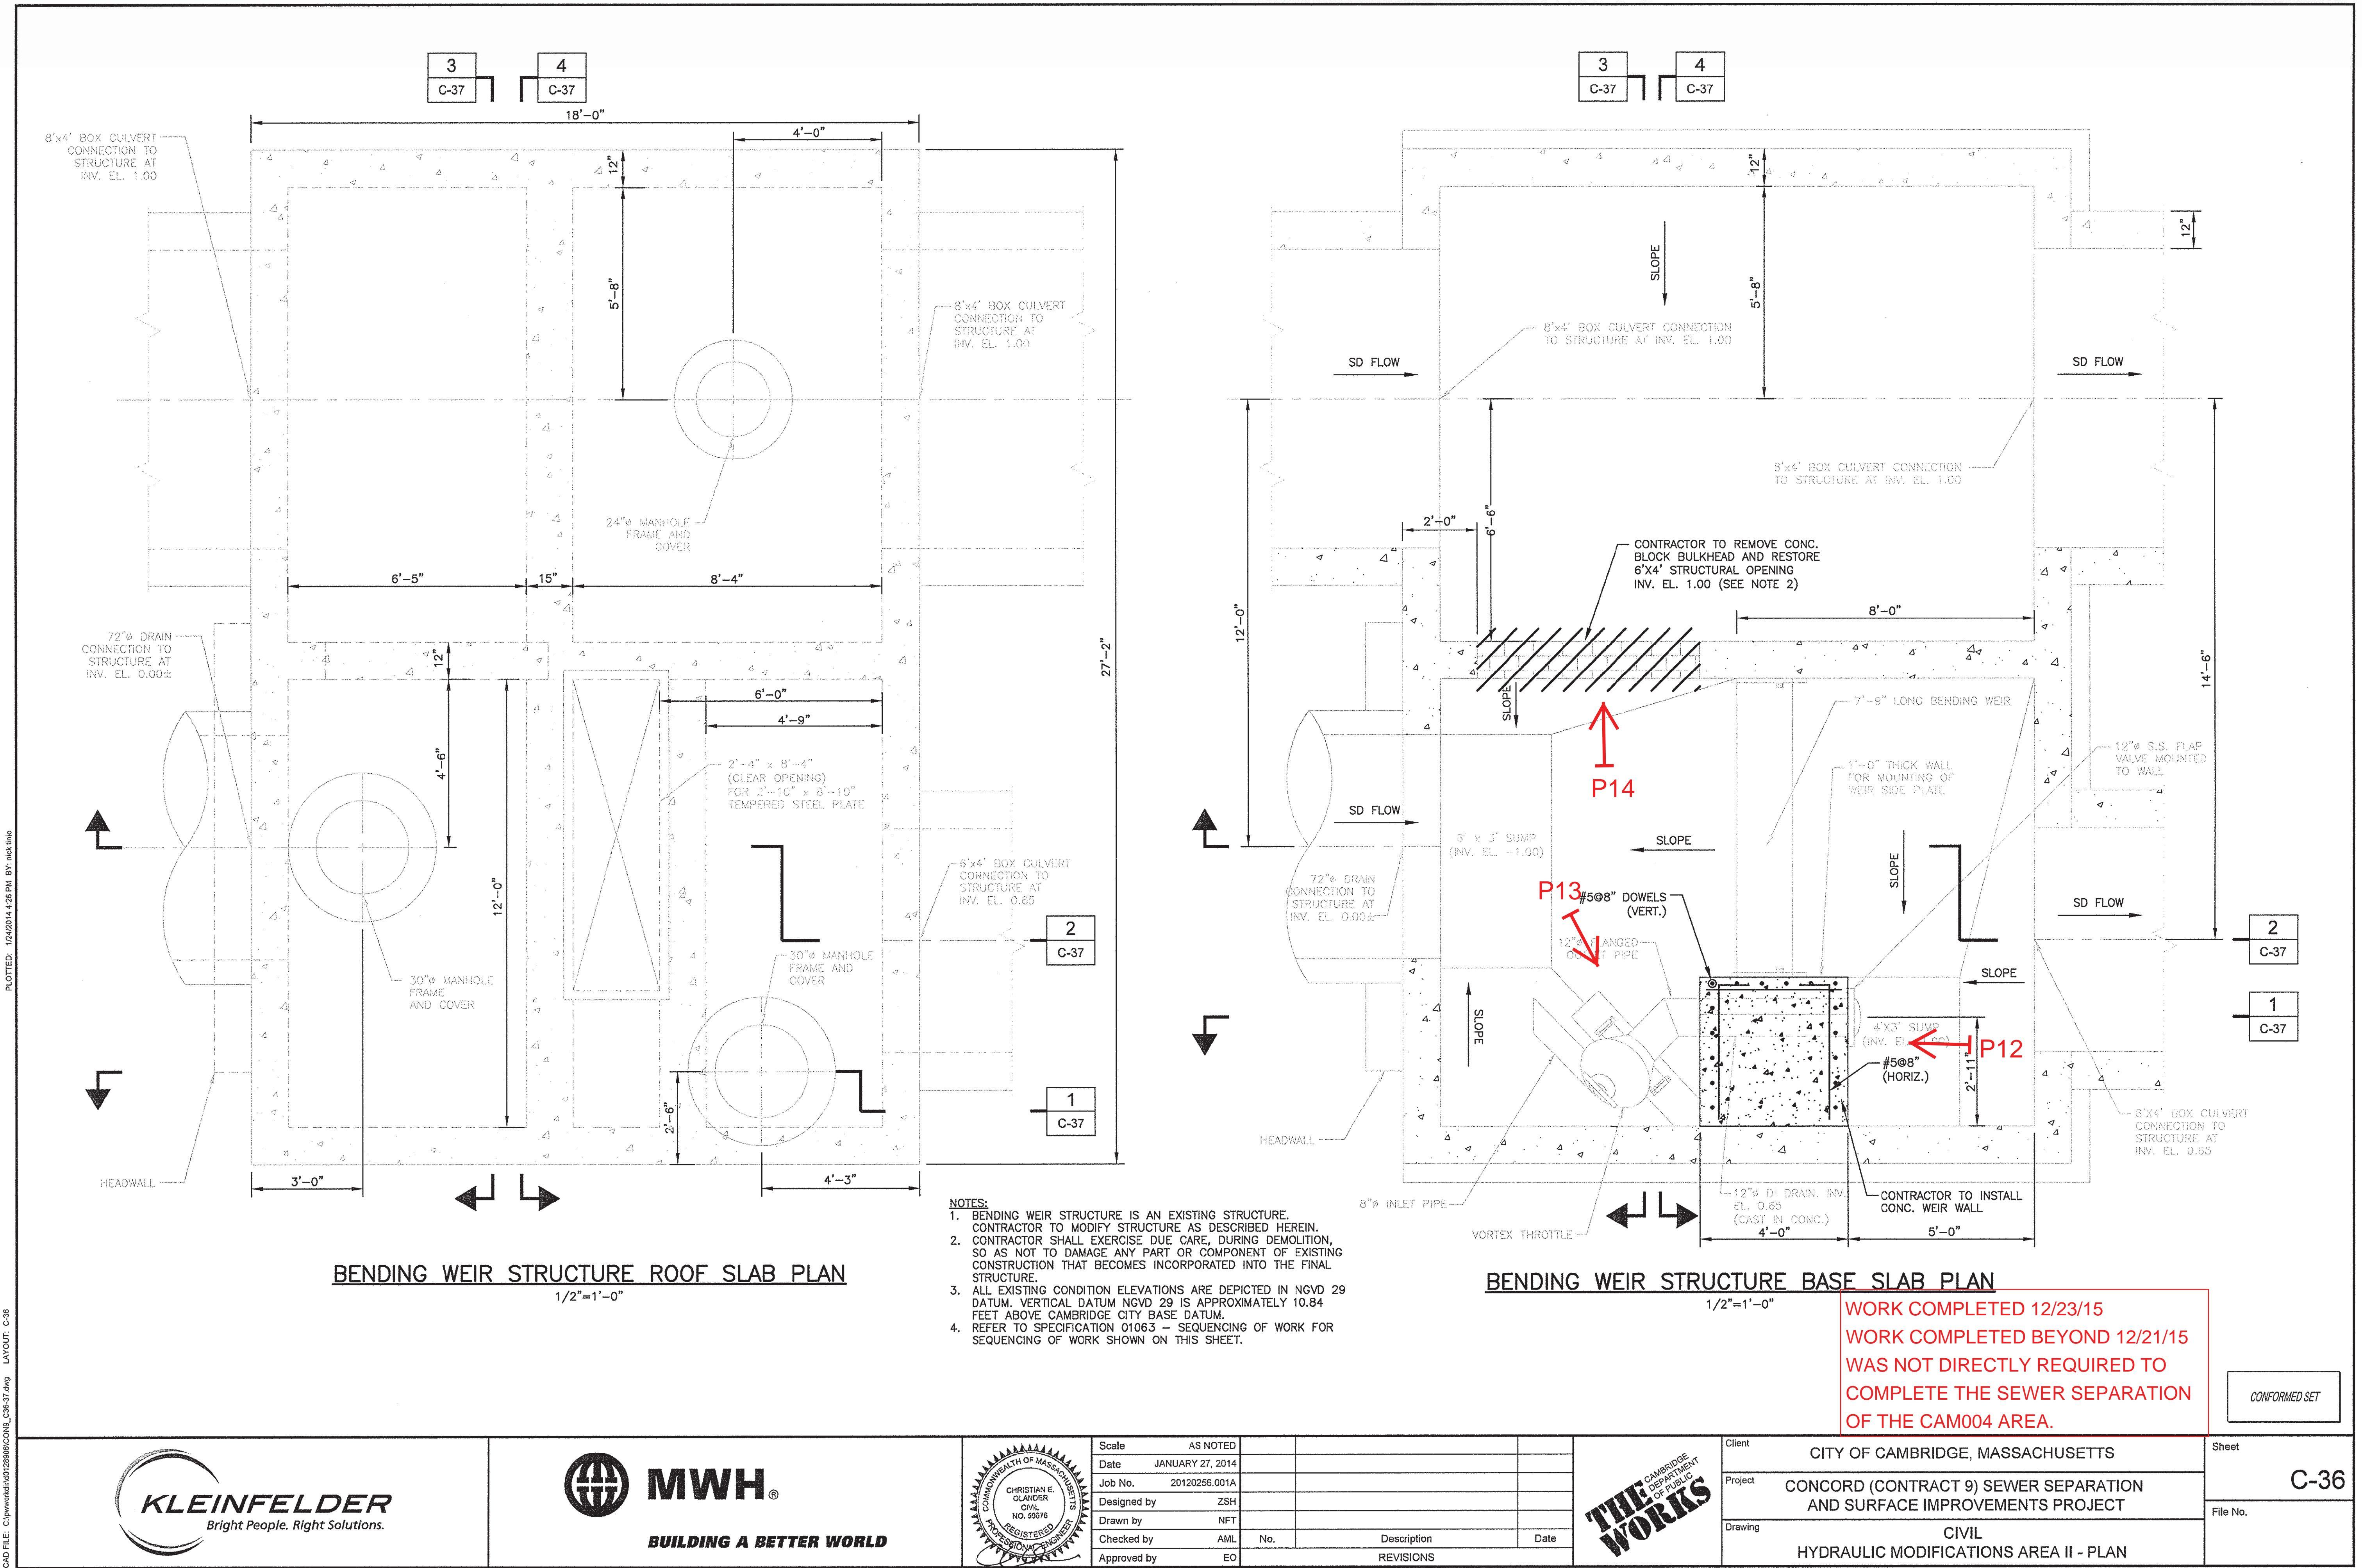
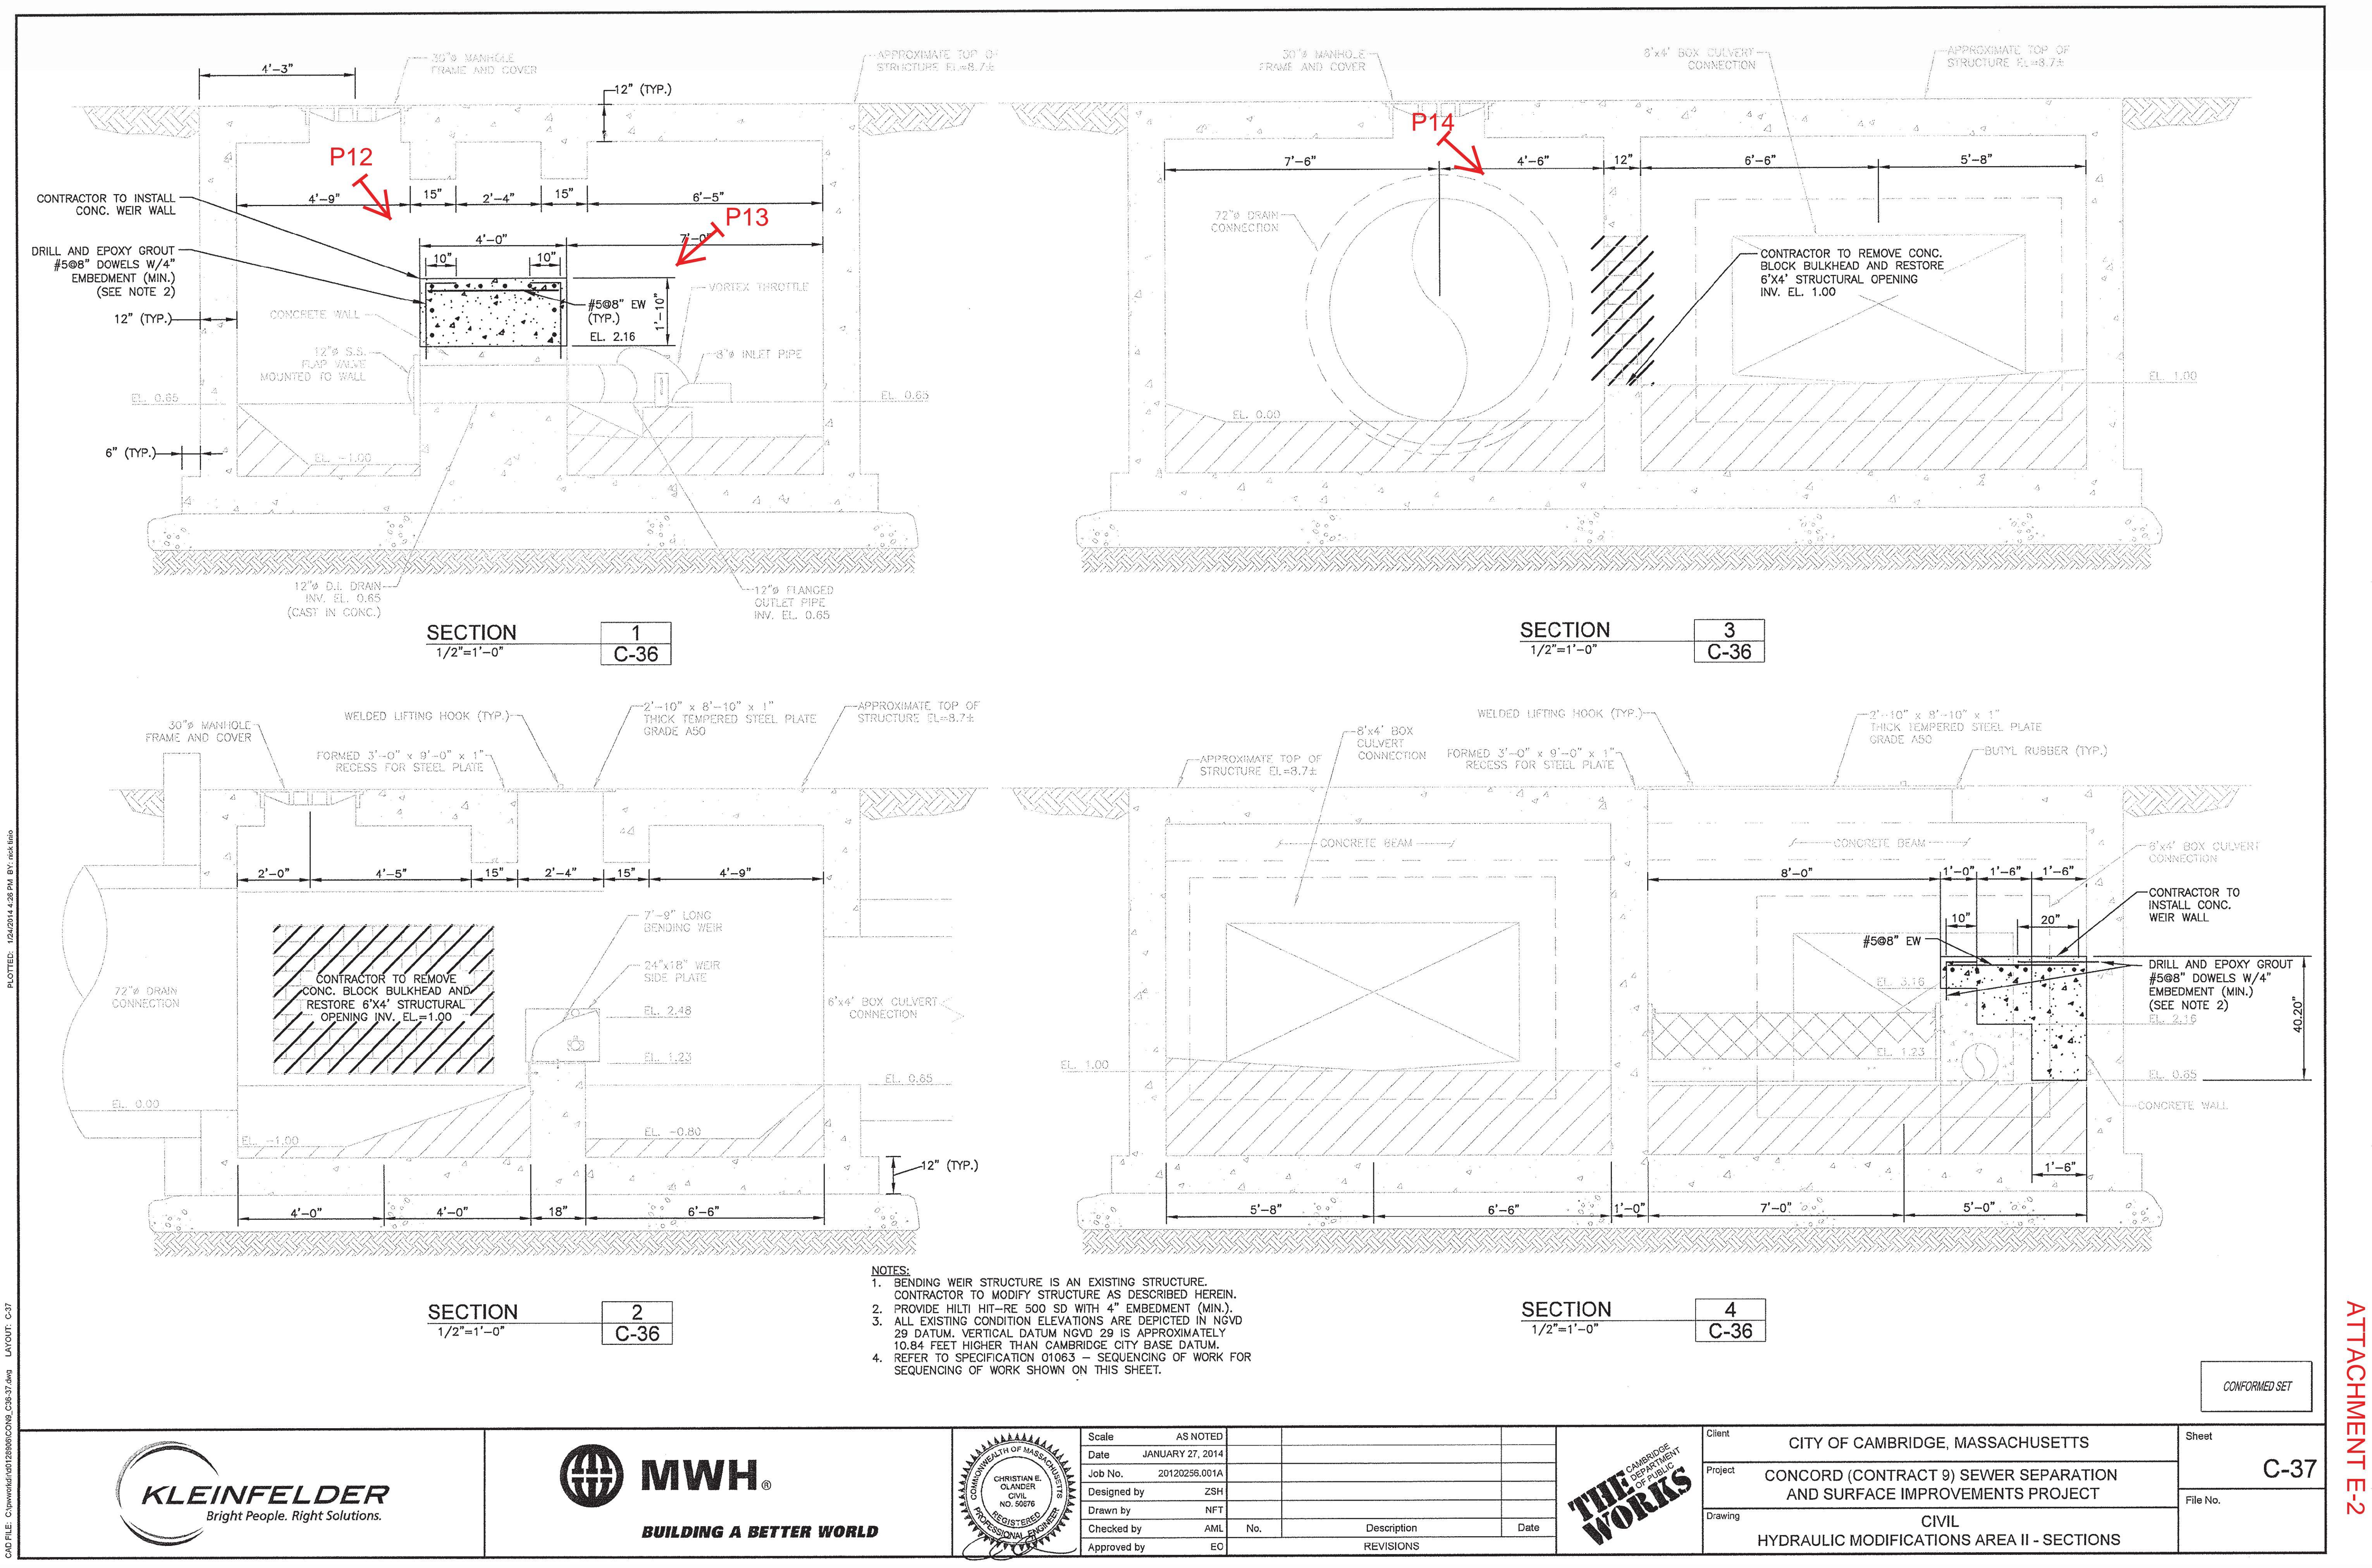
Modifications to the bending weir structure included raising the elevation of the weir wall adjacent to the bending weir and removing the temporary masonry block bulkhead that was installed between the 72" storm drain and the 4'x8' box culvert. Removing the bulkhead will deflect more frequent storm flows in the 72" drain to the newly created wetlands. The larger, less frequent storms will cause the bending weir to deflect and release excessive flood waters to Little River. The location of the Bending Weir Structure is shown on Attachment B-1. Details of the modifications are illustrated in Photographs P12, P13, and P14 on Attachments E-1, E-2 and E-3.
