Main Library Expansion Project

Cambridge, Massachusetts

Existing Conditions Report and Preservation Recommendations

January 31, 2003

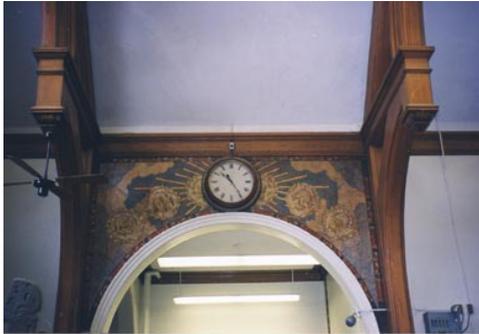
View of Mural, Delivery Room, 2002

- Peeling paint, water stains and plaster cracks were noted in the main reading areas from past roof leaks. In one instance, damaged plaster has affected one of the Delivery Room murals.
- More significant water damage was found in the ceiling of the semi-circular room of the Stack Wing.
- Cracked, water damaged, and flaking plaster was found in the Cambridge Room.
- Cracked and patched plaster were noted at dormered areas of the second floor of the 1894 Wing.
- The worst damage has occurred above the east stair at the junction of the 1889 and 1894 wing. This area of active water infiltration has been noted in the description of the Copper Roof. In addition, there are water stains and damaged plaster at the exterior wall opposite the east stair.

f. Murals: Mural paintings are located in the archways of the original Delivery Room and half dome at the end of the Reading Room. These are generally in good condition, having been cleaned and sealed in 1990. The mural on the west archway was also restored following water damage from the roof. It appears that new damage has occurred in this location since the mural was last repaired.

f. Murals: Investigate need for restoration at damaged areas.

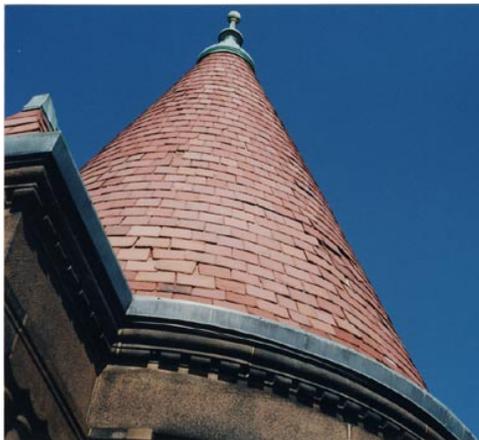
Slate Roof at Tower, 2002

a. Slate Roof. The red slate roofing, copper ridge caps and flashing appear to be generally in good condition and have benefited from appropriate maintenance and repair. However, after 114 years, the roof shows inevitable signs of age and may be reaching the end of its expected life span. The slate roof was physically examined with a representative from Gilbert & Becker. The attics under these roofs were also surveyed. In four areas, slates were removed in order to inspect the condition of the flashings, roofing felt and wood sheathing. Ridge caps and valleys are weathered but appear to be appropriately detailed and functional. Step-flashing at dormers is generally in good working order. Plaster damage on the west wall of the Cambridge Room suggests that step-flashing at parapets requires attention. An examination of the roofing felt indicated that, in areas receiving direct sunlight, this material is all but disintegrated. According to the roofer, there is now limited second means of defense against moisture should a slate become loose or missing. The risk of developing leaks in the future is great. In the attic, areas of staining indicate a history of numerous leaks. The rafters and wood sheathing, however, appear to sound, indicating that past leaks have not caused significant damage. (Refer to discussion of open mortar joints in Section 2.3 as an additional source of moisture infiltration).

- Install new membrane roof over apsidal end of Stack Wing.
- Clean out and maintain gutters and downspouts on a regular basis, at least twice a year.
- Upgrade current bird deterrent systems.
- Repair step-flashing along chimney at copper roof.
- Repair open joints in copper roof.
- Repair flashing at parapet above west wall of Cambridge Room.
- Consider phased plan for total replacement of slate roof and associated copper ridges, valleys and flashing.
- Establish a cost estimate for total replacement of flat seam copper roofing and slate roofing with associated copper ridges, valleys and flashing.

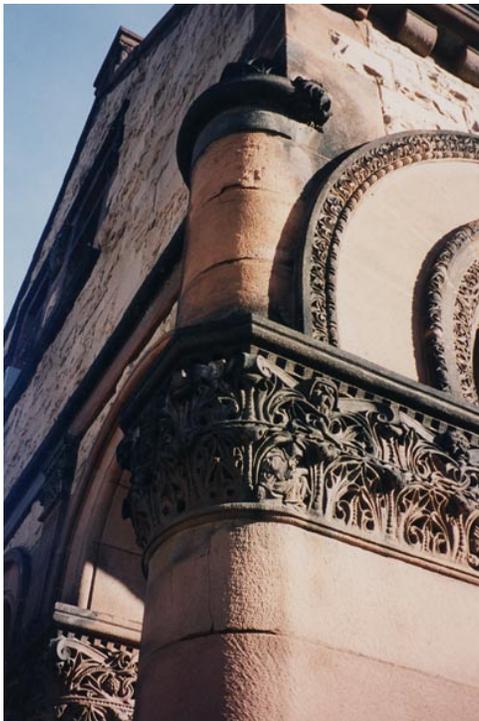
West Portico, 2002

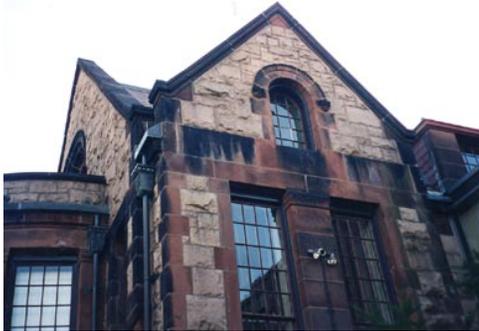
The granite is heavily soiled in certain locations but its condition remains excellent. The sandstone is typically in worse condition. Although Dedham sandstone is more durable than most, it is significantly softer than granite and, unfortunately, has been deployed throughout the building façade in the most exposed locations such as sills and cornices. The condition of the sandstone varies from instances of moderate to severe spalling, cracking and surface erosion. Most surfaces are extensively soiled and there is extensive pigeon staining in recessed areas. It should be noted, however, that in only a few instances is the deterioration considered structural. These most deteriorated elements include the projected sandstone soffits at the second floor dormer windows above the portico and sandstone quoins on the north elevation of the Stack Wing.

West Elevation, Stack Wing, 2002

- 100% repointing of stone.
- Patch cracks and deteriorated areas with mortar colored to match the sandstone.
- 100% Restoration cleaning. Clean existing masonry to prevent associated deterioration and to allow pointing and new construction work to match the original and age together.
- Replace stone that is structurally compromised. Assume 5%.
- Replace stone removed in 1967 if the affected historic elevations are to be restored.

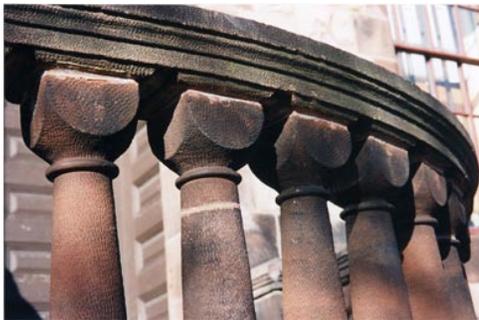
Balustrade, 1894 Wing, 2002

- Cracking of sandstone pier at main entrance.
- Erosion at window soffits at both 1889 and 1894 wings.
- Cracking and displacement outside semi-circular room of the Stack Wing.
- Deteriorated sandstone with efflorescence and algae growth east elevation of the 1894 Wing and at the north elevation of the Stack Wing.

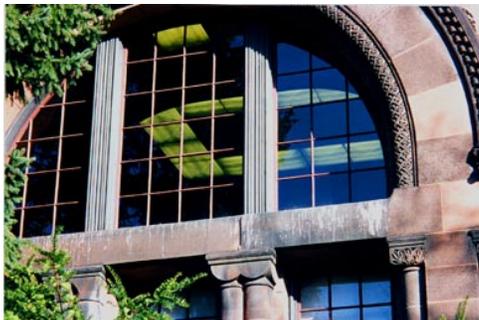
Window, South Elevation, 2002

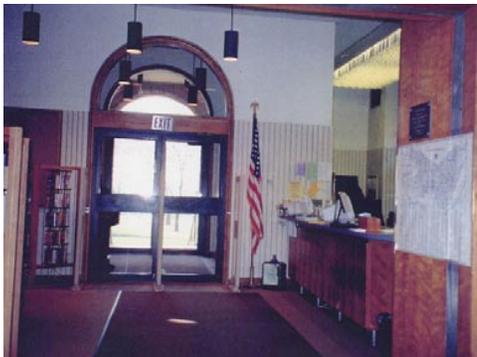
View of Entry, 2002

The original entry doors and transom were replaced with an aluminum storefront in 1967. This is in good condition, but is not historically appropriate. The 1889 design is documented in drawings and photographs. The exterior doors at the northeast corner of the 1894 Wing are original. They are in fair condition with peeling paint and split wood. It should be noted that all of the windows, sash as well as frame, in the west elevation of the Stack Wing and in the north elevation of the 1889 Structure were removed during the construction of the 1967 Addition.

b. Doors and Hardware: Replace 1967 storefront in the vestibule and 1967 interior doors and transom inserts in the Delivery Room and in the Lecture Hall. Replace these with doors that match the original designs or are historically appropriate. Include hardware that meets current code requirements.

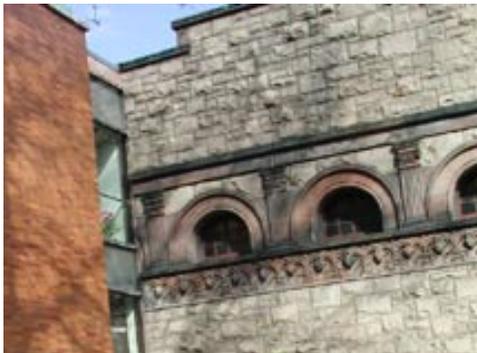
Juncture 1967 Stair and West Elevation

1898 Building. At that time, the entire brownstone cornice and associated copper gutter along these elevations were removed. All of the windows, frames and sash, were removed as well. New openings were cut into the granite at several locations. In addition, the stair tower added at that time encroached on the west elevation of the entry portico, resulting in the loss of two window bays and several linear feet of intricately carved brownstone frieze. (See photograph previous page.)

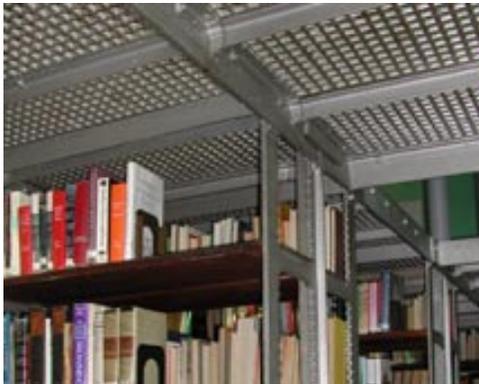
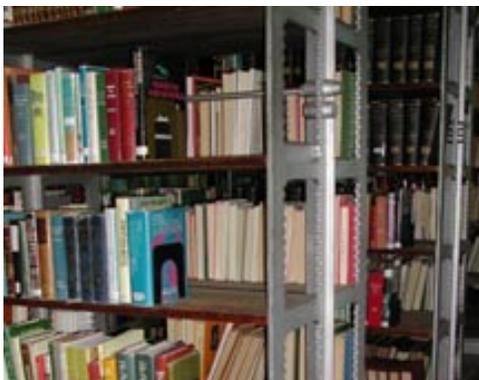
Former Children's Room, 2002

Stacks, Detail, 2002
