**The Ragon Institute of MGH, MIT and Harvard**  
**Proposed Demolition of 624 Main Street**  
**10 September 2020**

SUBJECT: Existing Conditions Summary  
624 Main Street, Cambridge, Massachusetts

**Subject** 624 Main Street – Structural Engineering Report

624 MAIN STREET  
**REVIEW OF BUILDING CONDITION**  
AUGUST 18, 2020

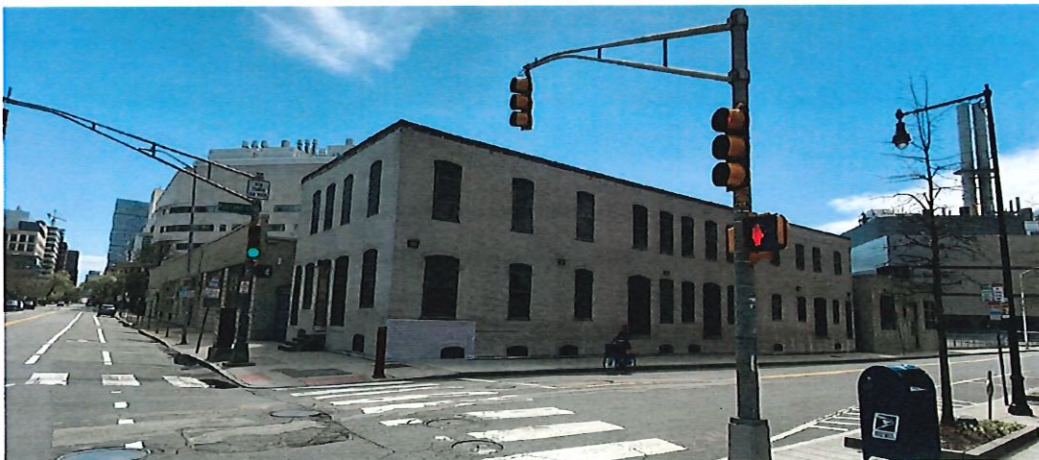
Figure 1 - 624 Main Street, Existing Conditions View

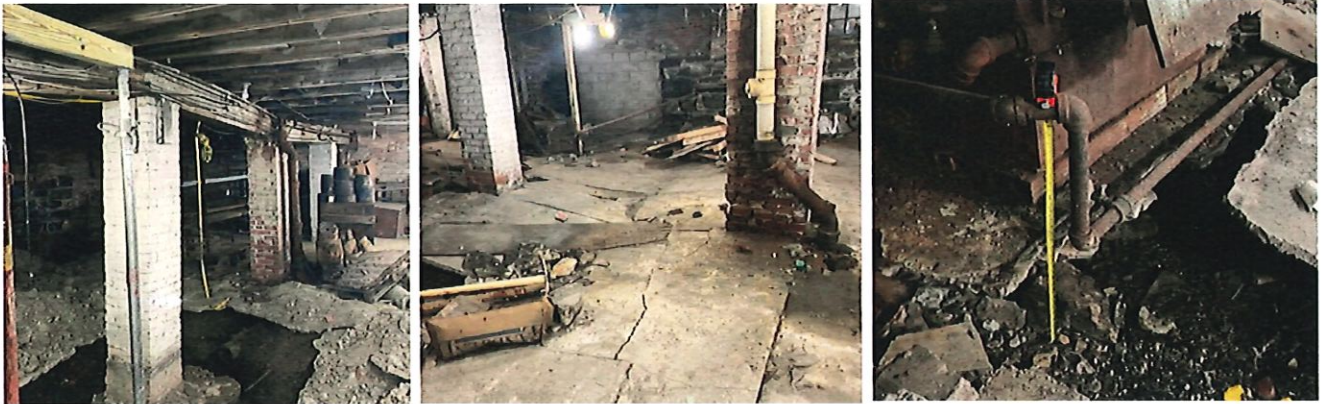
The building's exposure to water and weather over time has caused deterioration of the building's materials. This combined with the magnitude of total and differential settlements it has undergone, have resulted in failure of building's structural systems.

- Wood piles rot and compress causing total and differential settlement resulting in foundation walls that are cracked, bowed, and not plumb or level.
- Weather exposure and presence of water promote deterioration and loss of compressive strength of interior wood structure, and cracking, spalling or masonry walls.
- Ground floor slab and interior foundations settle due to a combination of improper design and construction, and incomplete removal of compressible Organic Deposits.

Deterioration of the building's materials have reduced their physical engineering properties (e.g., compressive strength, load carrying capacity, etc.) and total and differential settlements have caused structural elements to be stressed beyond normal service conditions. This reduction in strength coupled with the increased stress has resulted in a condition beyond failure for the major structural components of the building. This condition, therefore, makes it not feasible to salvage or repair the building, or attempt to return any portion of it to useful service.
