Project 200609.05 – Vibration Monitoring Data Report – 22 to 28 March 2026, Riverview Condominiums, 221 Mt. Auburn Street, Cambridge, MA

APPENDIX A

Multi report

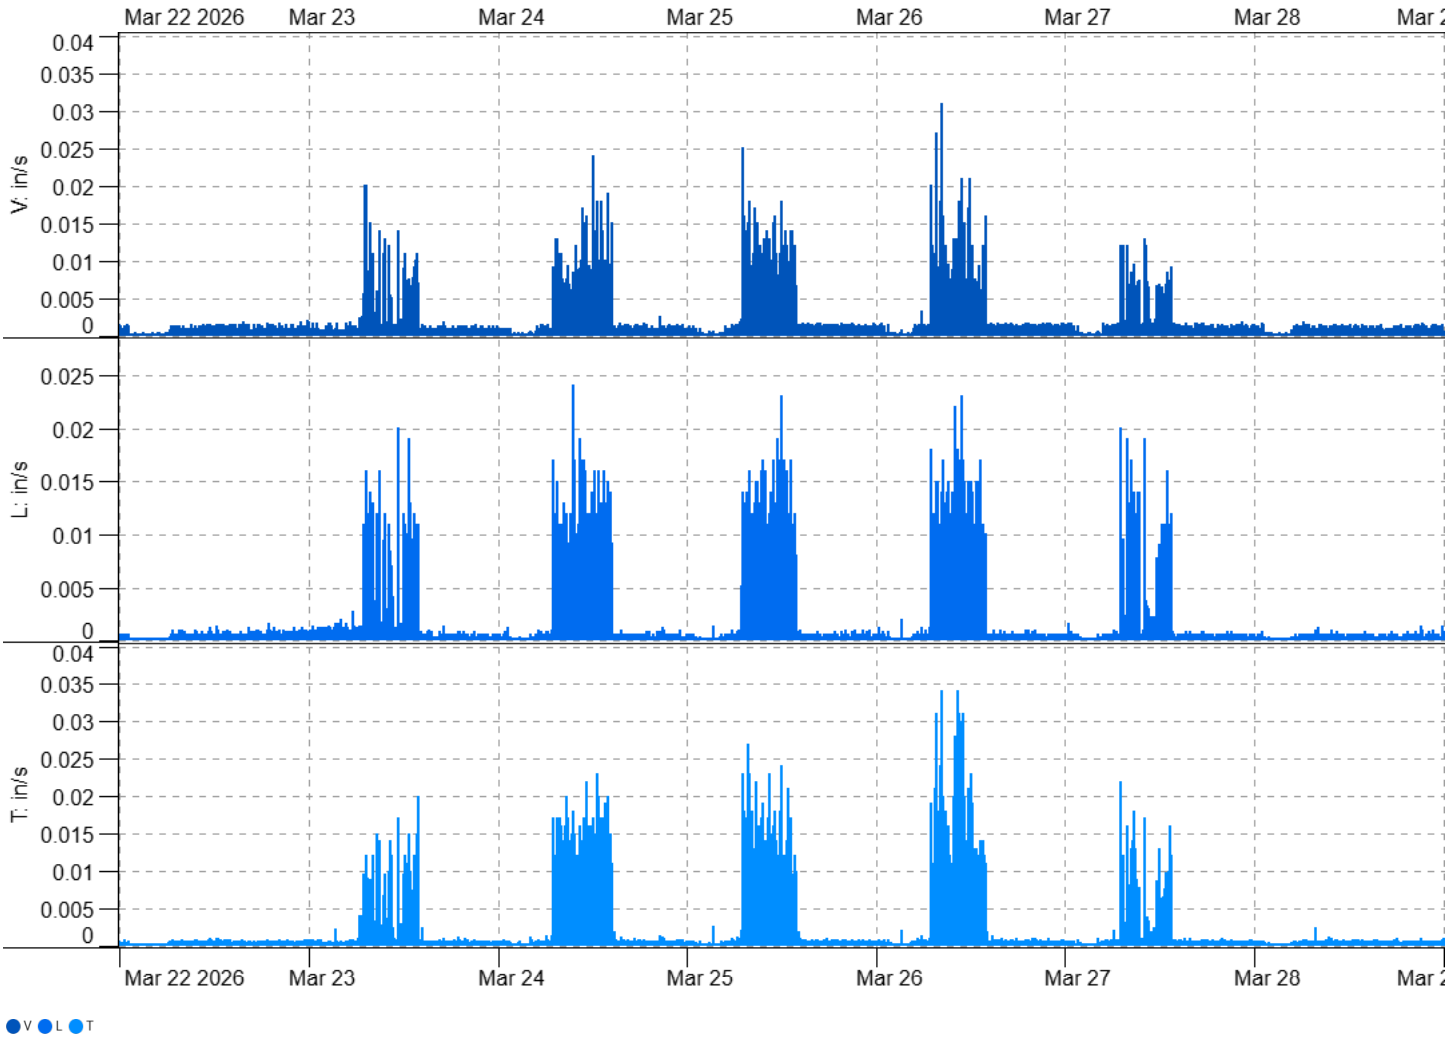
Riv1, Bradbury Building [22 Bradbury St.], C22, Serial number: 110294, Calibrated: 2025-07-30,

V	L	T
Max	0.03 in/s	0.02 in/s	0.03 in/s
Date	2026-03-26	2026-03-24	2026-03-26
Time	08:22:30	09:32:30	08:22:30
Hz	6.5	3.25	4.5

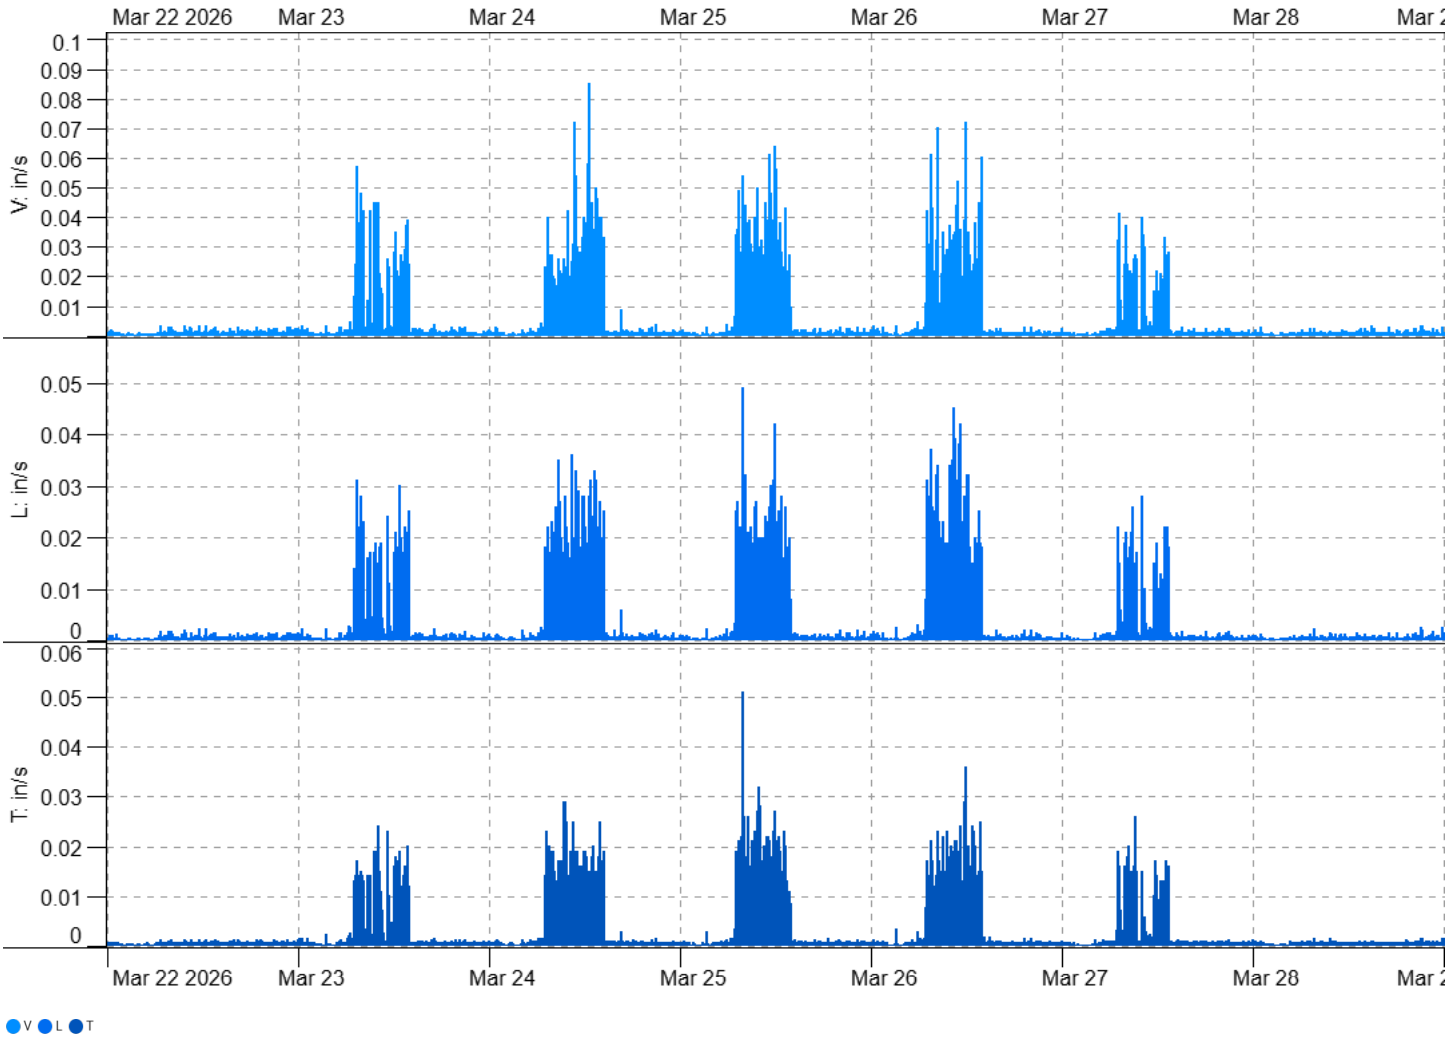
Riv2, 205 Mt. Auburn St., Cambridge, MA, C22, Serial number: 102013, Calibrated: 2025-07-23,

V	L	T
Max	0.09 in/s	0.05 in/s	0.05 in/s
Date	2026-03-24	2026-03-25	2026-03-25
Time	12:37:30	07:52:30	07:52:30
Hz	8.1	1.75	14.7

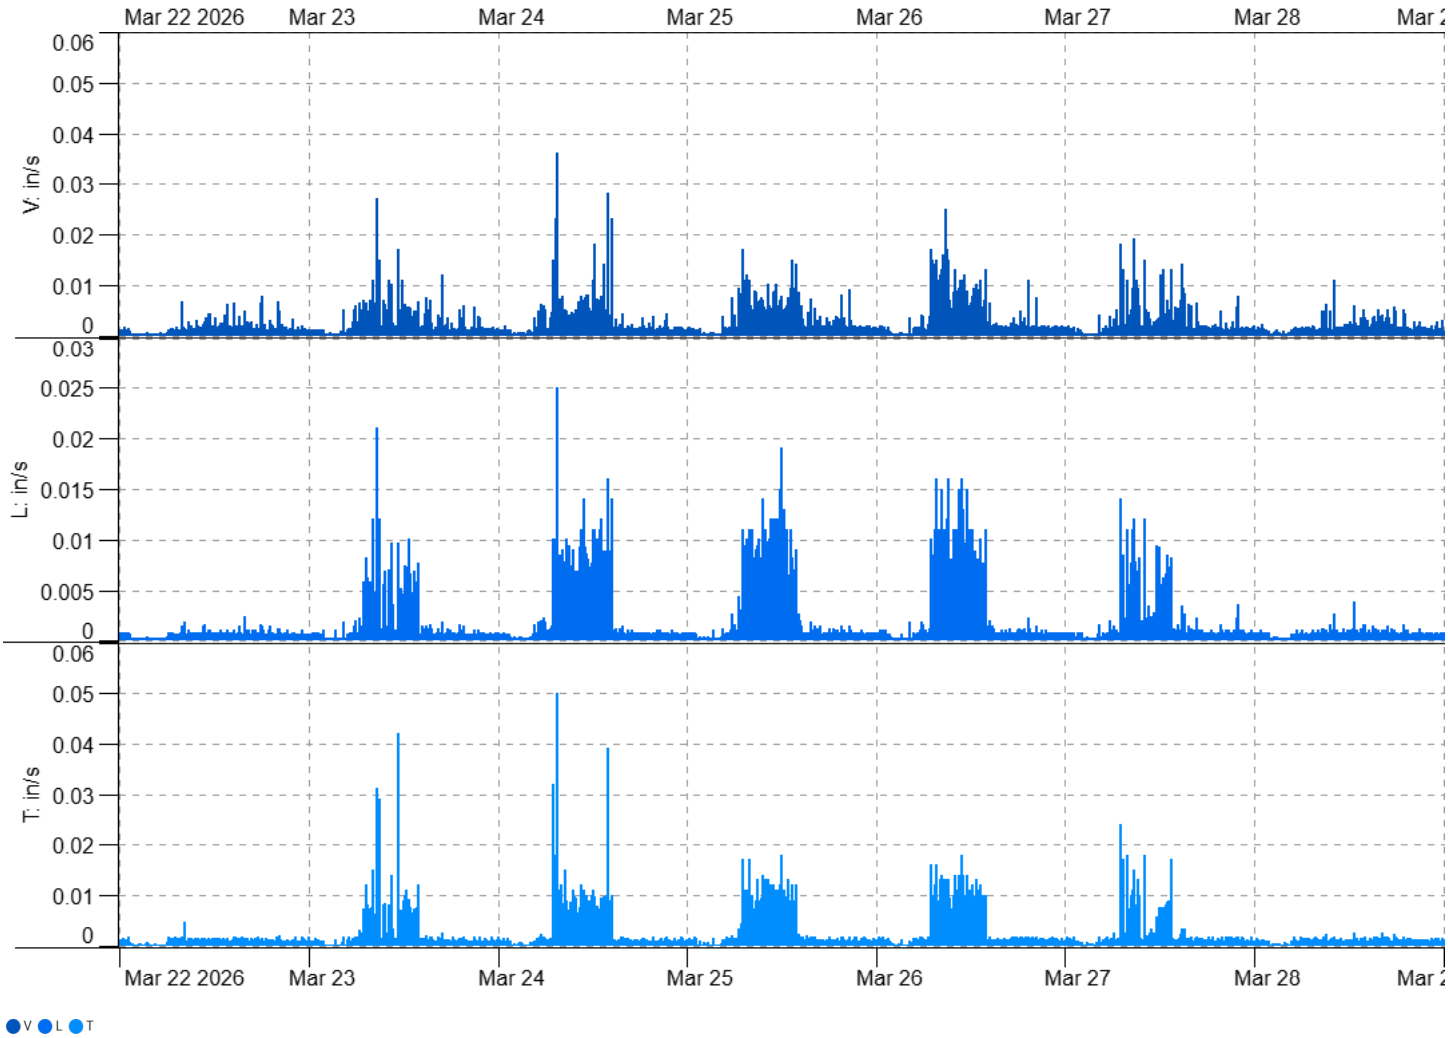
Riv3, 38 Bradbury St., Cambridge, MA, C22, Serial number: 103199, Calibrated: 2025-06-09,

V	L	T
Max	0.04 in/s	0.03 in/s	0.05 in/s
Date	2026-03-24	2026-03-24	2026-03-24
Time	07:27:30	07:27:30	07:27:30
Hz	5	4.95	4.9

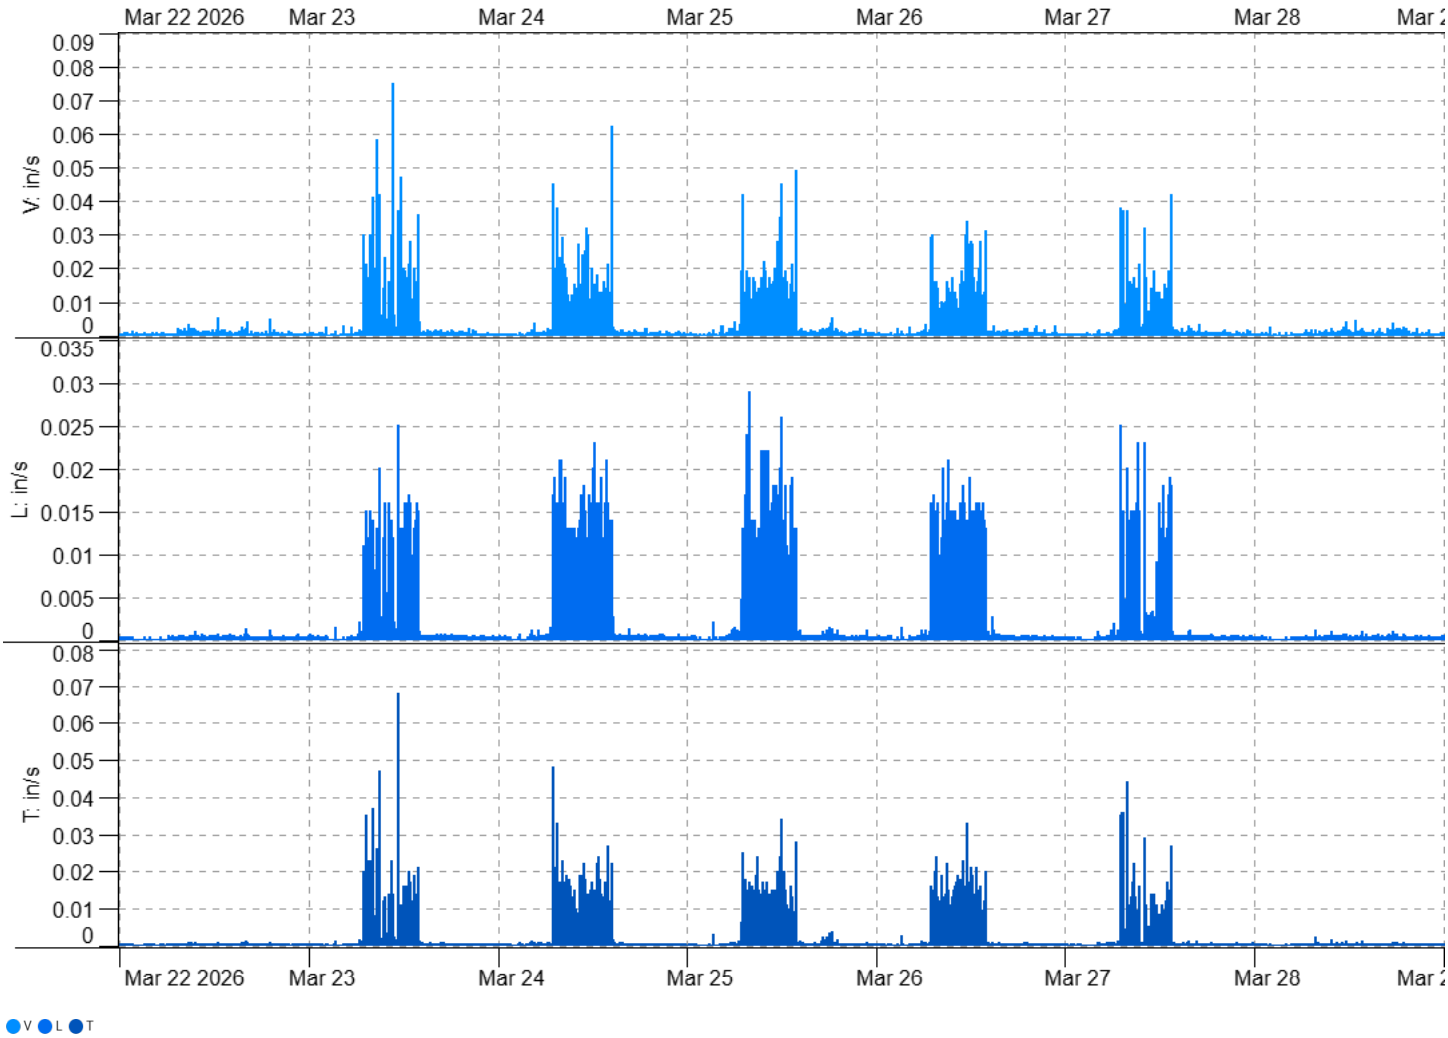
Riv4, 1 Sparks St., Cambridge, MA, C22, Serial number: 102403, Calibrated: 2025-07-02,

V	L	T
Max	0.08 in/s	0.03 in/s	0.07 in/s
Date	2026-03-23	2026-03-25	2026-03-23
Time	10:37:30	07:52:30	11:17:30
Hz	10.7	3.4	4.55

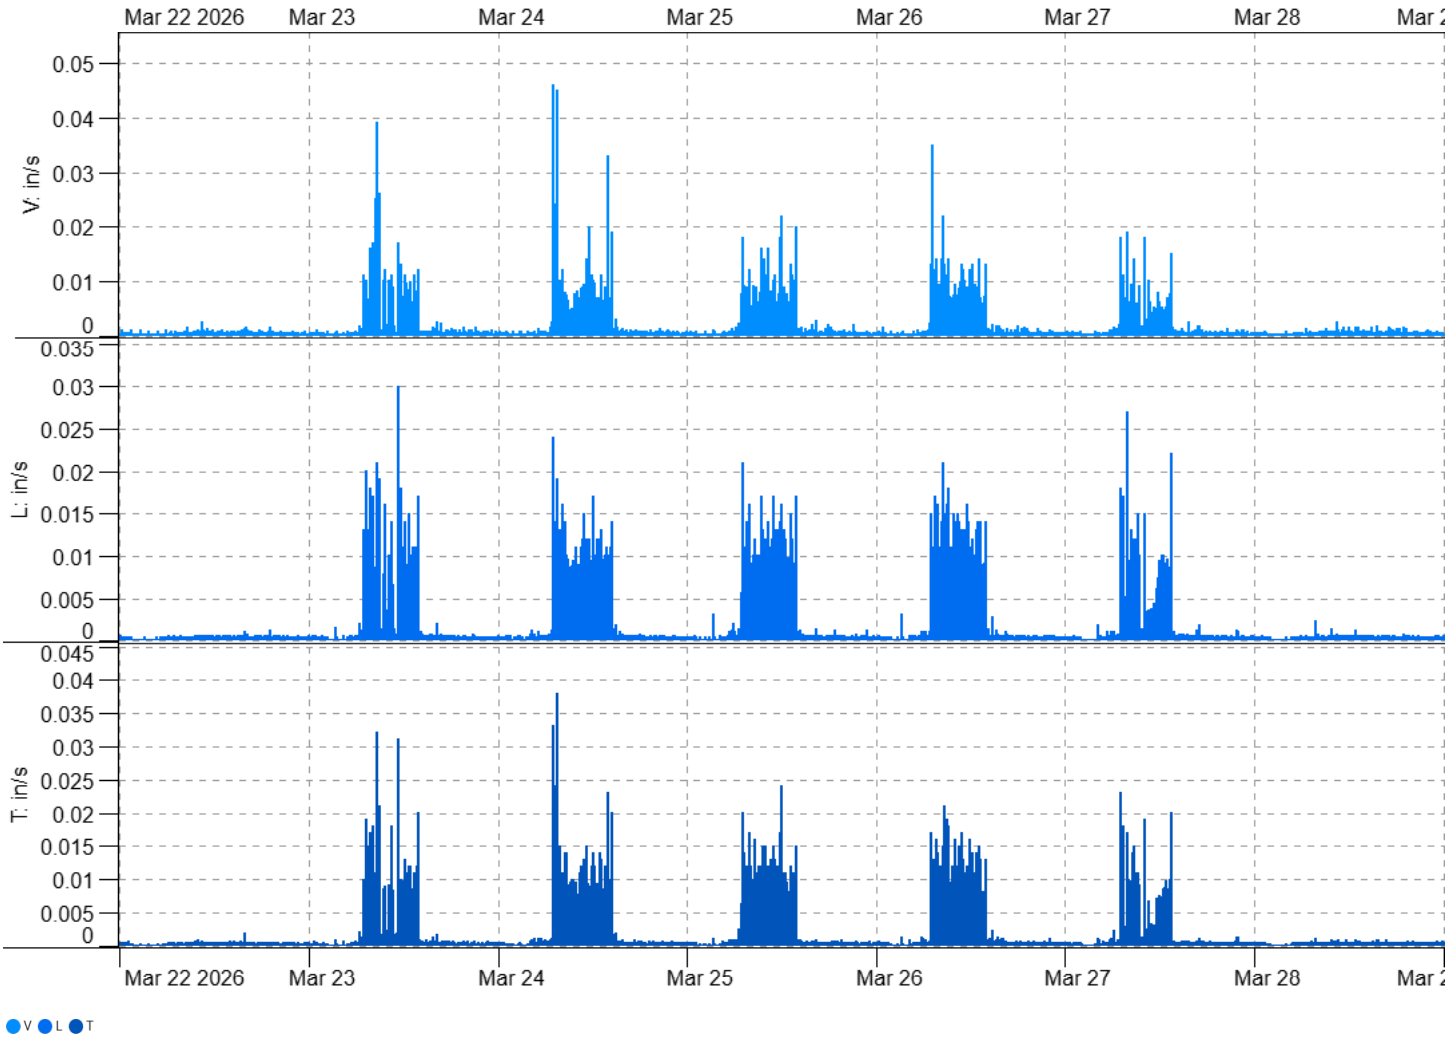
Riv5, 7 Sparks St., Cambridge, MA, C22, Serial number: 104002, Calibrated: 2025-07-02,

V	L	T
Max	0.05 in/s	0.03 in/s	0.04 in/s
Date	2026-03-24	2026-03-23	2026-03-24
Time	07:02:30	11:17:30	07:27:30
Hz	11	4.7	5.3

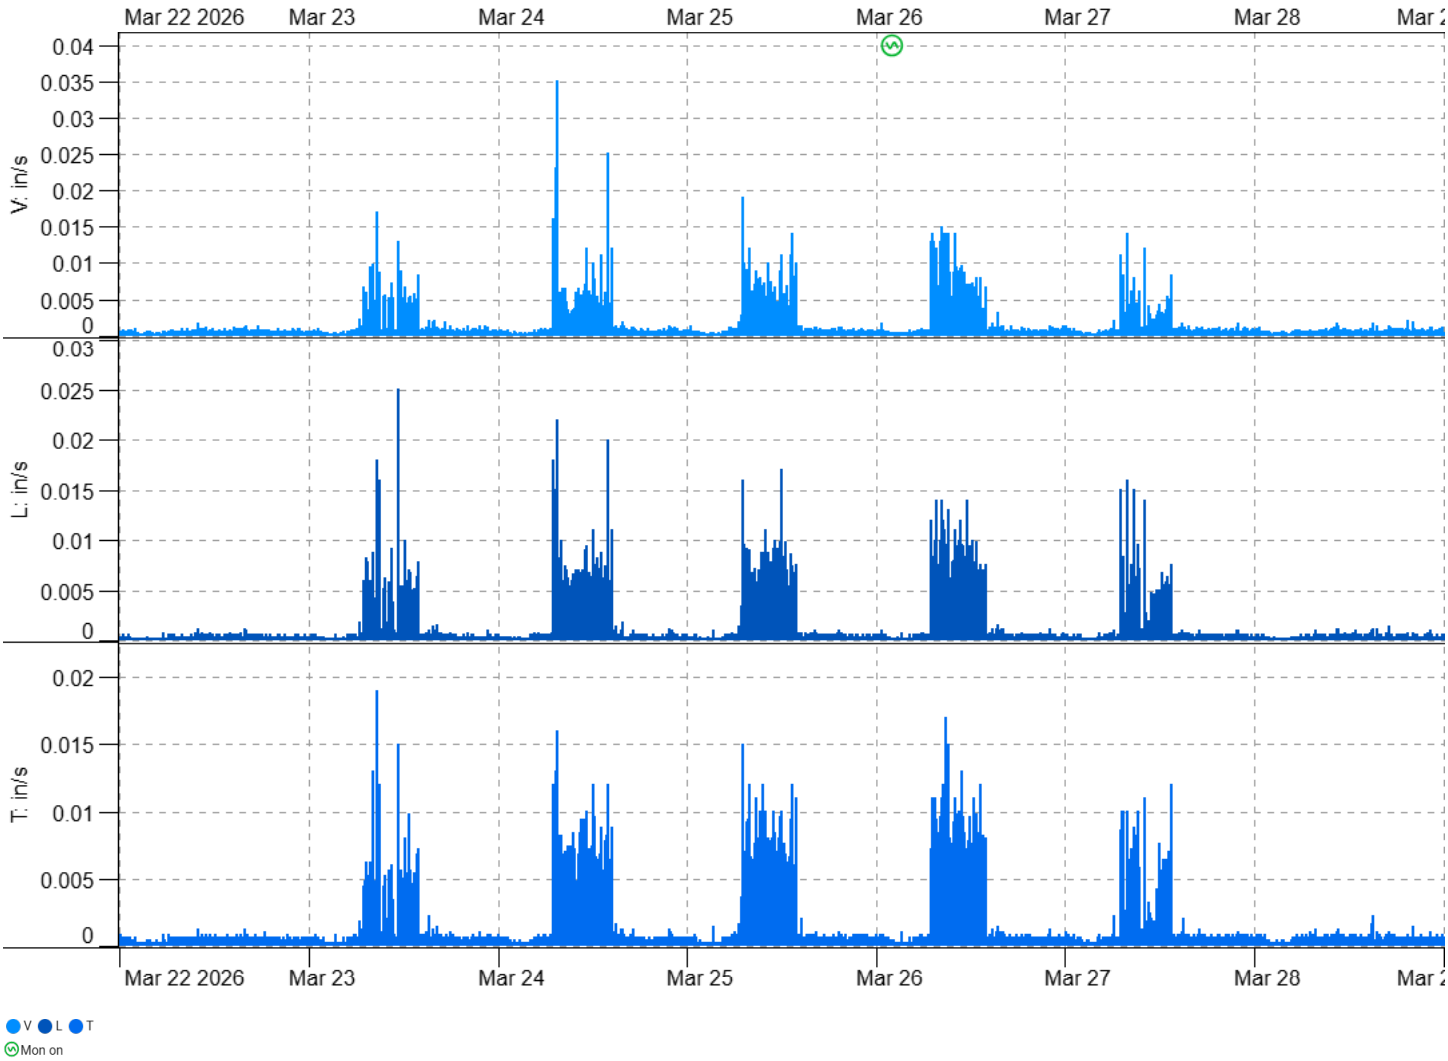
Riv6, 11 Sparks St., Cambrdige, MA, C22, Serial number: 110329, Calibrated: 2025-07-02,

X-span	2026-03-22 00:00 - 2026-03-29 00:00		
Y-span	V: 0 - 0.04 in/s, L: 0 - 0.03 in/s, T: 0 - 0.02 in/s		
	V	**L**	**T**
Max	0.04 in/s	0.03 in/s	0.02 in/s
Date	2026-03-24	2026-03-23	2026-03-23
Time	07:27:30	11:17:30	08:37:30
Hz	5.15	4.8	5.6
