# 99-3 Brattle Reed and Burnham Halls

October 11, 2022

Cambridge Historical Commission

Located on Brattle Street in historic Cambridge, MA, the former campus is a historic landmark located next to the Longfellow house. The chapel was designed by the architectural firm of Ware and Van Brunt, who would later create the Quadrangle of residences, classrooms, and library. The chapel was consecrated on November 16, 1869. [William Robert Ware](#) and [Henry Van Brunt](#) were leading architects of their era, also responsible for Harvard's [Memorial Hall](#) nearby. The school had a close relationship with Harvard's Divinity School, allowing for cross-registration of classes.

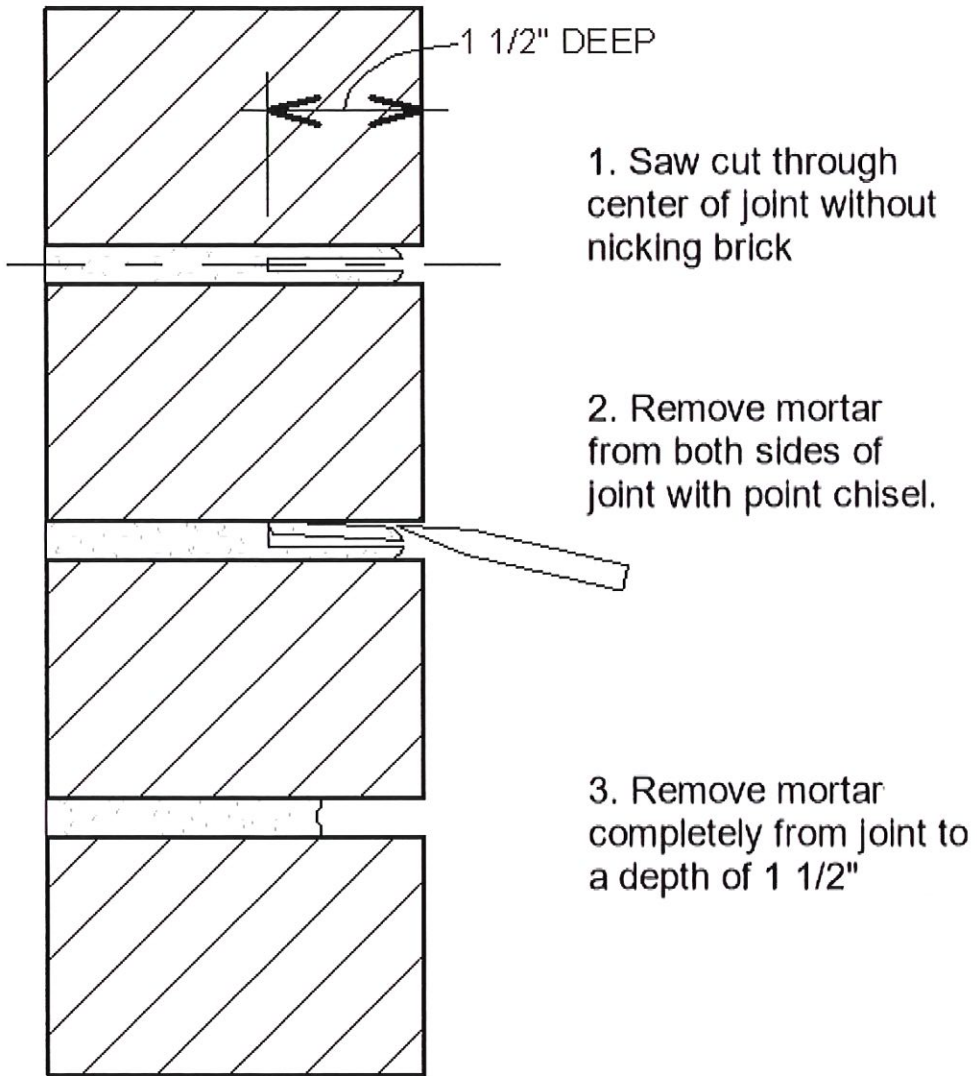
1. Mortar Removal Method

# BRICK RE-POINTING

## SPECIFIED RE-POINTING METHOD

3.4 REPOINTING

- A. Rake out and repoint joints to the following extent:
  - 1. All joints in areas indicated.
- B. Do not rake out and repoint joints where not required.

- C. Rake out joints as follows, according to procedures demonstrated in approved mockup:
  - 1. Remove mortar from joints to depth of joint width plus 1/8 inch. Do not remove unsound mortar more than deep; consult Architect for direction.

- 2. Remove mortar from brick and other masonry surfaces within raked-out joints to provide reveals with square backs and to expose masonry for contact with pointing mortar. Brush, vacuum, or flush joints to remove dirt and loose debris.

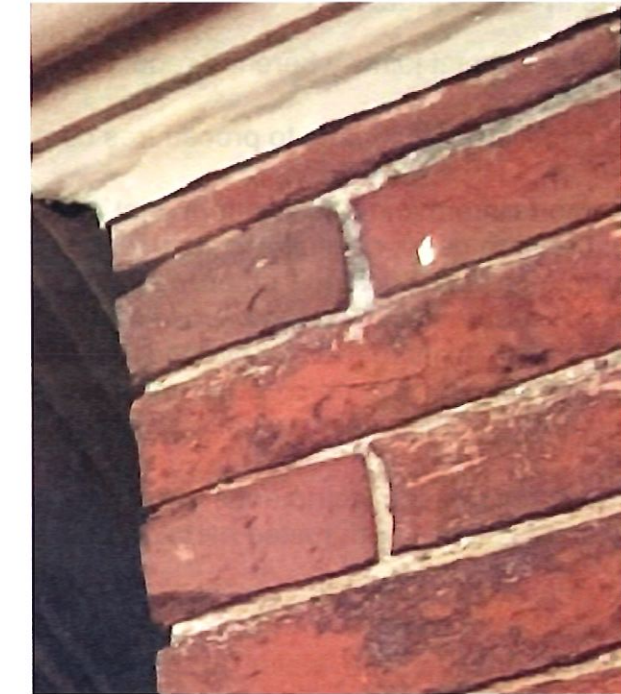
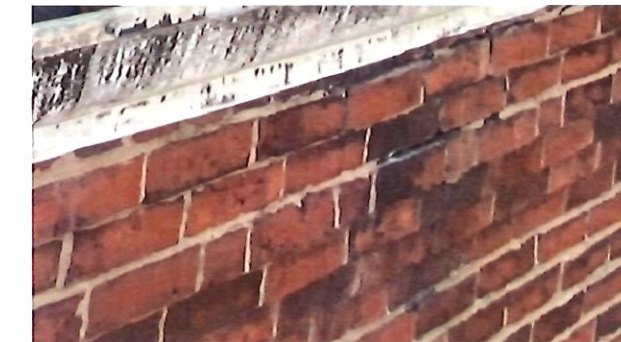
3. Mortar Matching Method

\*Color of sand and color of paste are to be matched separately. If adjacent mortar is dirty, its underlying clean color will be matched, and then dirty water ("Acqua Sporca") will be added to match adjacent.

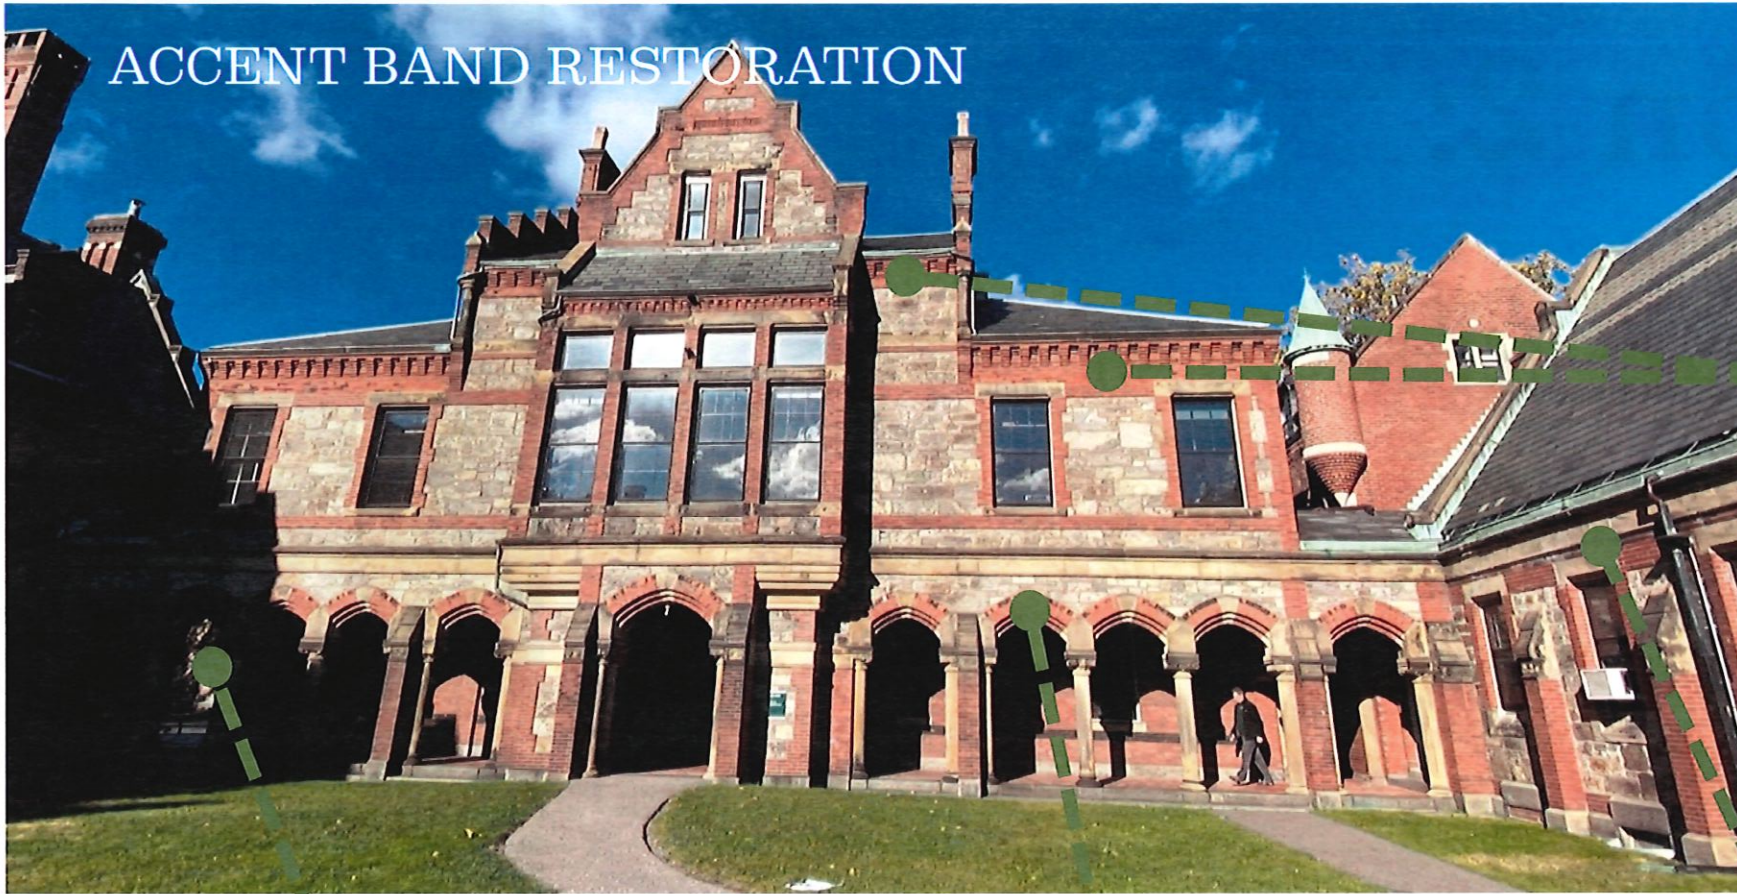
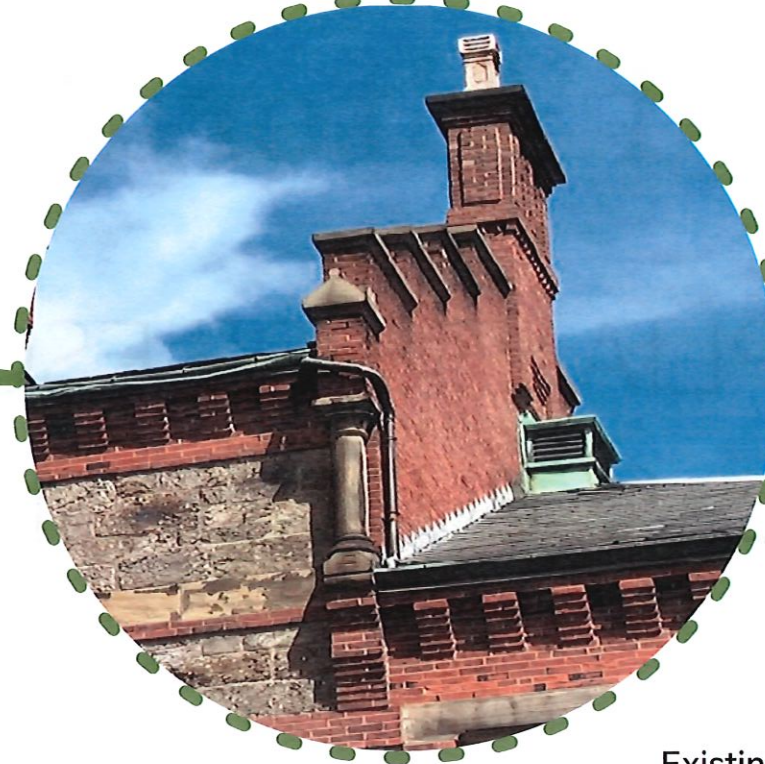
# ACCENT BAND RESTORATION

## Proposed Actions:

1. Restore all dark-colored accent banding with matching silicate paint that includes a potassium silicate binder for better adhesion, weathering protection and durability.

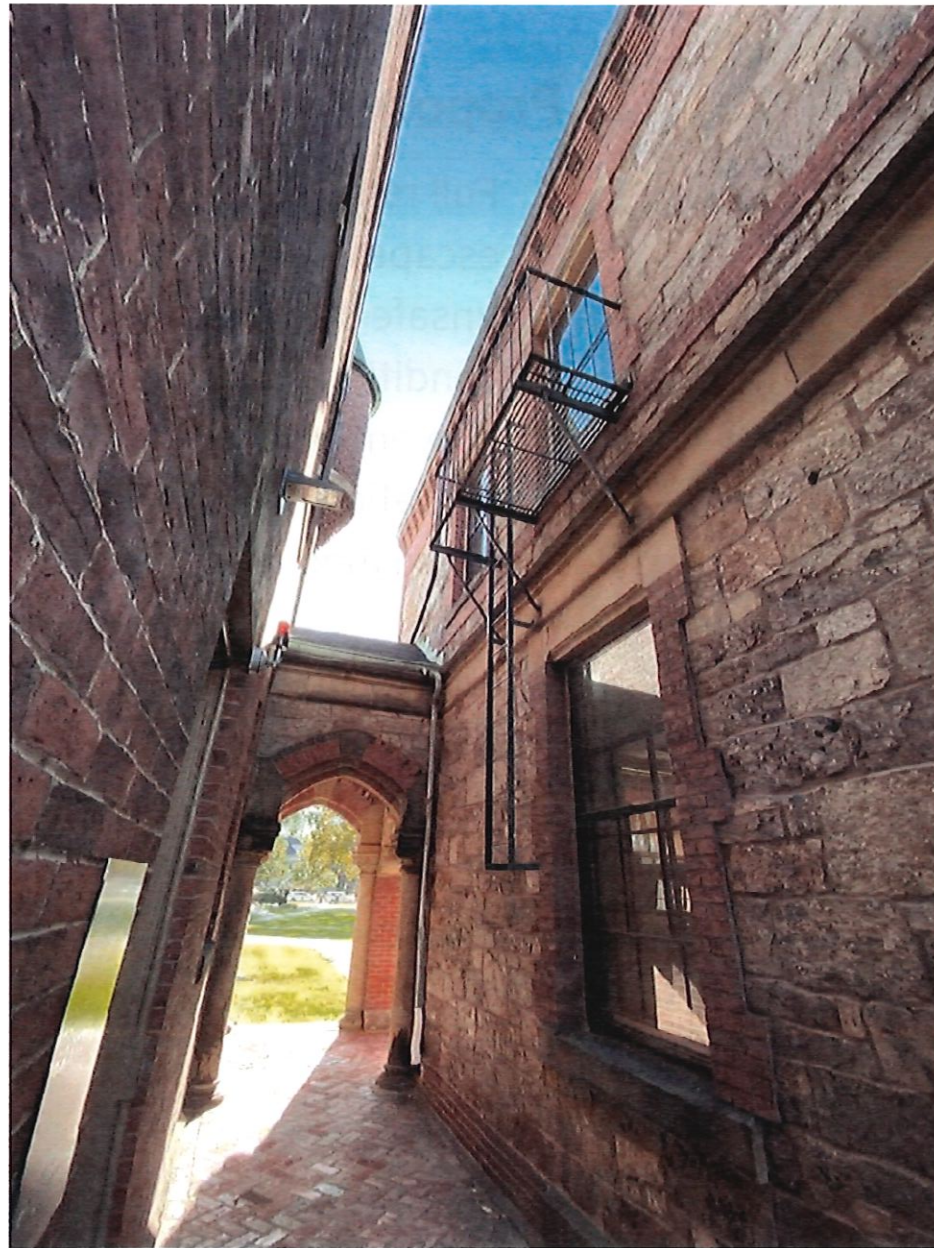
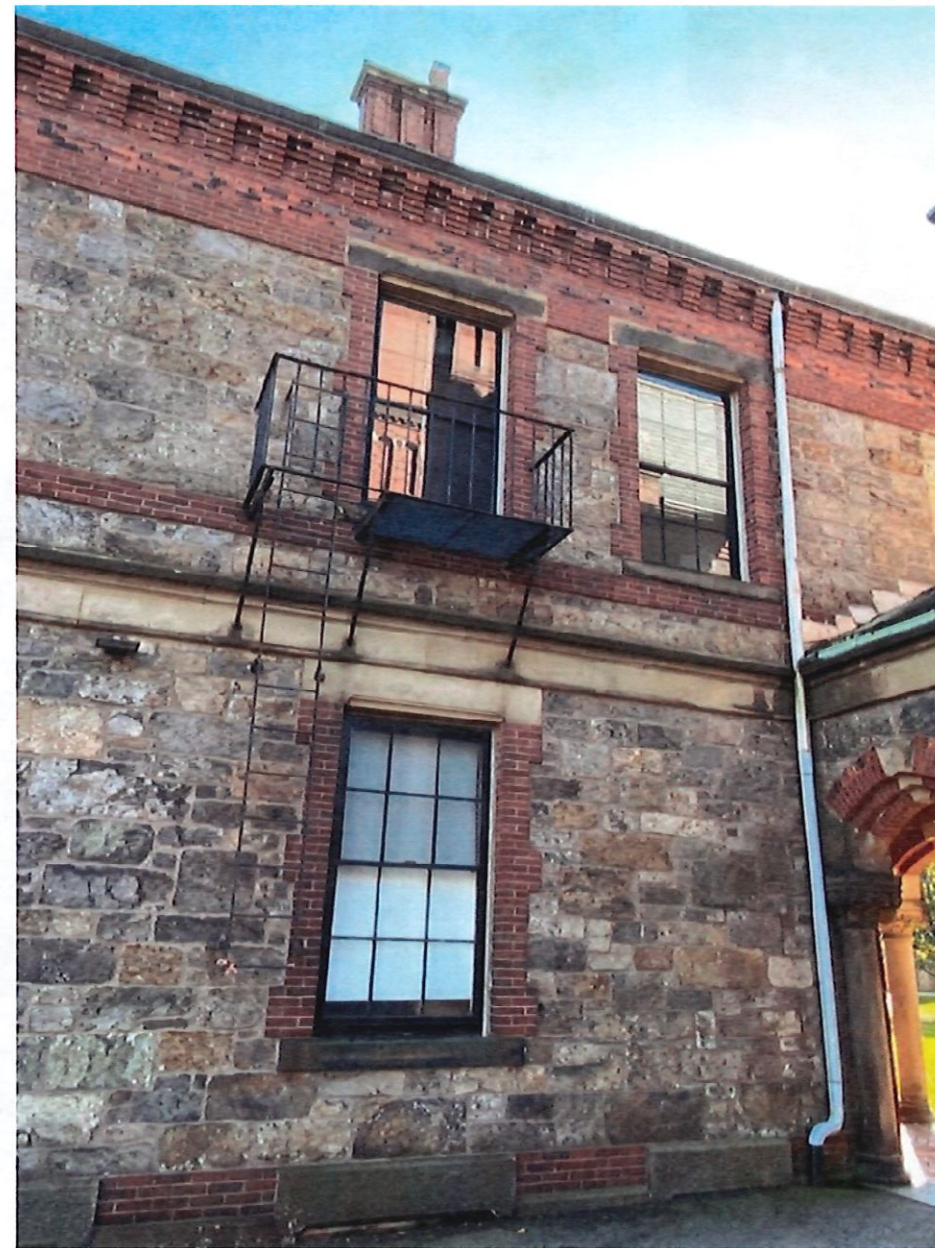
## Existing Fire Escapes Are Not Code-Compliant

- Fire escapes are not required with the building's designed life safety improvements.
- Existing conditions are deteriorating & unsafe.

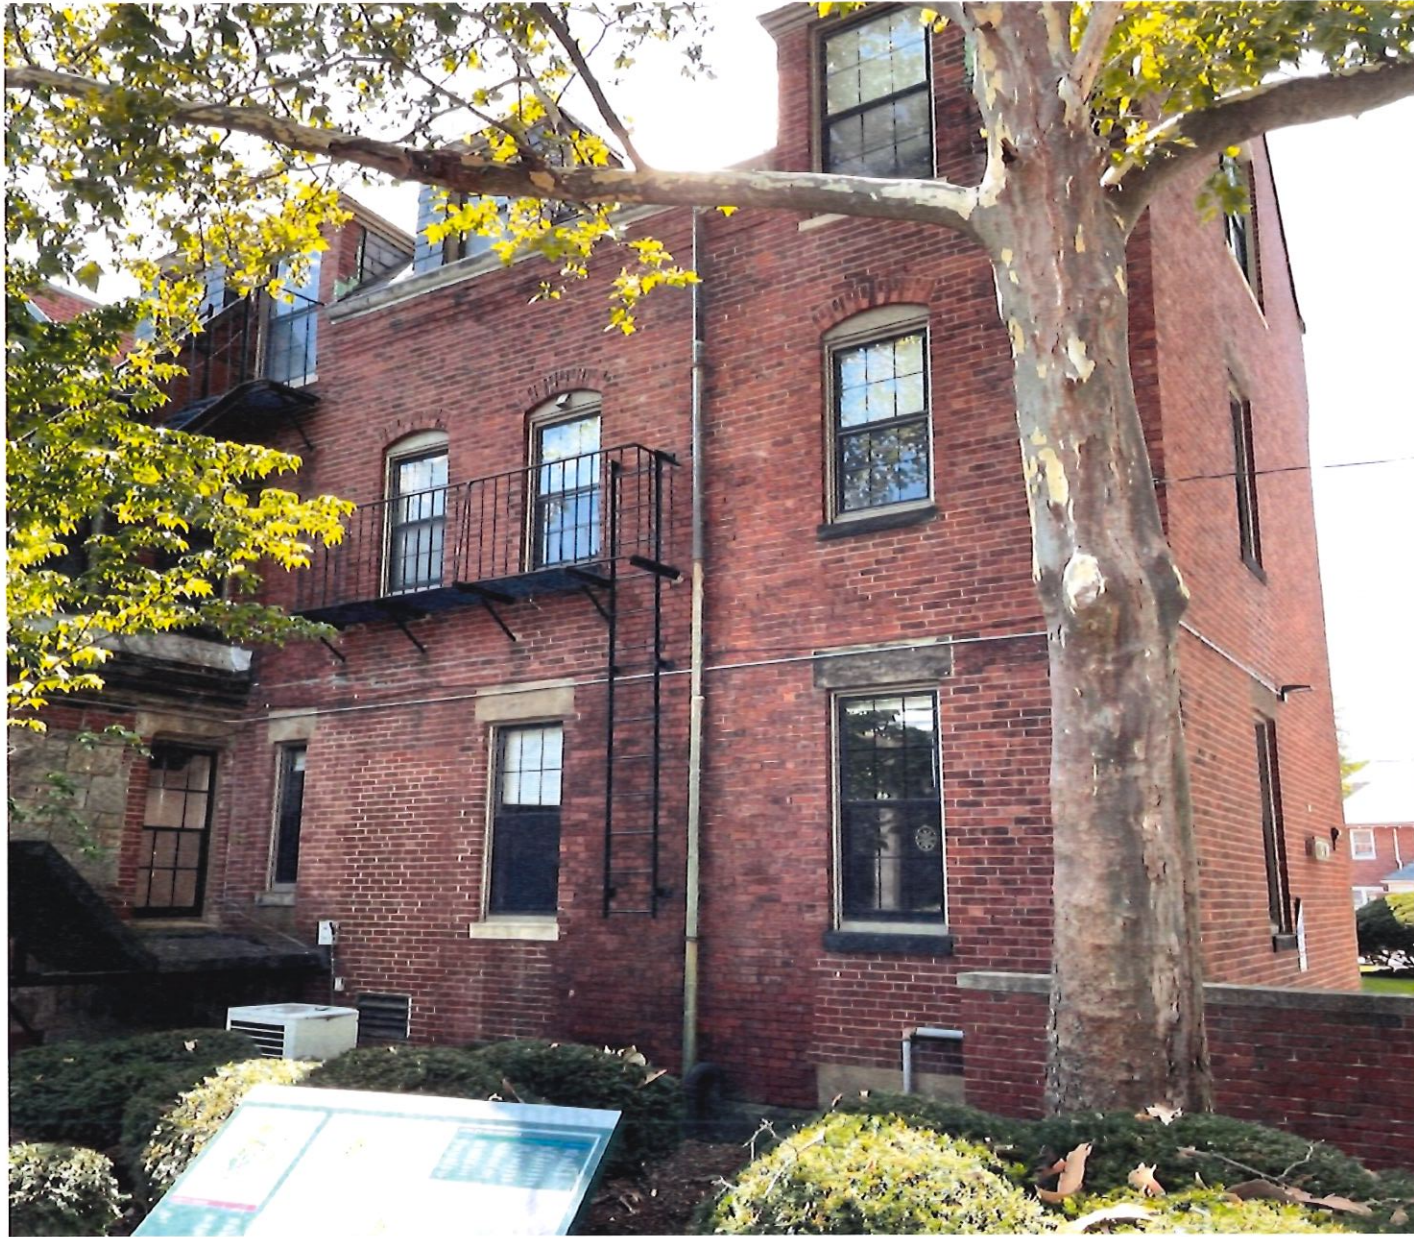
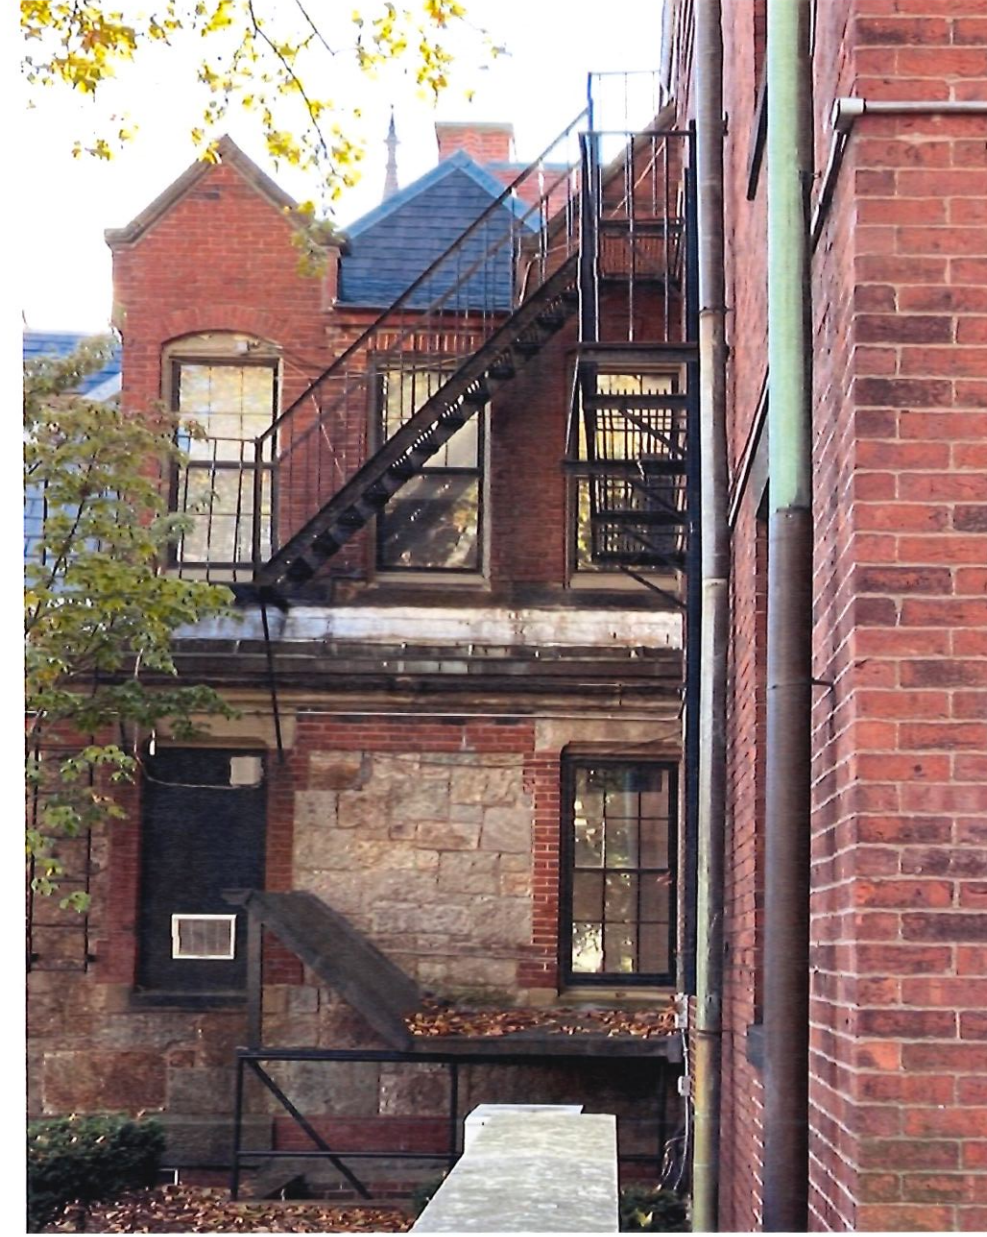
### Proposed Actions:

1. Full removal of all fire escapes to eliminate unsafe structural conditions and to prevent further oxidation and staining of existing masonry.
2. Fire escape anchors to be **core-drilled** out, followed by **dutchman repair** of masonry to match.

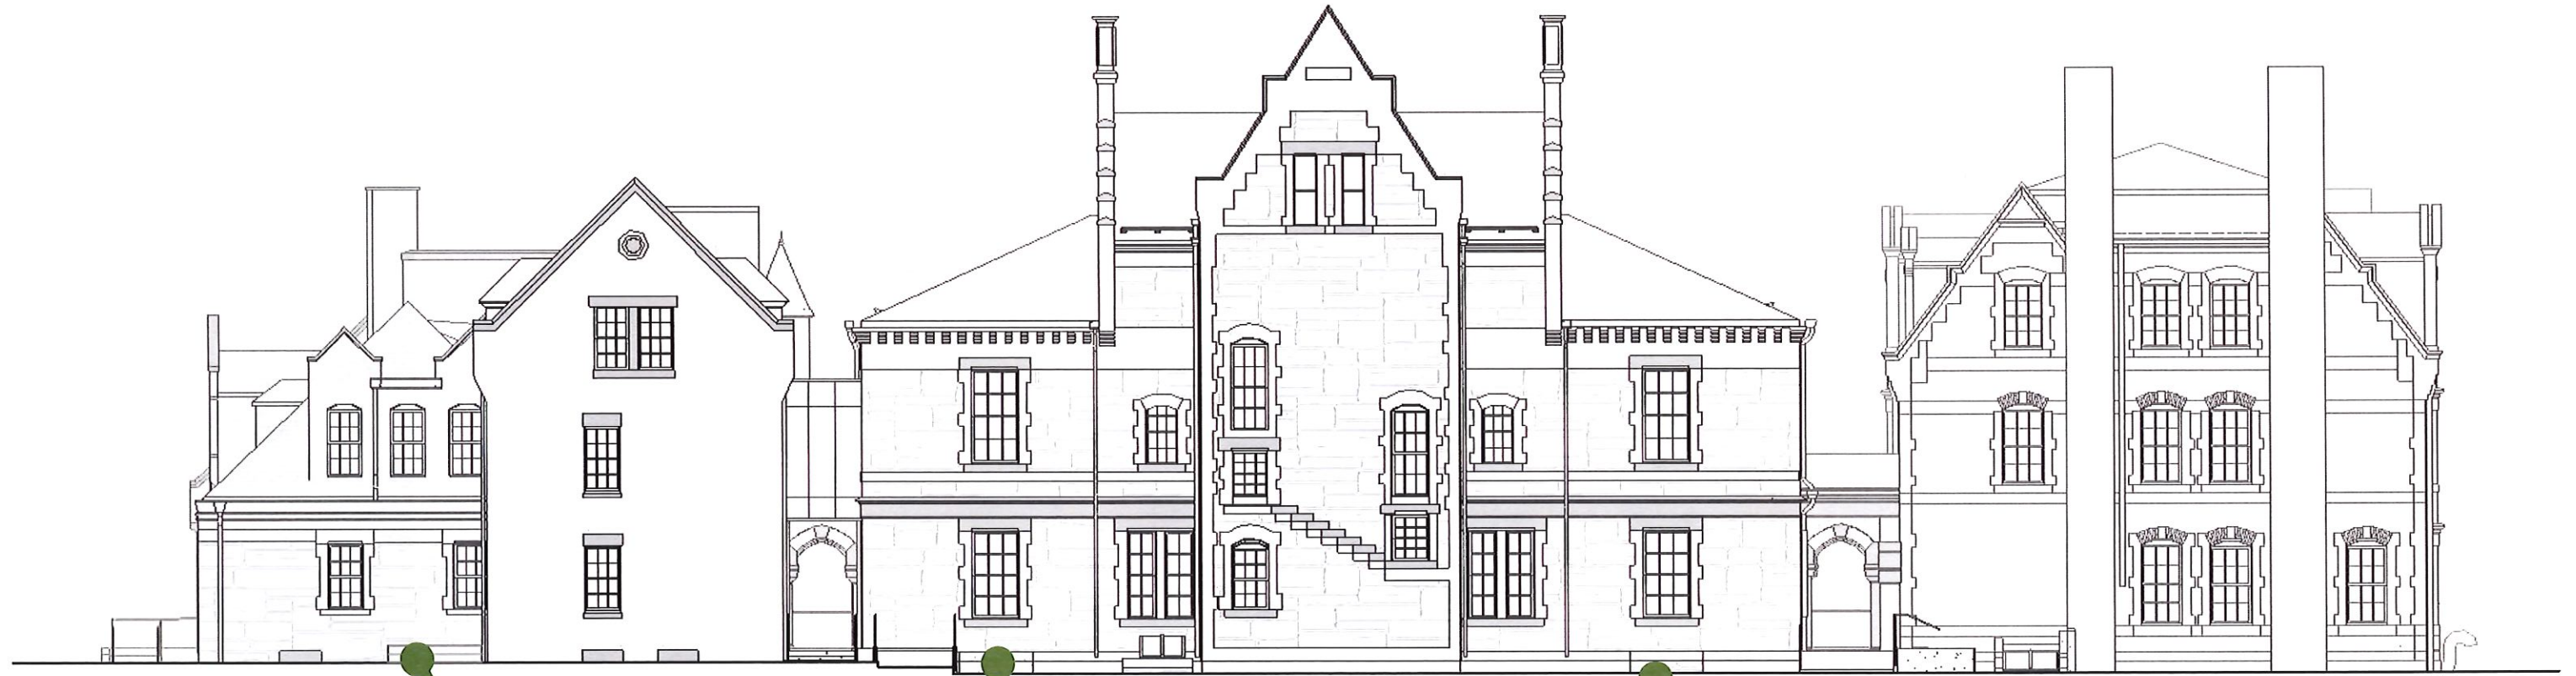
# REED, BURNHAM AND LAWRENCE HALLS - NORTH ELEVATION

BURNHAM  
HALL

REED  
HALL

LAWRENCE  
HALL

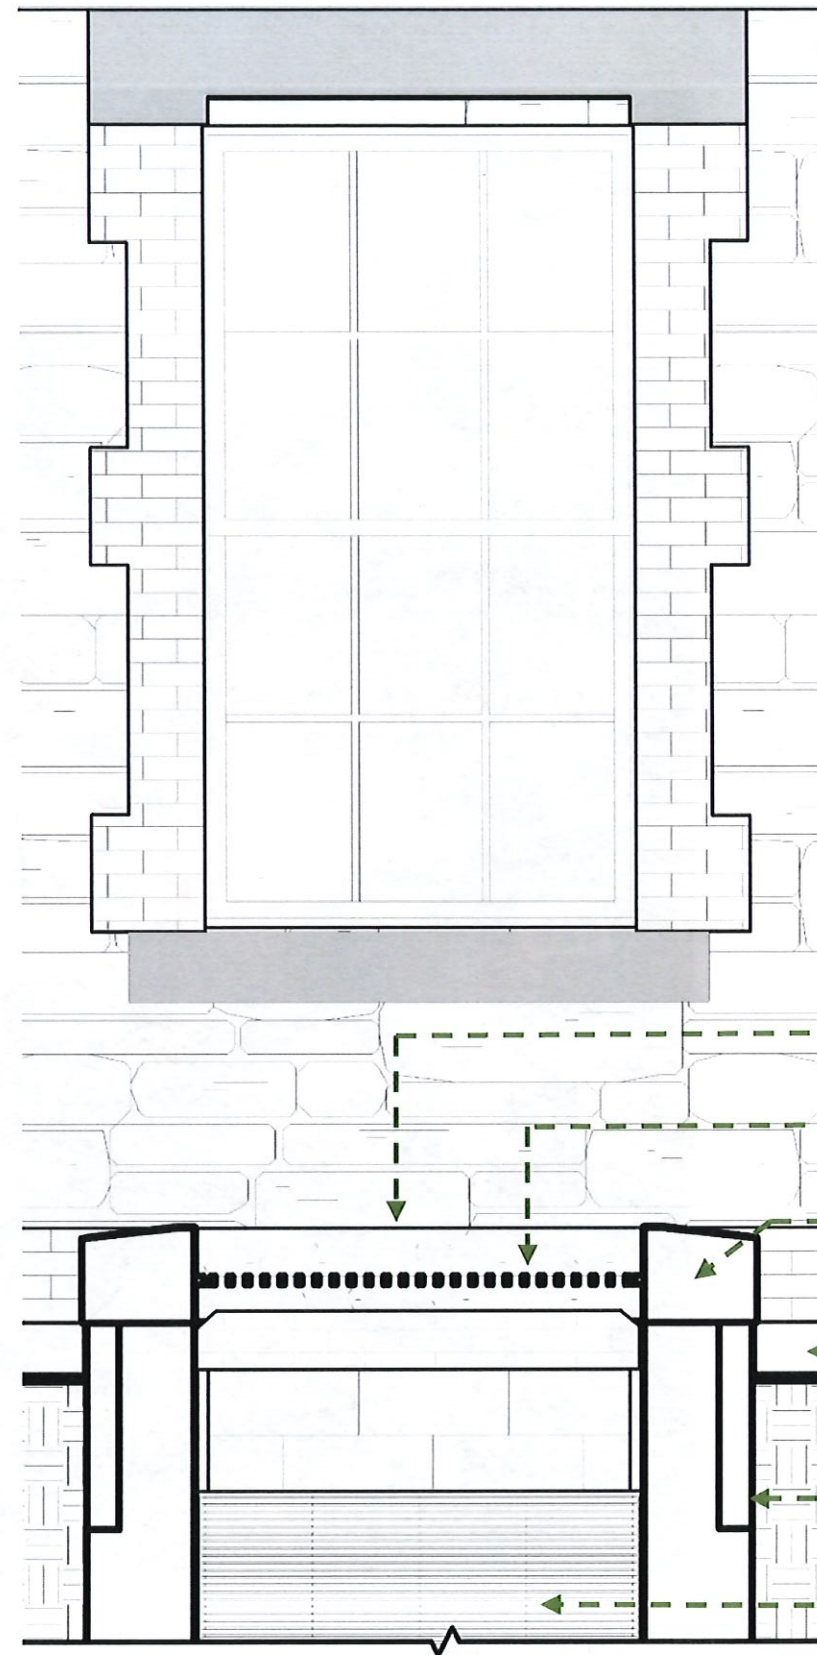
SECTION

- Existing Granite Lintel
- Areaway Grate
- Proposed Granite Cap
- Existing Granite Water Table
- Proposed Granite Veneer
- Proposed louver

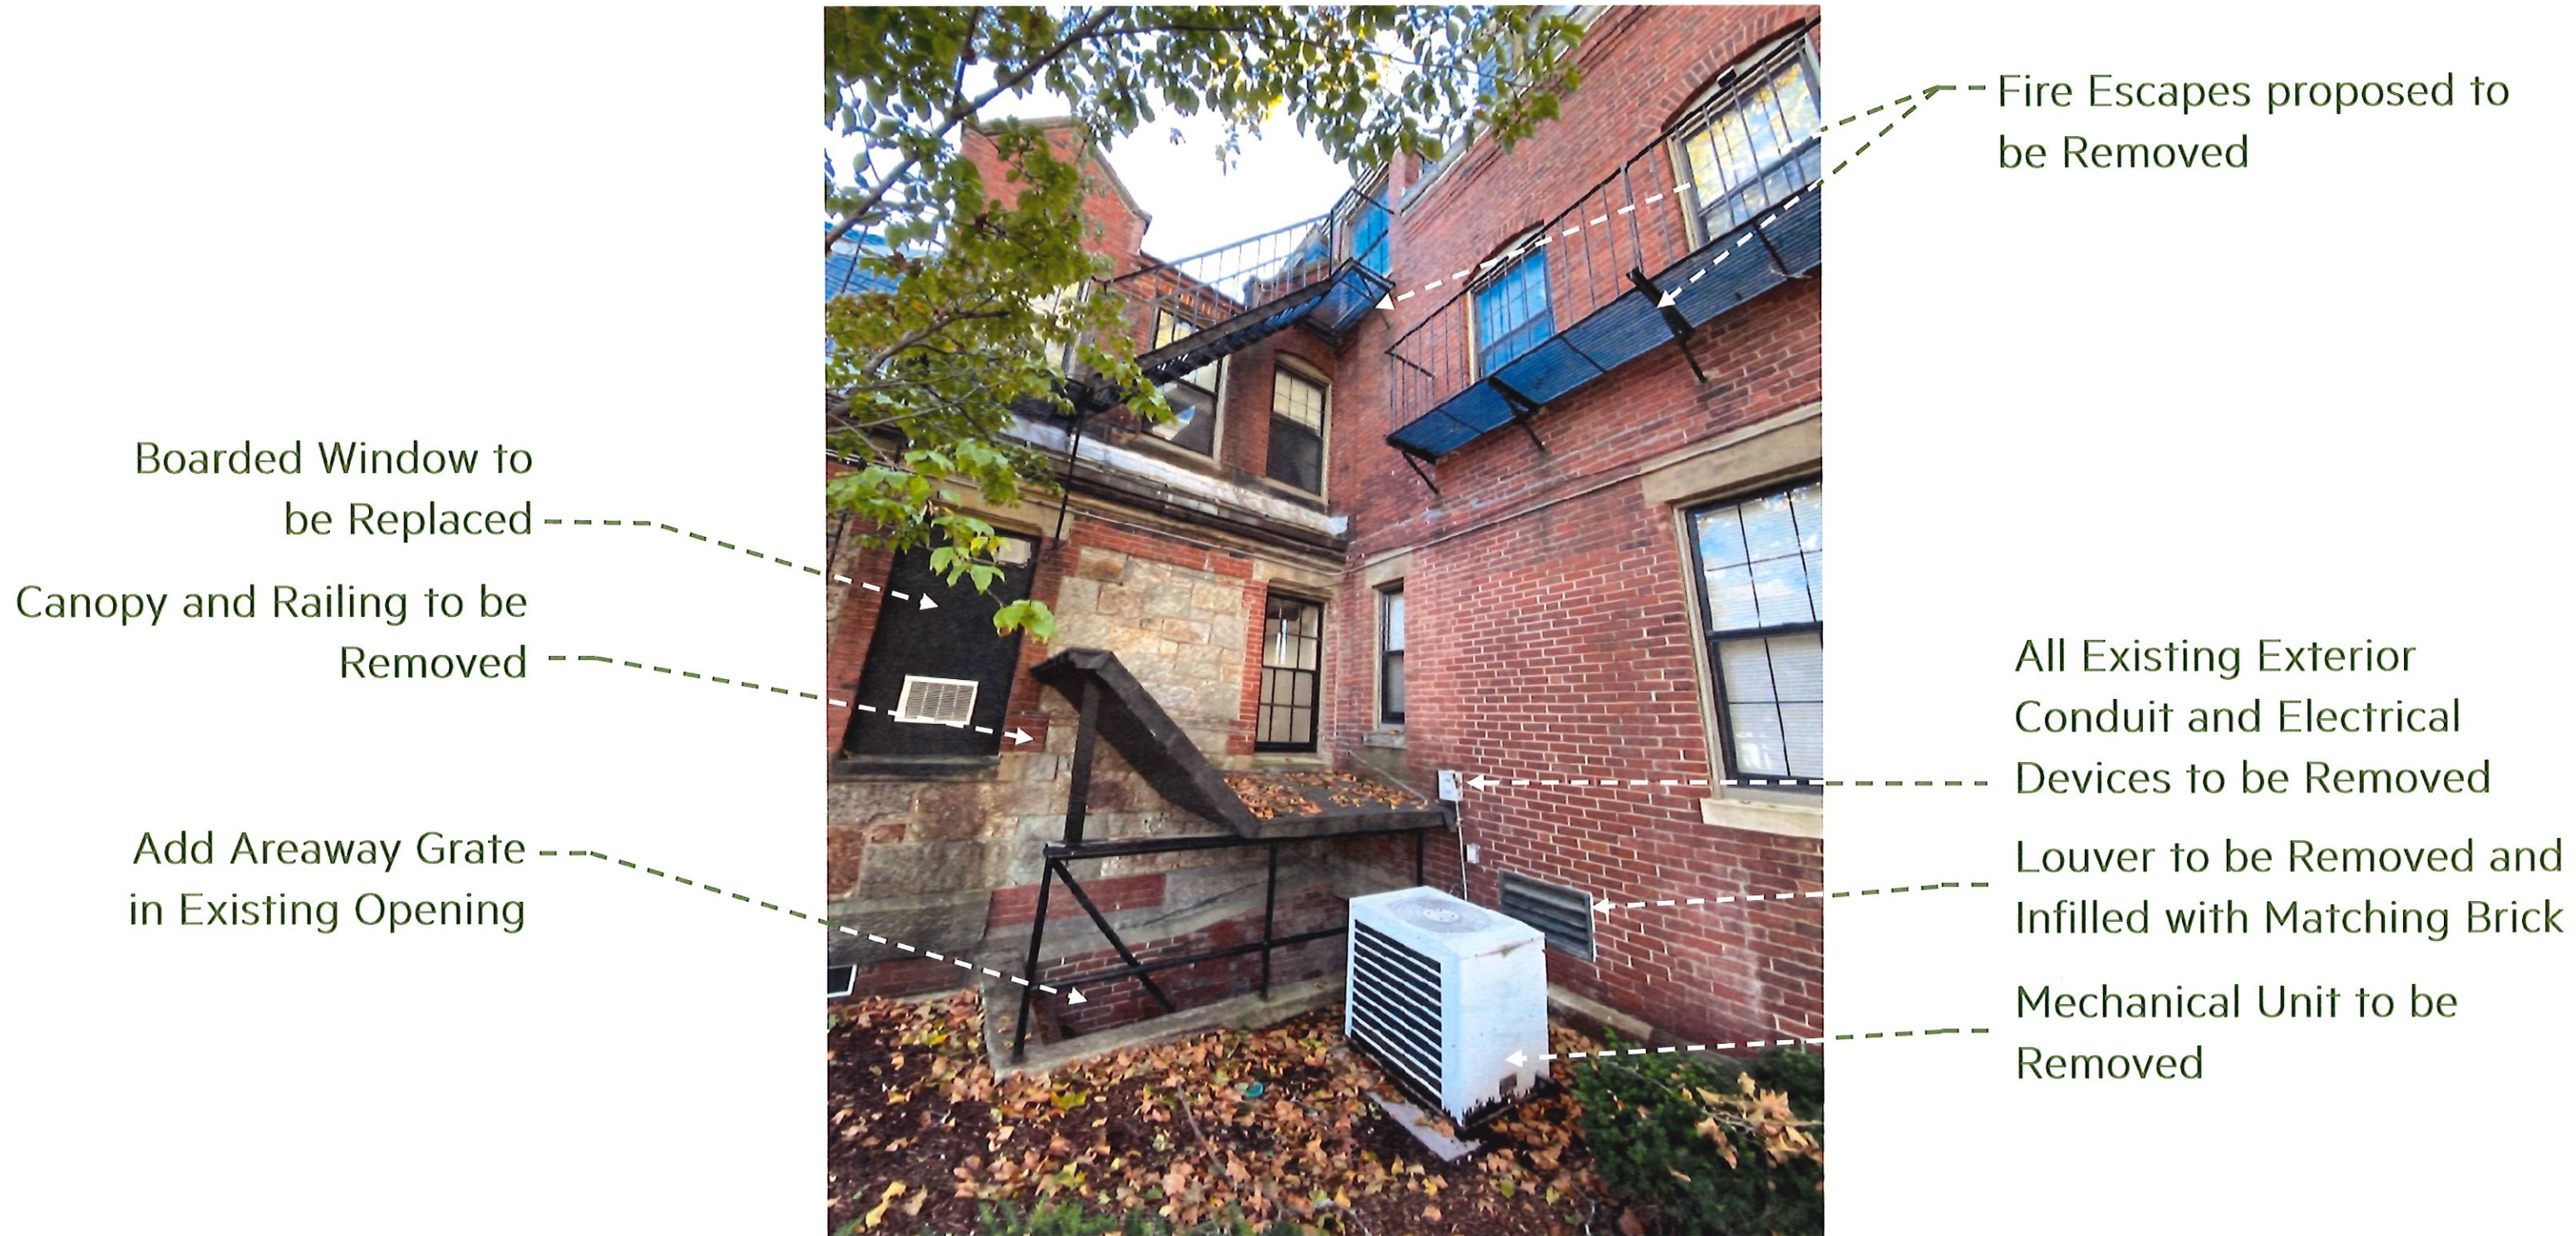
BURNHAM HALL EXISTING AREAWAY

# EXISTING EAST AREAWAY

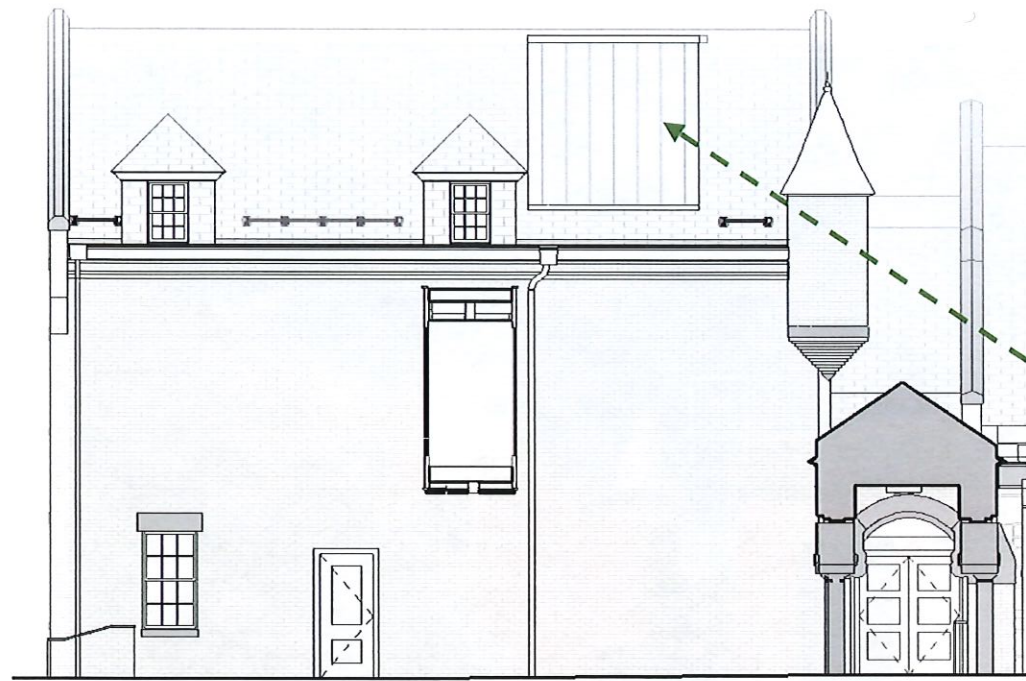
BURNHAM HALL - WEST ELEVATION

Proposed elevator overrun

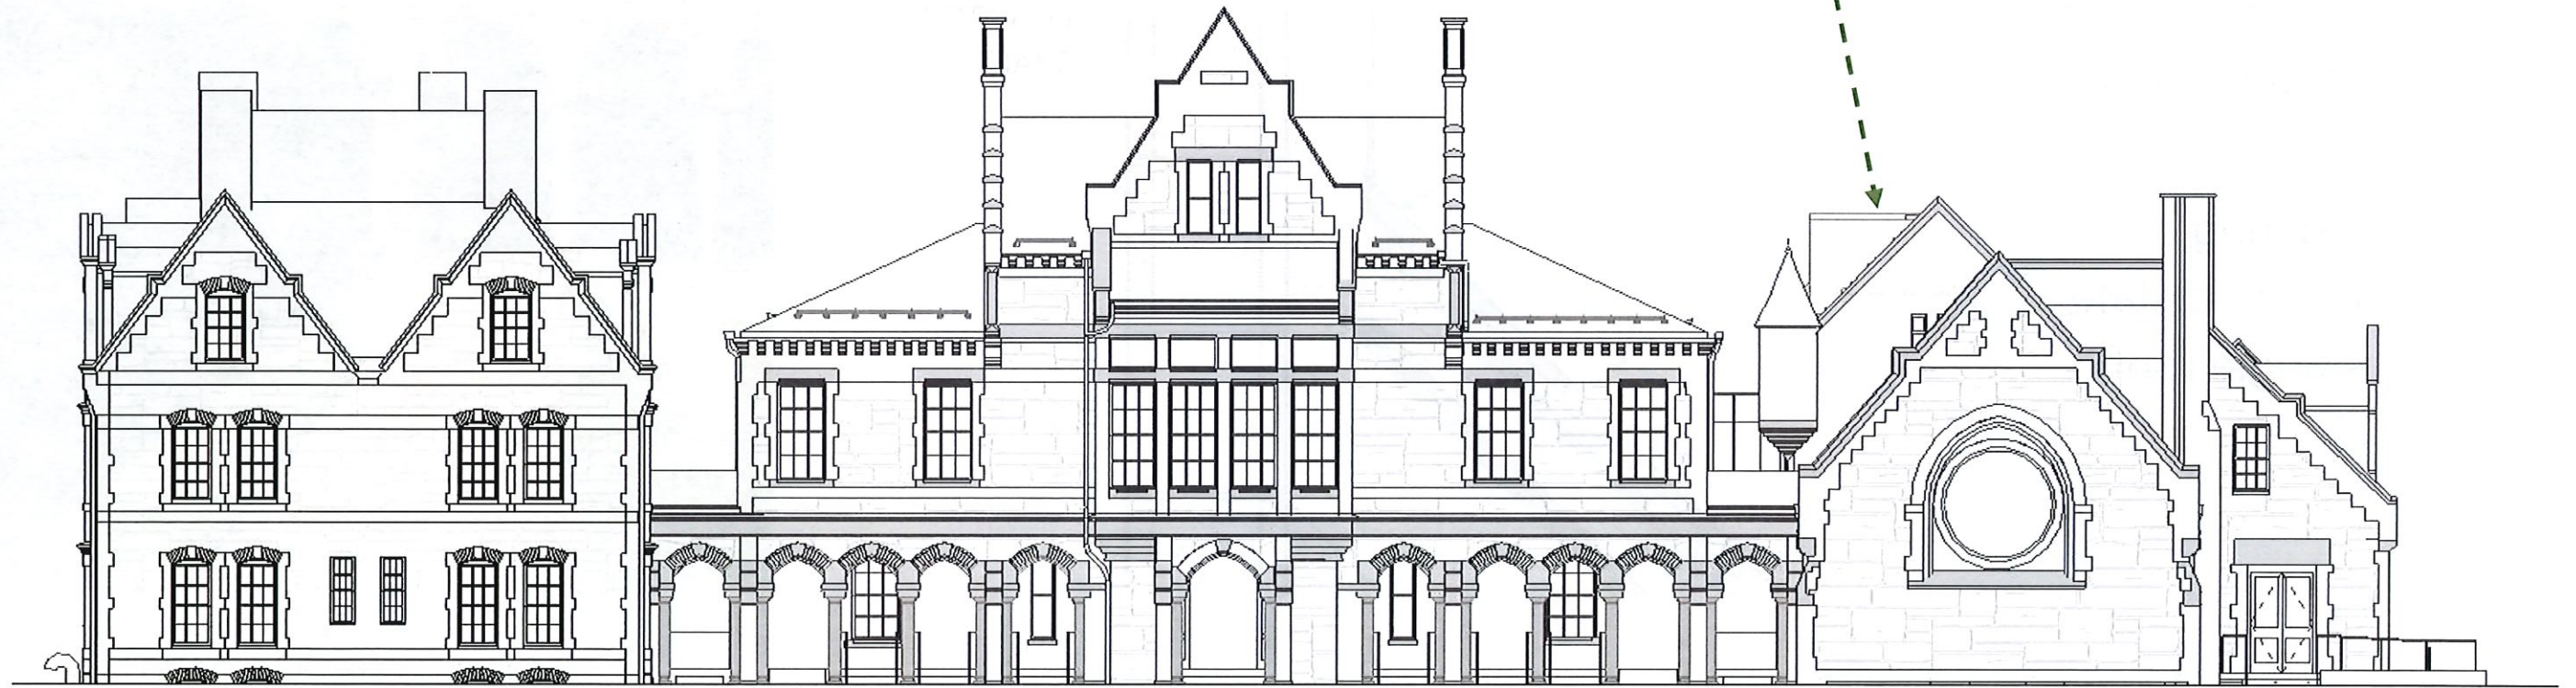
REED AND BURNHAM HALLS - SOUTH ELEVATION

Freedom grey  
copper coping  
and scupper

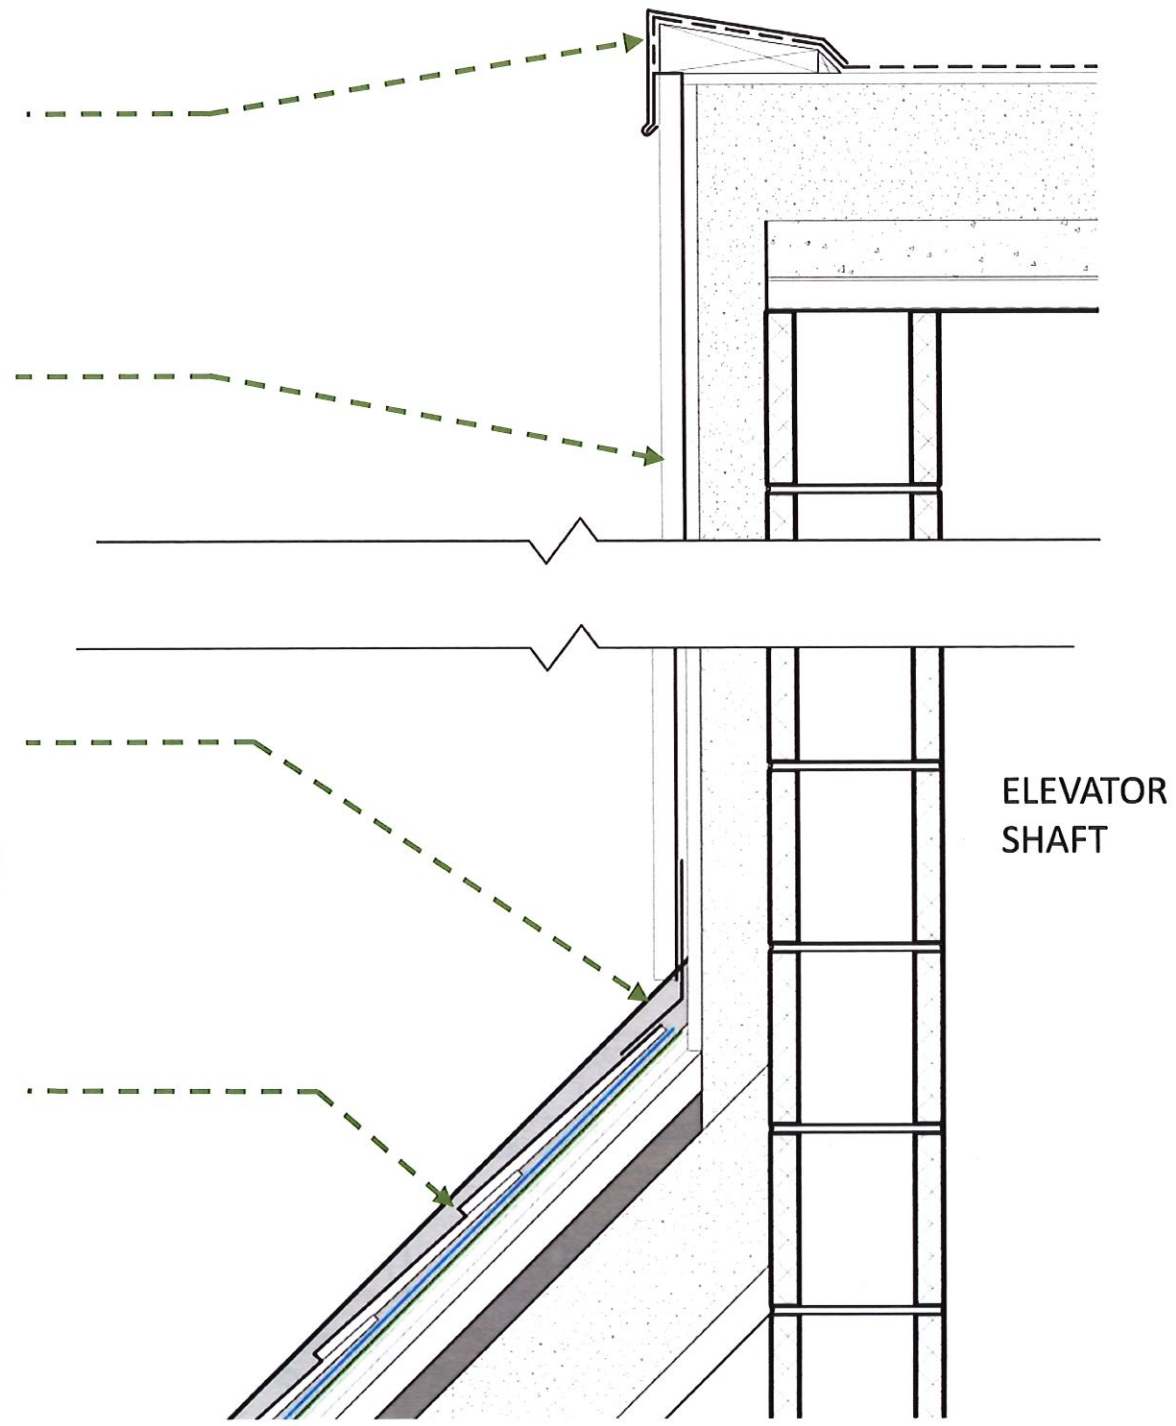
SECTION AT ROOF OVER ELEVATOR

Exposed  
freedom grey  
copper flashing  
to match existing

Existing or  
restored slate  
shingle roof
