# 99-3 Brattle Reed and Burnham Halls

October 11, 2022

Cambridge Historical Commission

Located on Brattle Street in historic Cambridge, MA, the former campus is a historic landmark located next to the Longfellow house. The chapel was designed by the architectural firm of Ware and Van Brunt, who would later create the Quadrangle of residences, classrooms, and library. The chapel was consecrated on November 16, 1869. [William Robert Ware](#) and [Henry Van Brunt](#) were leading architects of their era, also responsible for Harvard's [Memorial Hall](#) nearby. The school had a close relationship with Harvard's Divinity School, allowing for cross-registration of classes.

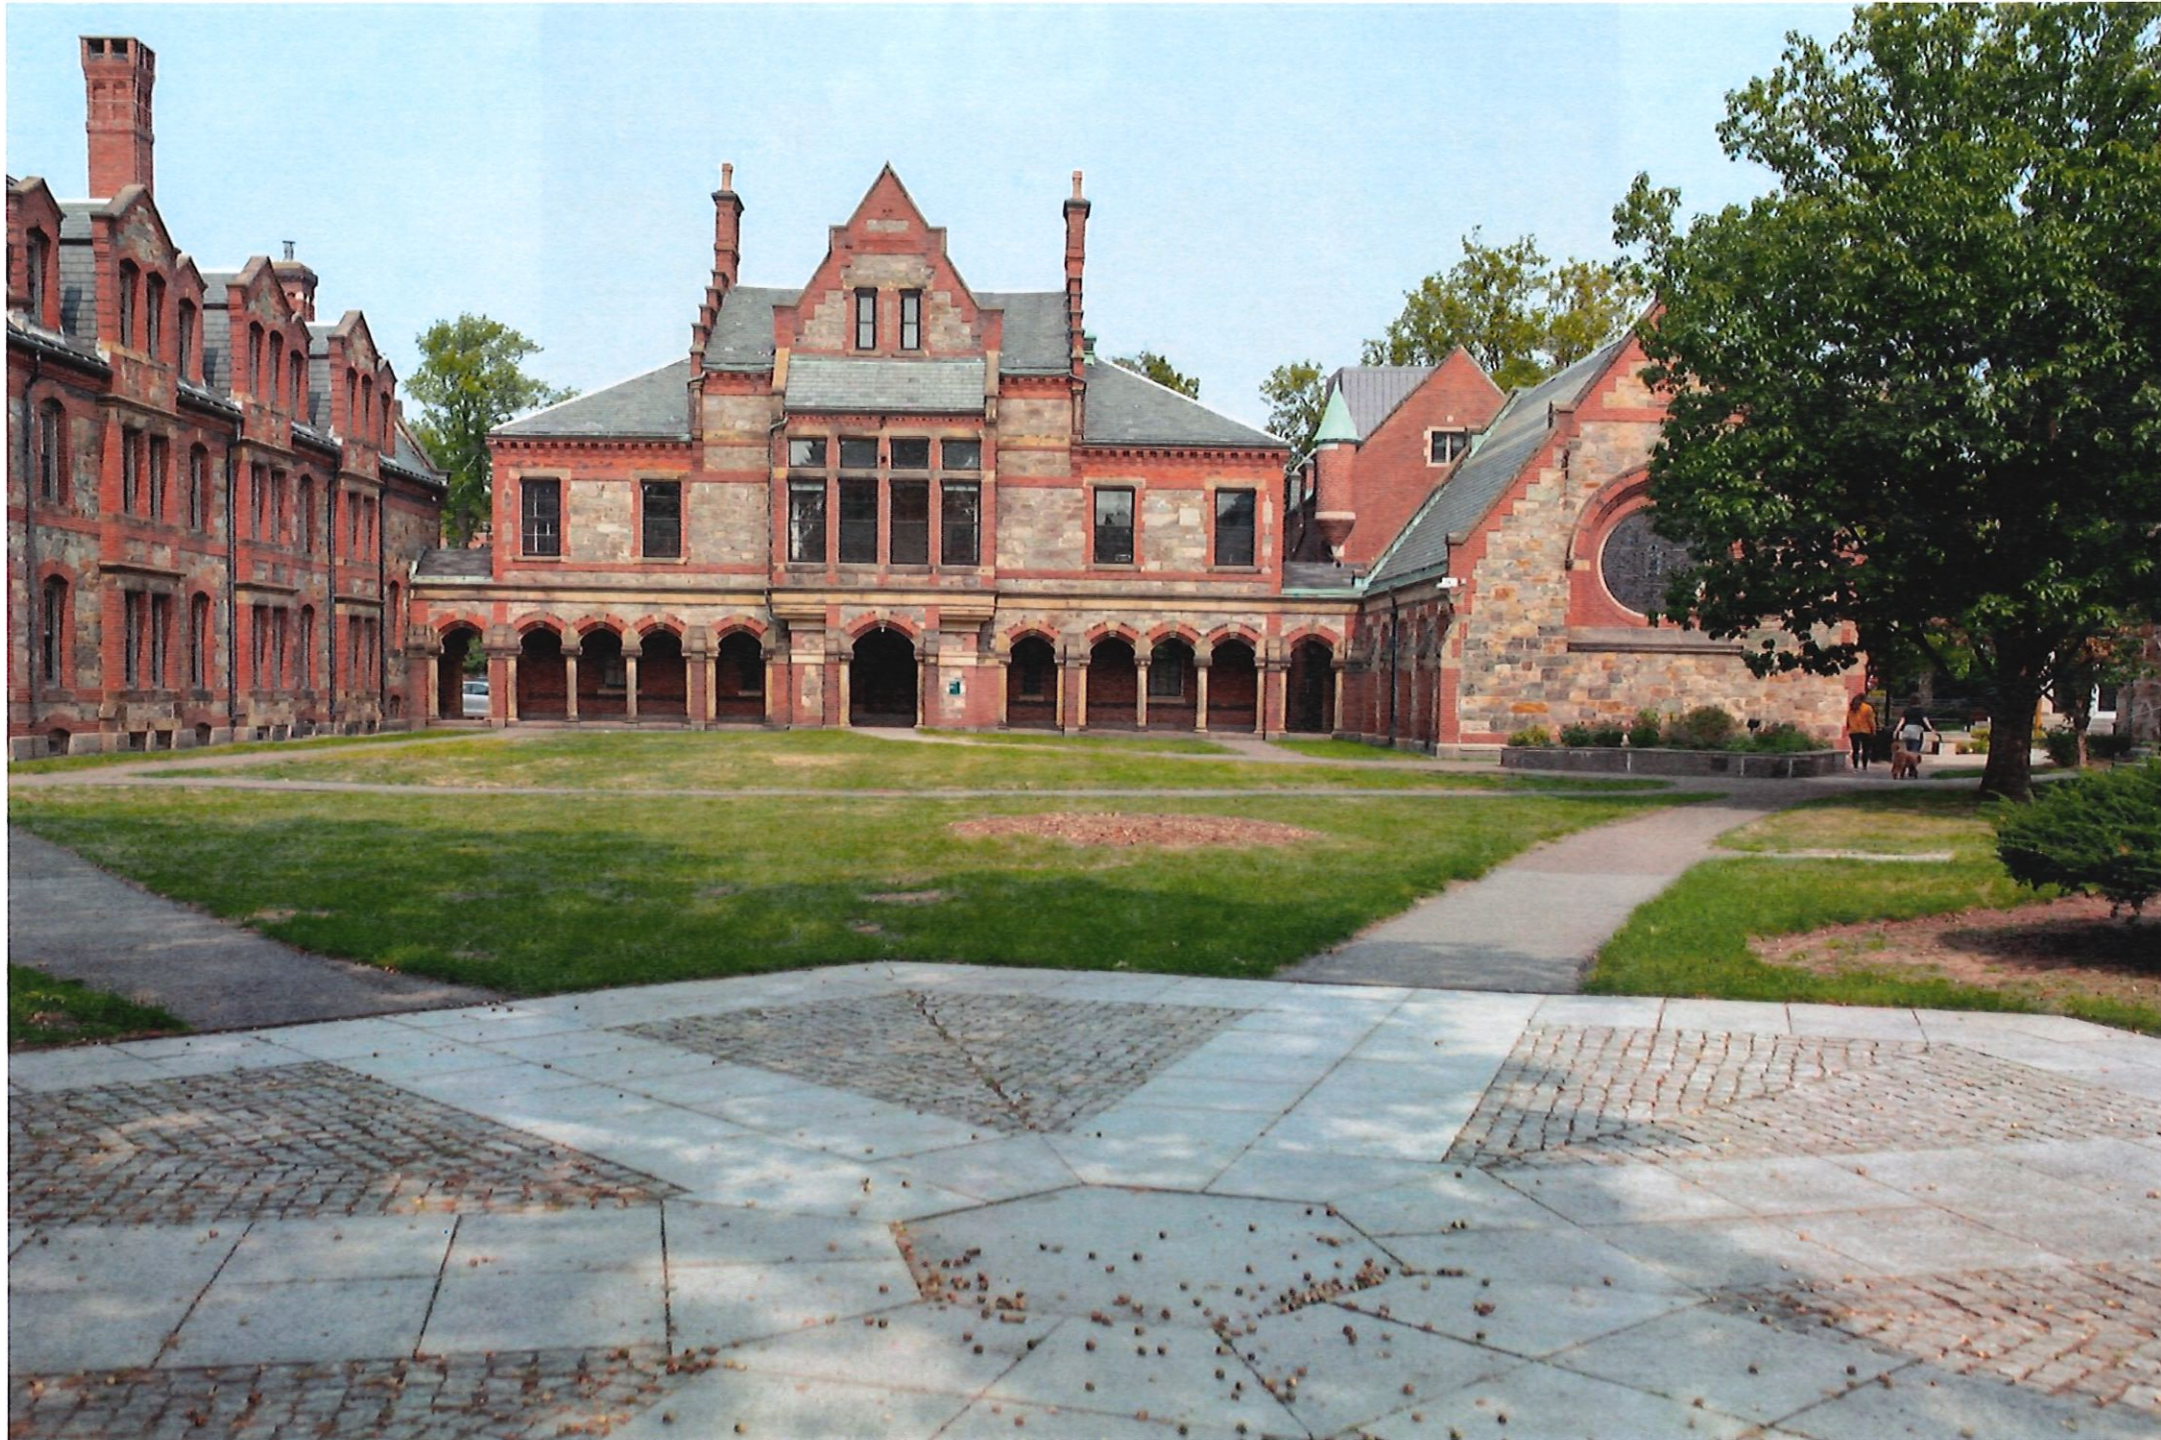
## PROPOSED VIEW FROM QUAD

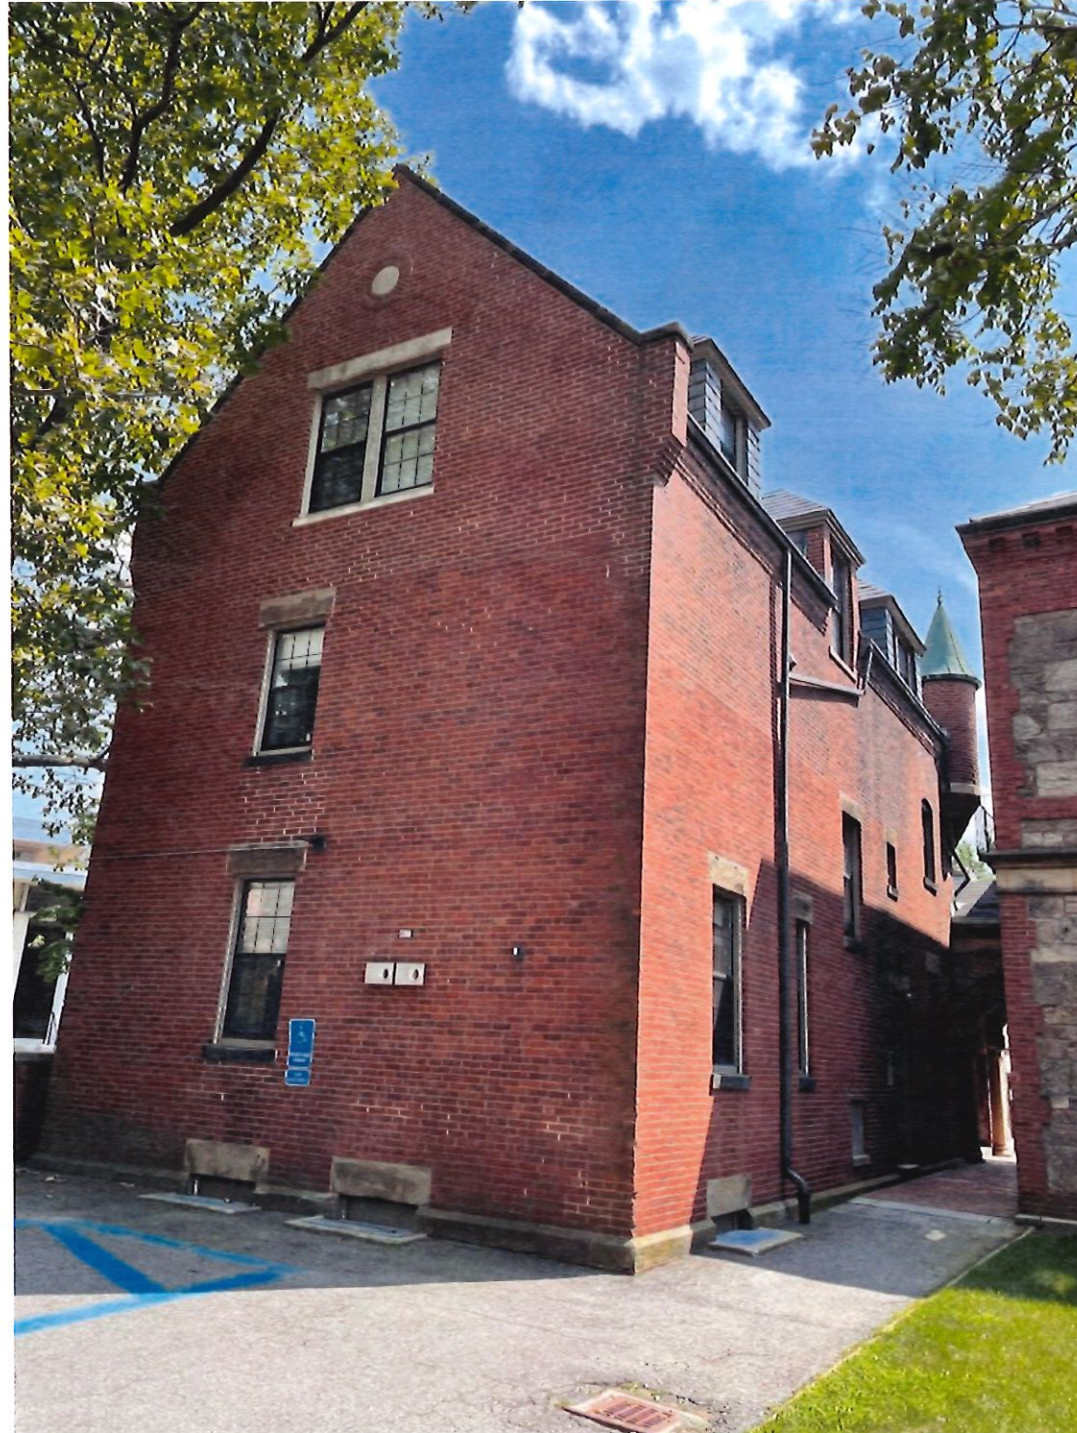
EXISTING VIEW FROM NORTH  
ST. JOHN'S ROAD EXTENSION

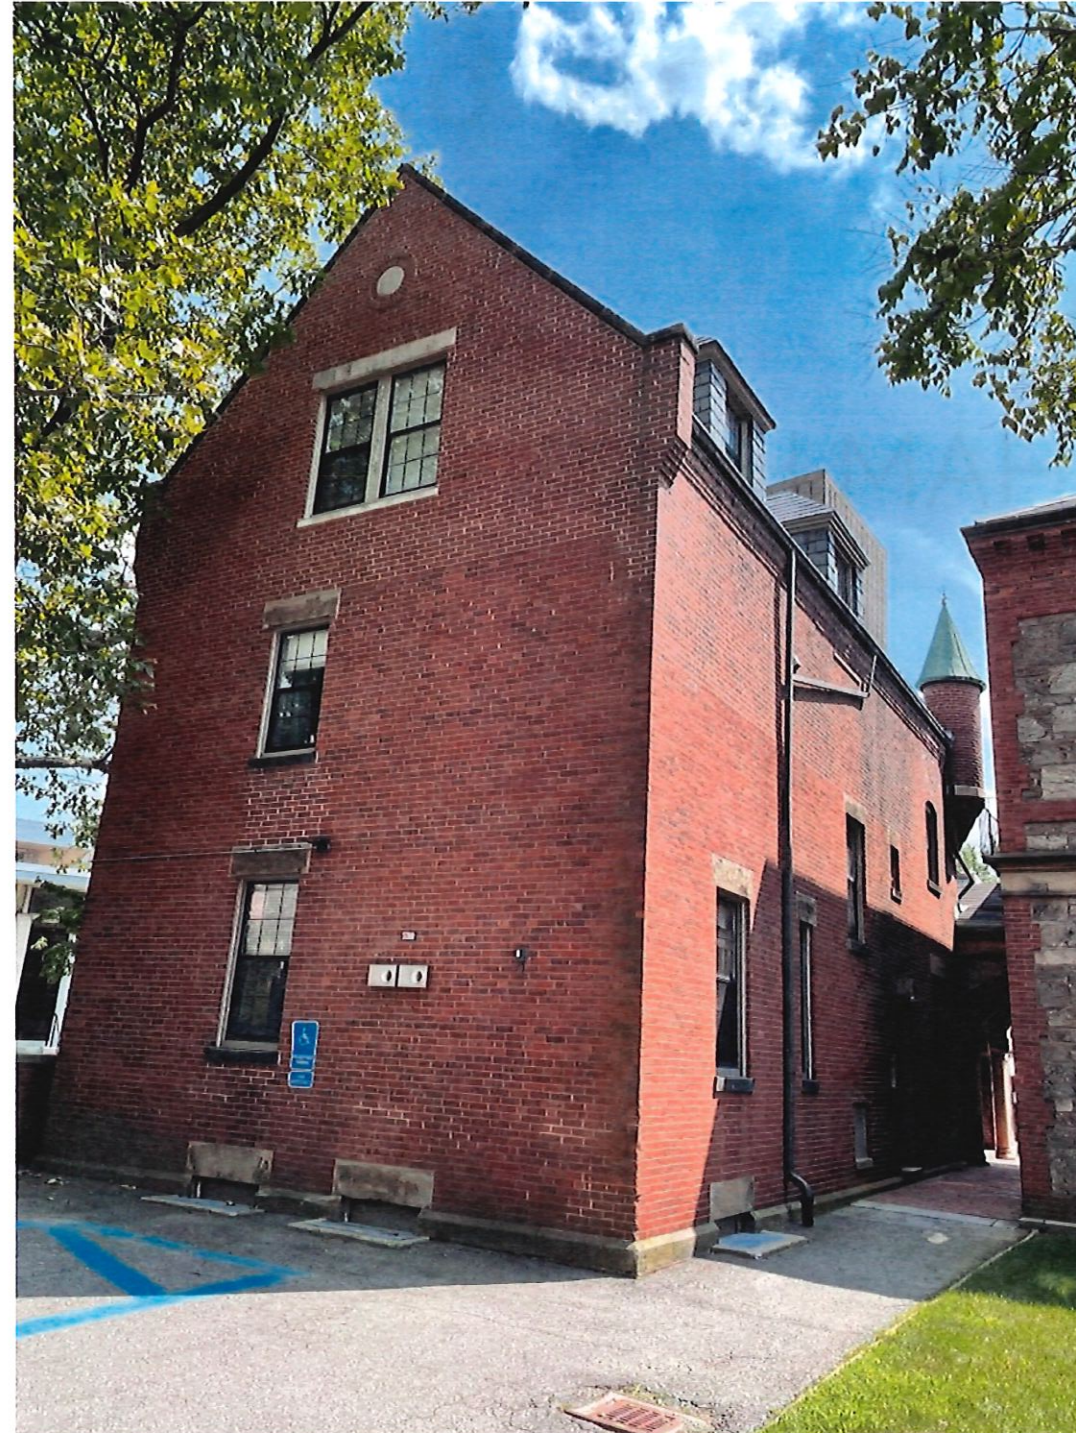
PROPOSED VIEW FROM NORTH  
ST. JOHN'S ROAD EXTENSION

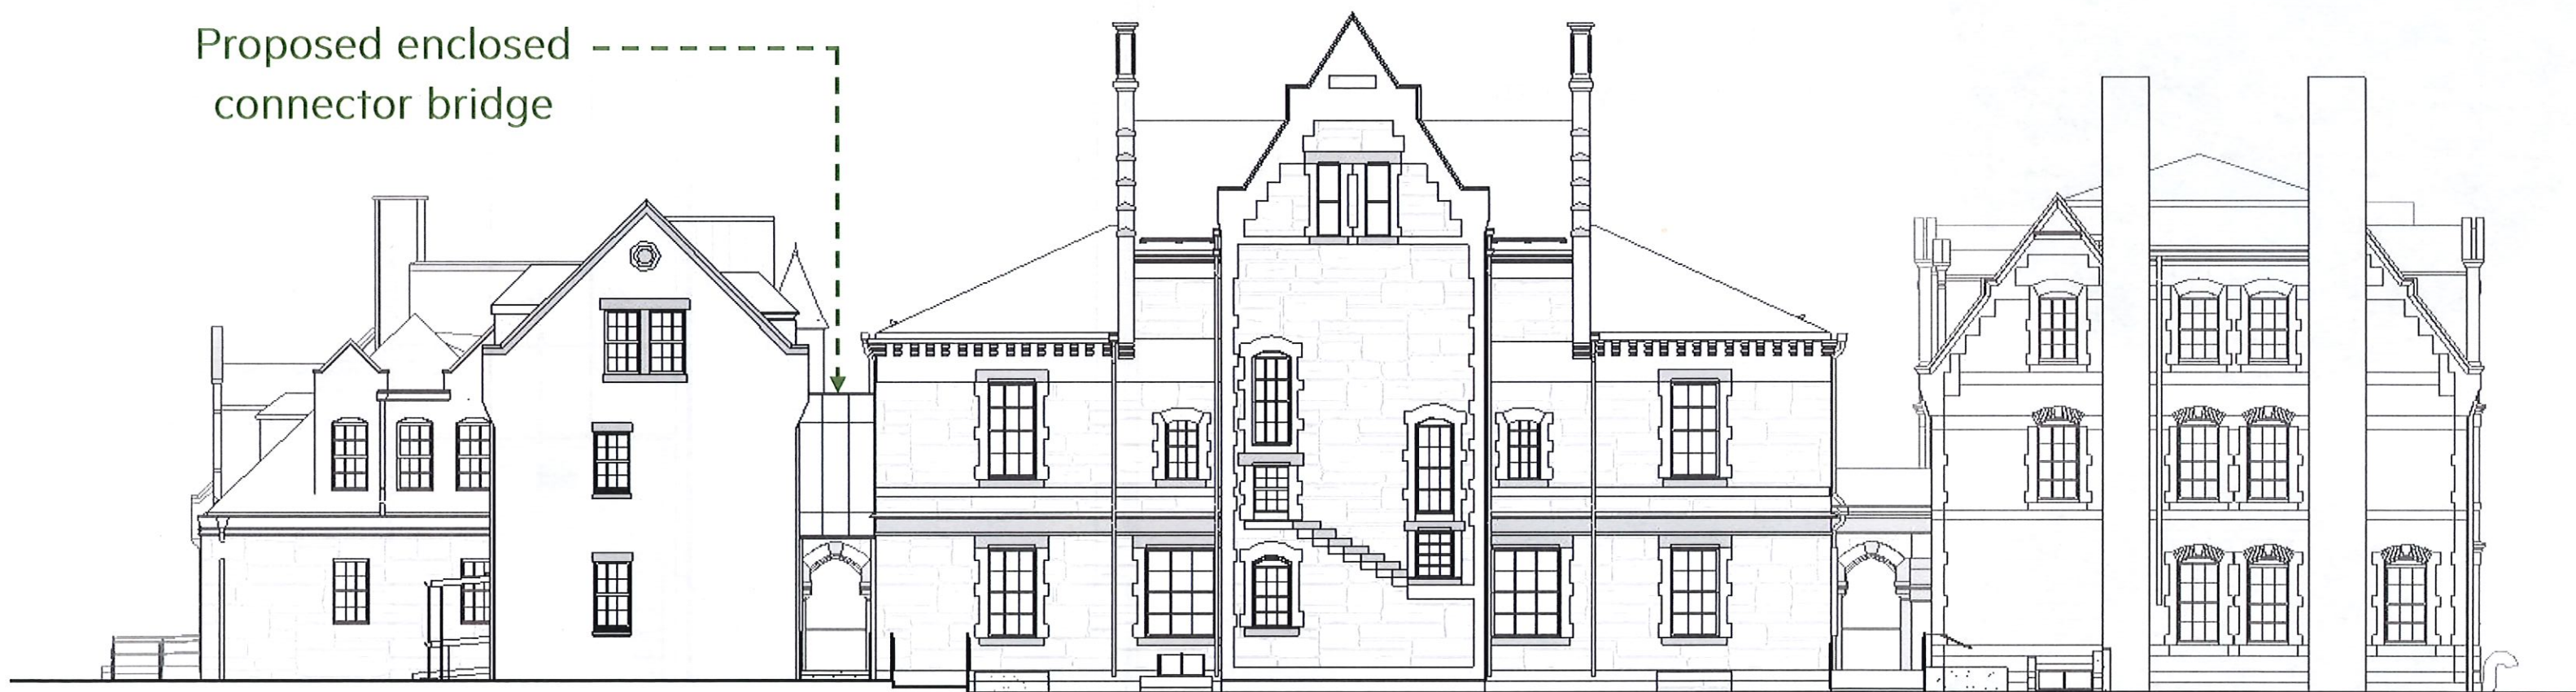
BURNHAM, REED, AND LAWRENCE HALLS - NORTH ELEVATION

Proposed enclosed  
connector bridge

BURNHAM HALL

REED HALL

LAWRENCE HALL

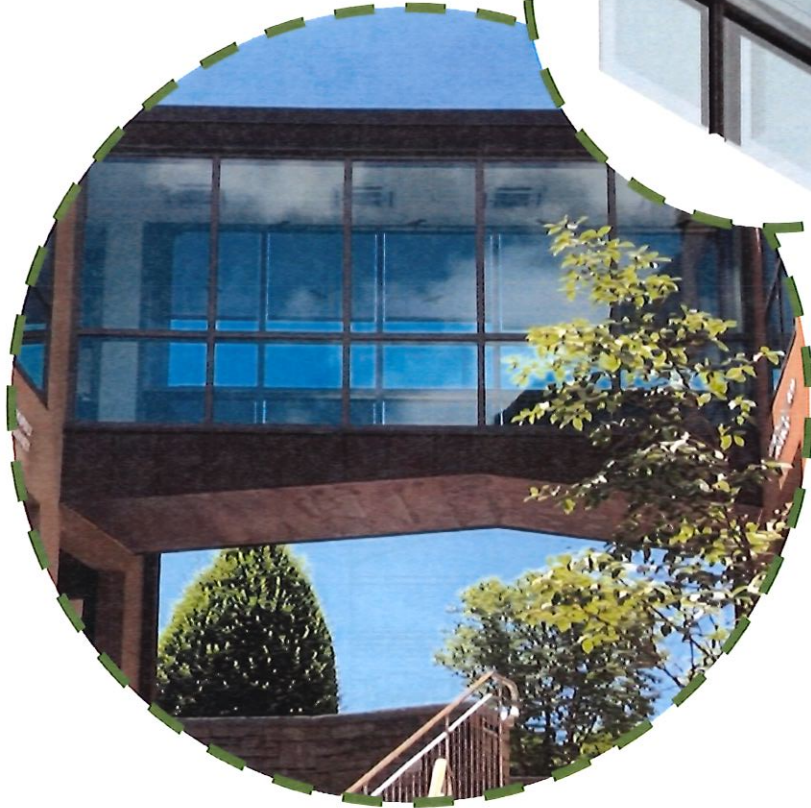
Silicone Joint Glazing  
System with  
Interior Grey Frame

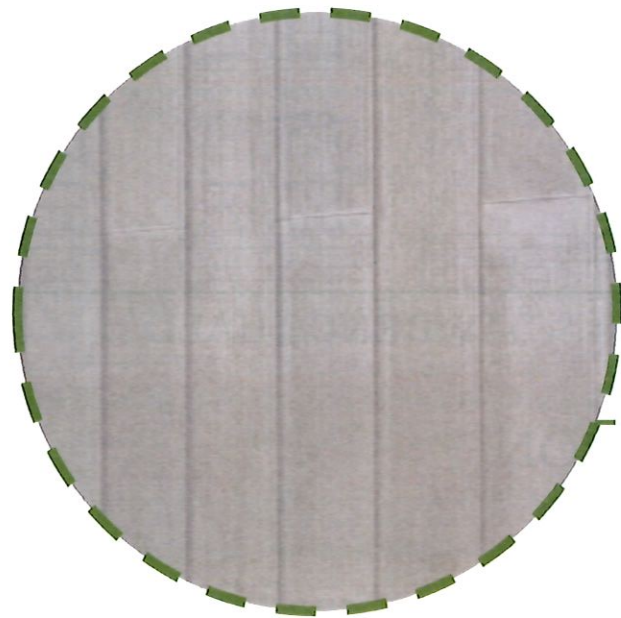
Flat seam simulated  
lead-coated copper soffit

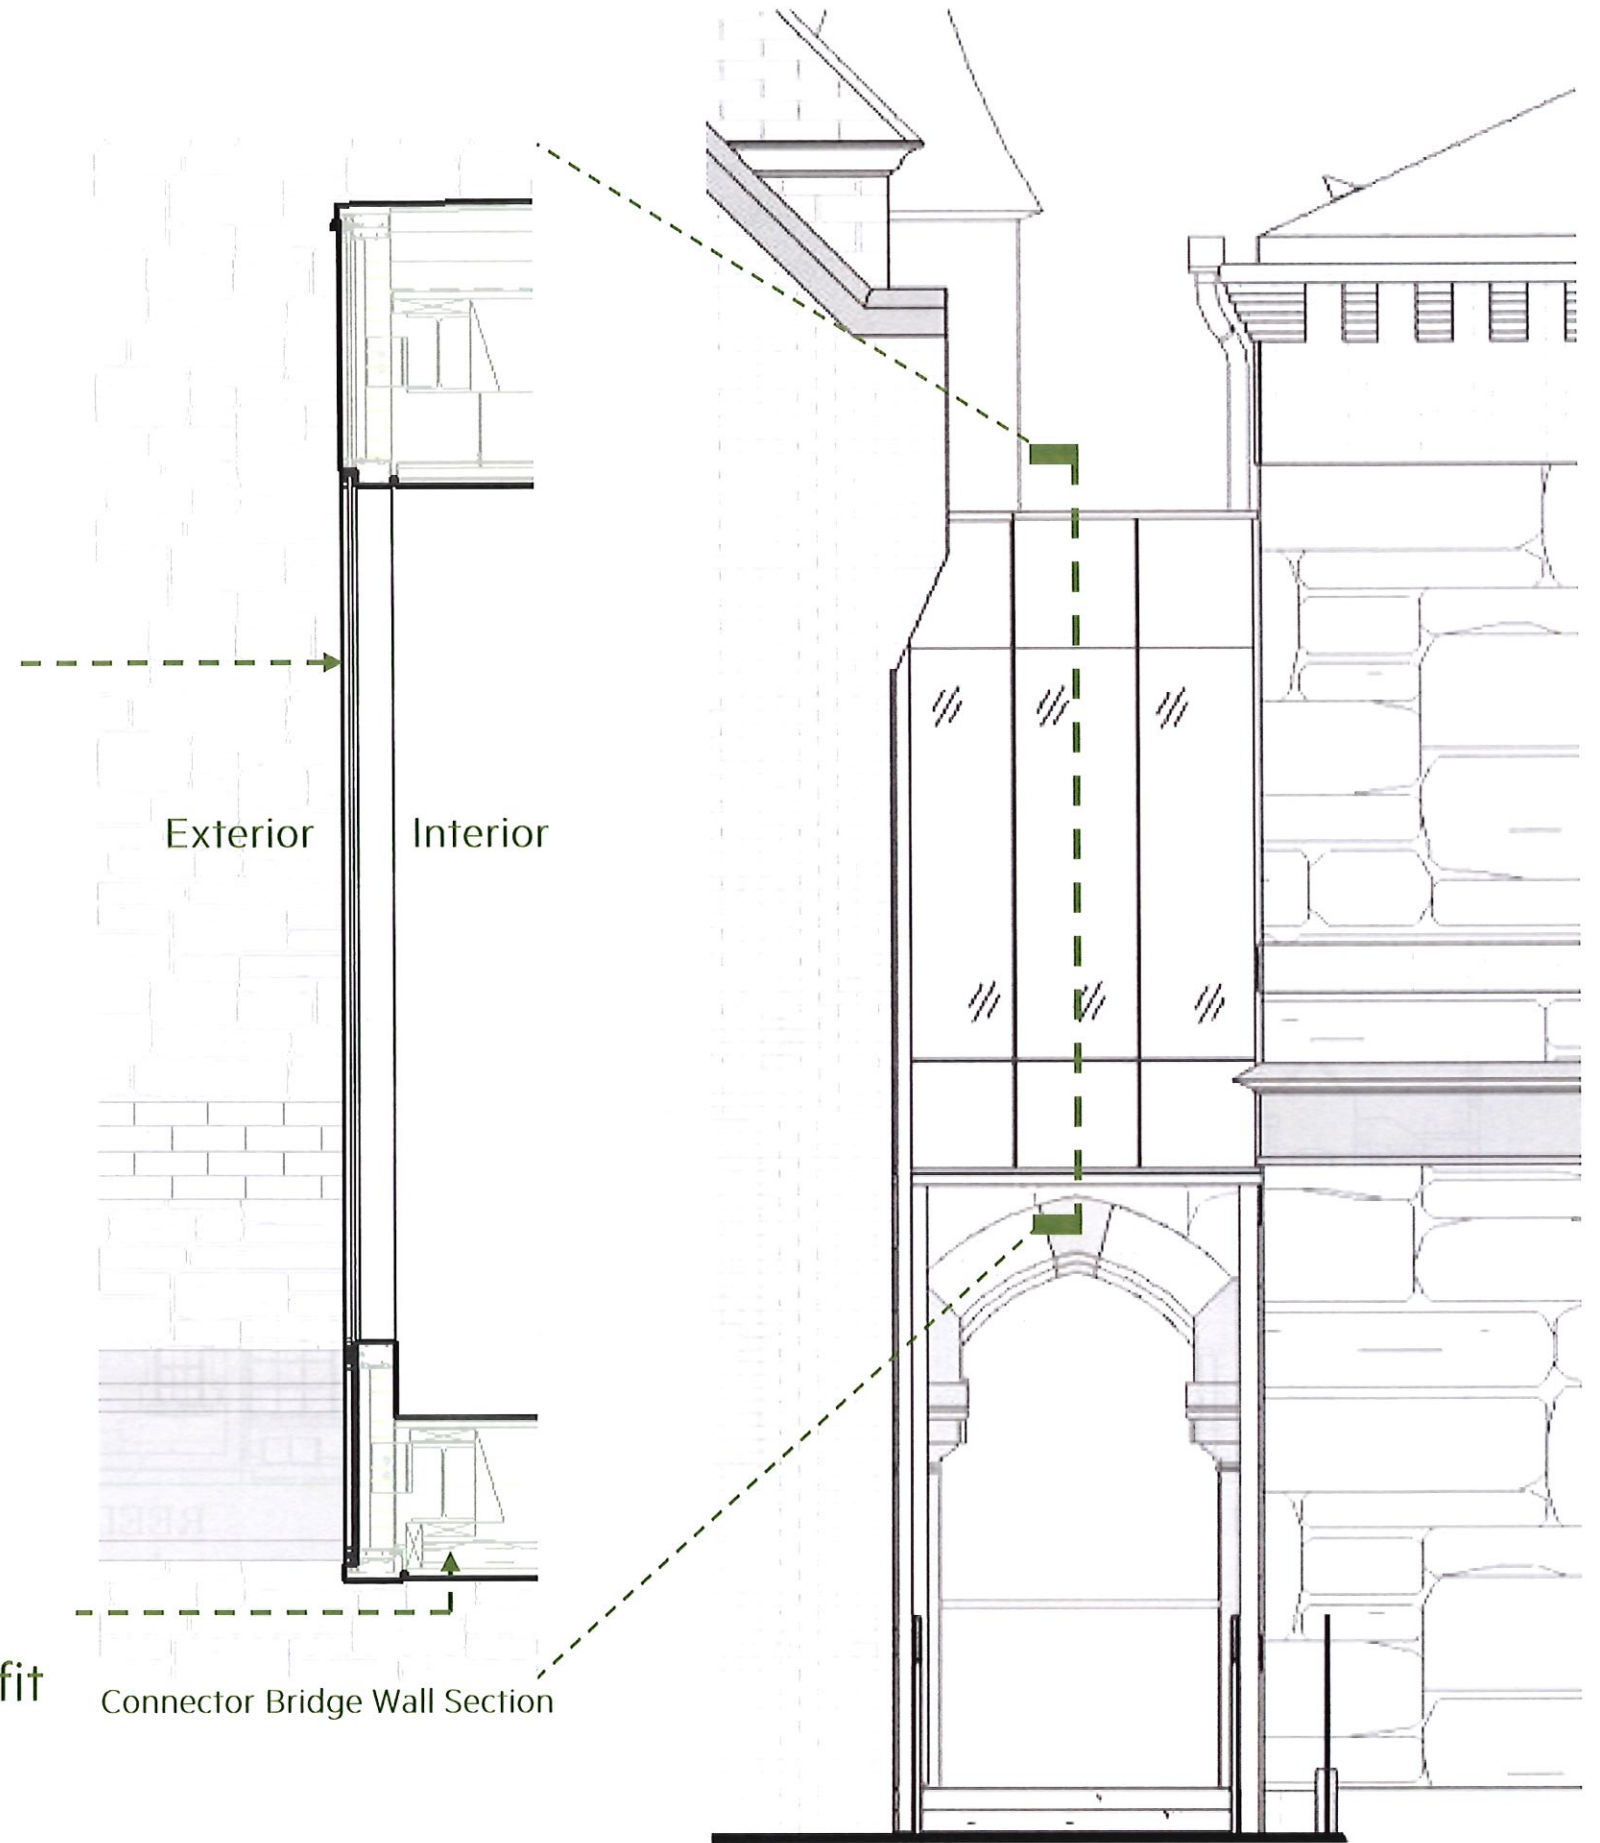
Connector Bridge Wall Section

Exterior

Interior

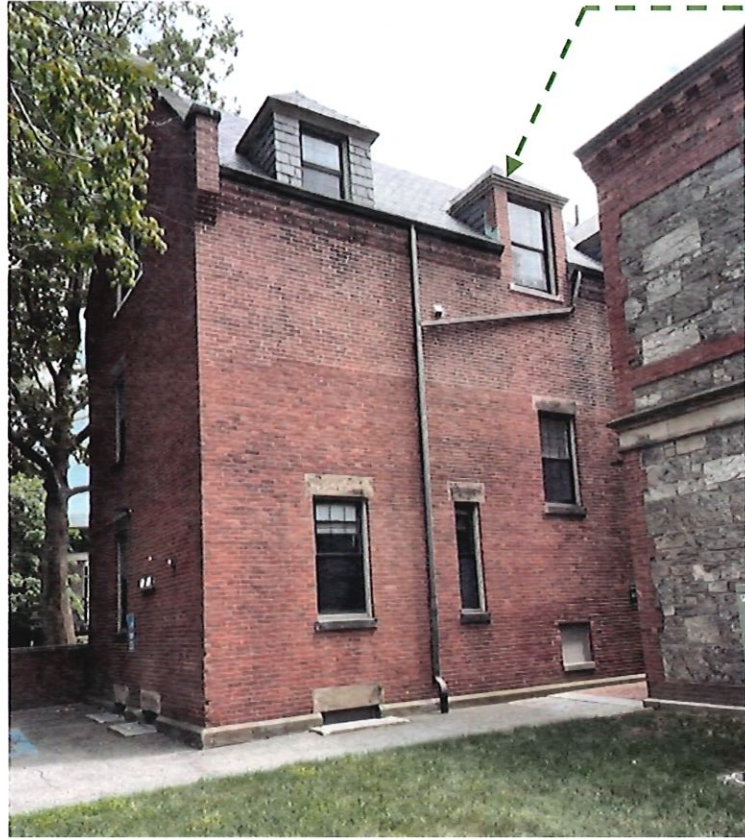
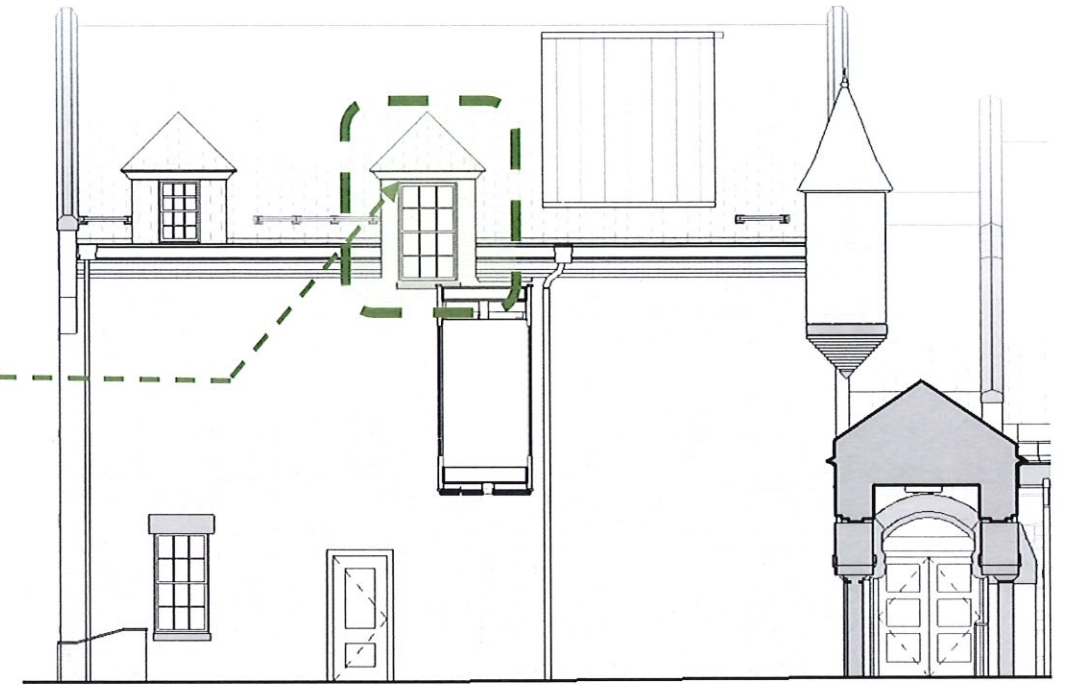
BURNHAM HALL - PROPOSED WEST ELEVATION

Existing dormer to be relocated 3' south

Existing dormer

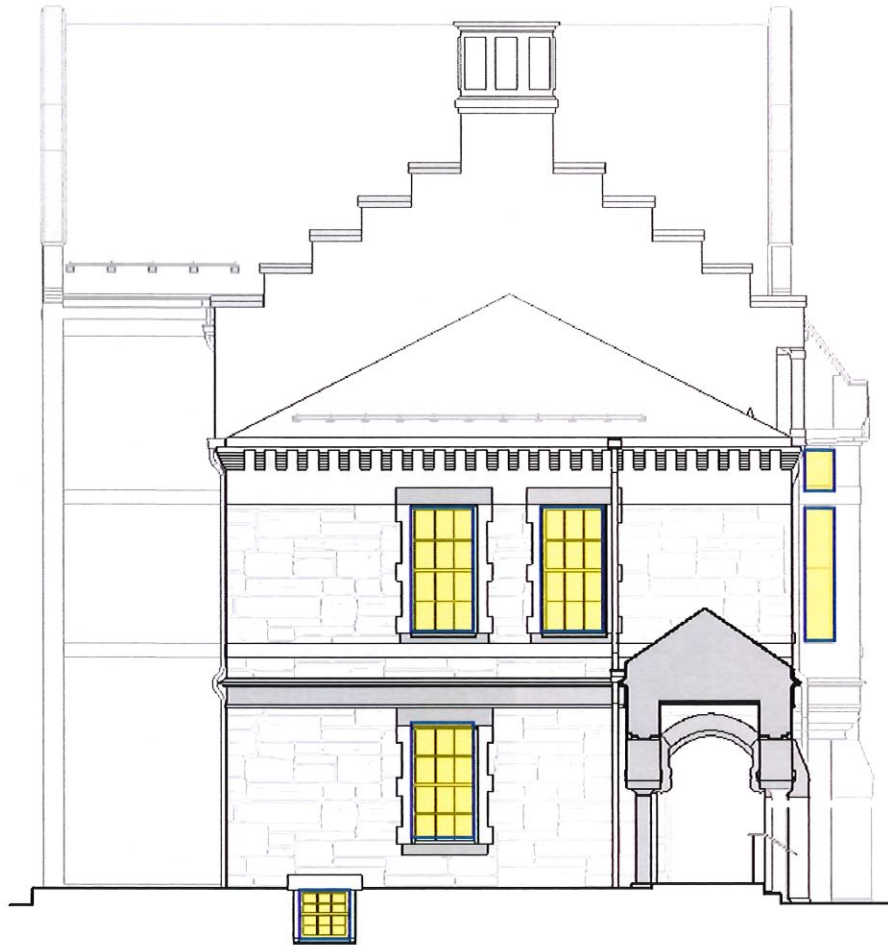
REED WEST ELEVATION

**New wood sash to match existing historic**

- Insulated glass panel in new sash with muntins, stiles and rails to match historic wood windows.
- Restored historic frames and hardware.

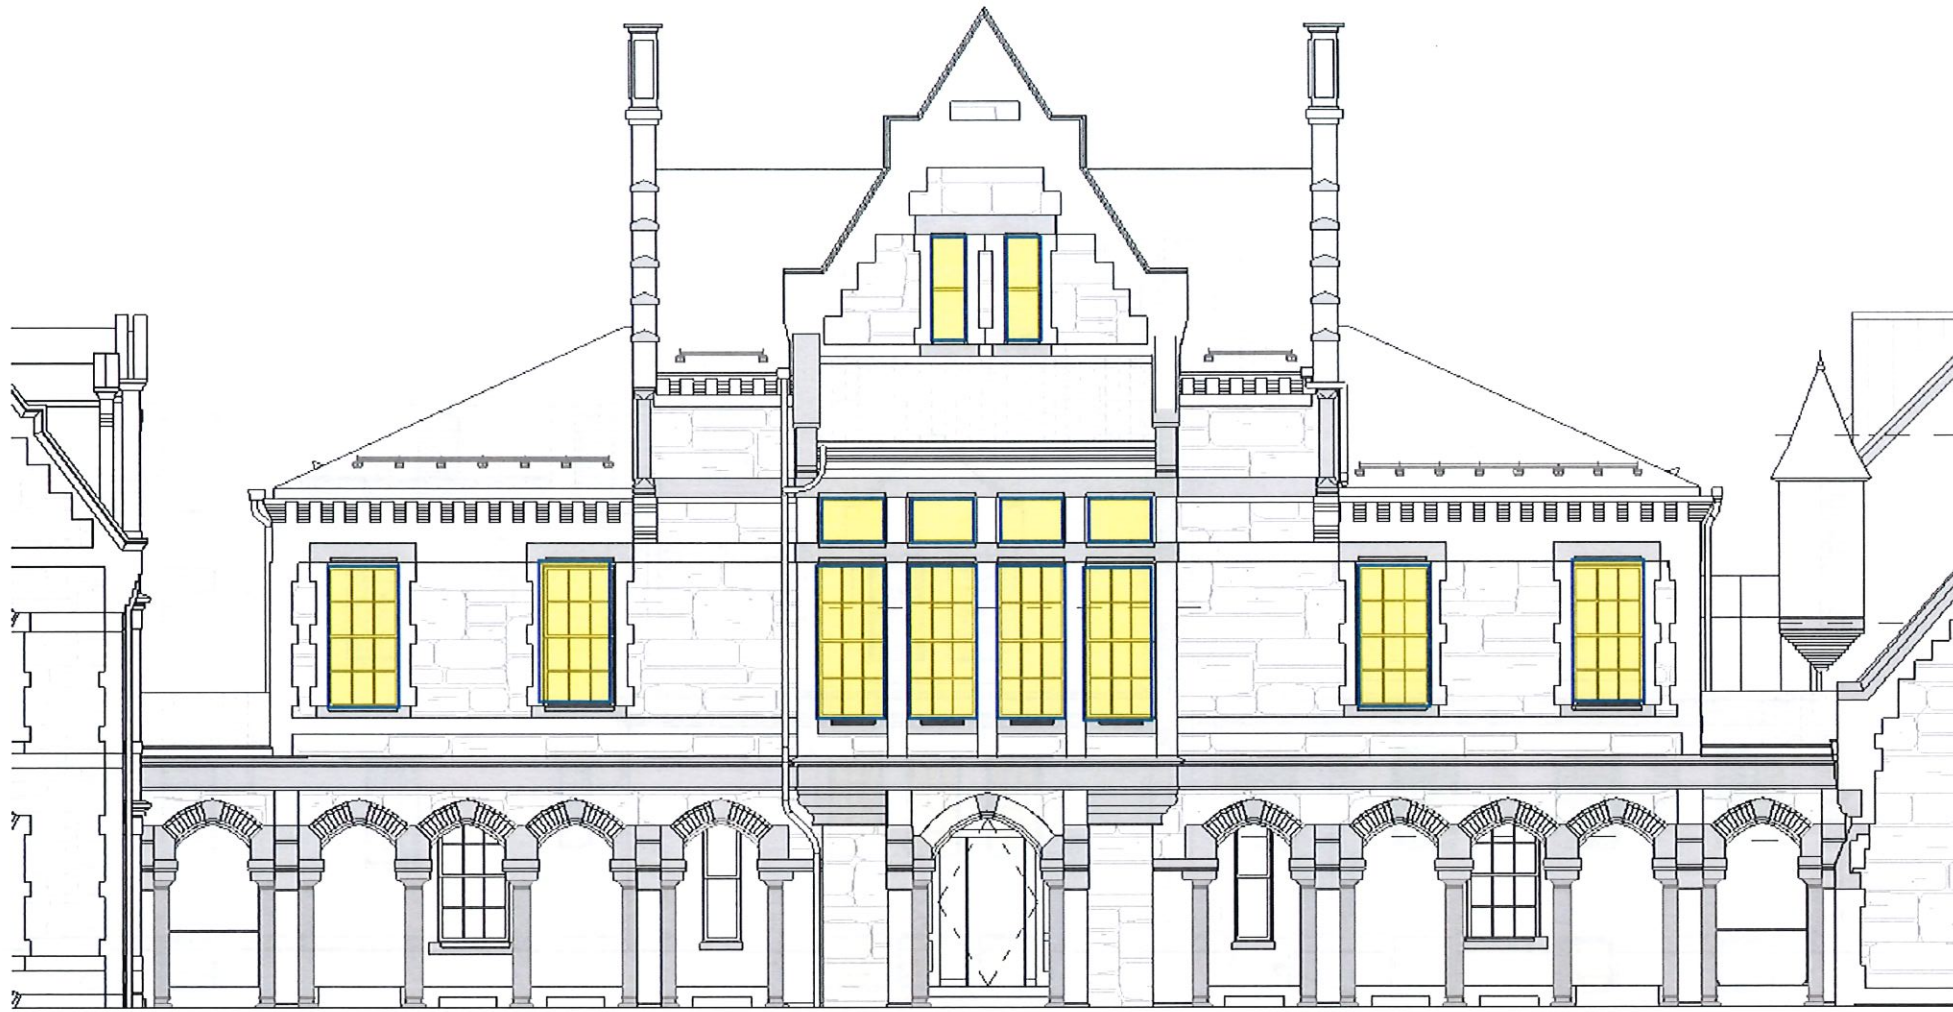
REED SOUTH ELEVATION

**New wood sash to match existing historic**

- Insulated glass panel in new sash with muntins, stiles and rails to match existing historic wood windows.
- Restored historic frames and hardware.

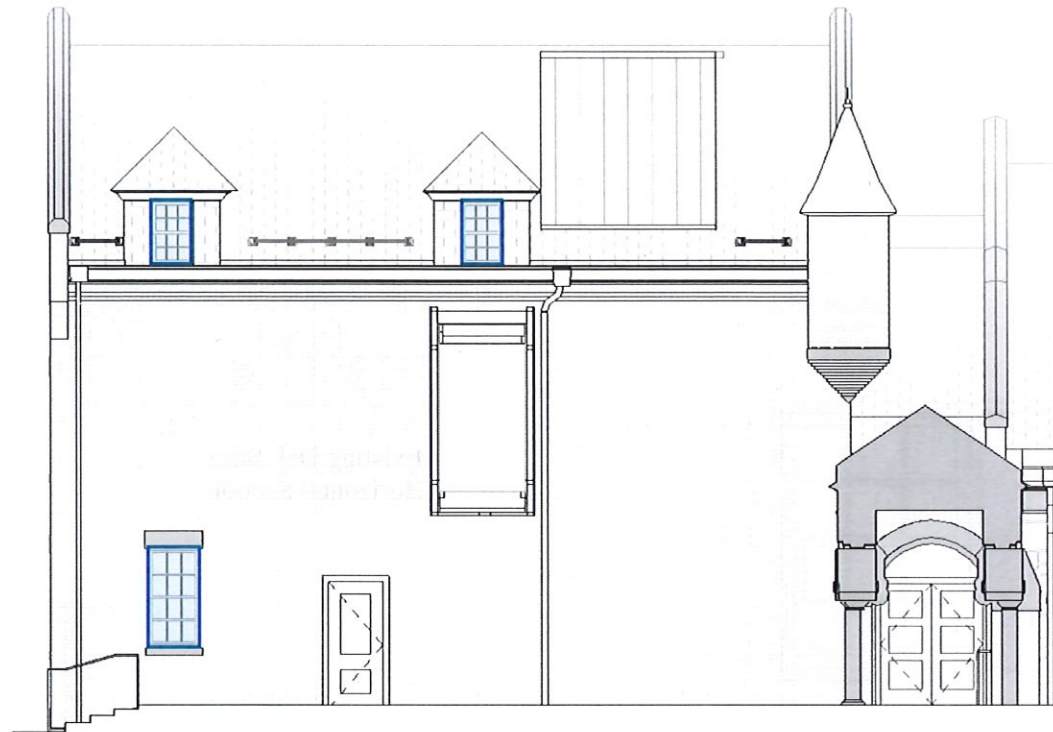
BURNHAM WEST ELEVATION

**New wood sash to match existing historic**

- Insulated glass panel in new sash with muntins, stiles and rails to match historic wood windows.
- Restored historic frames and hardware.

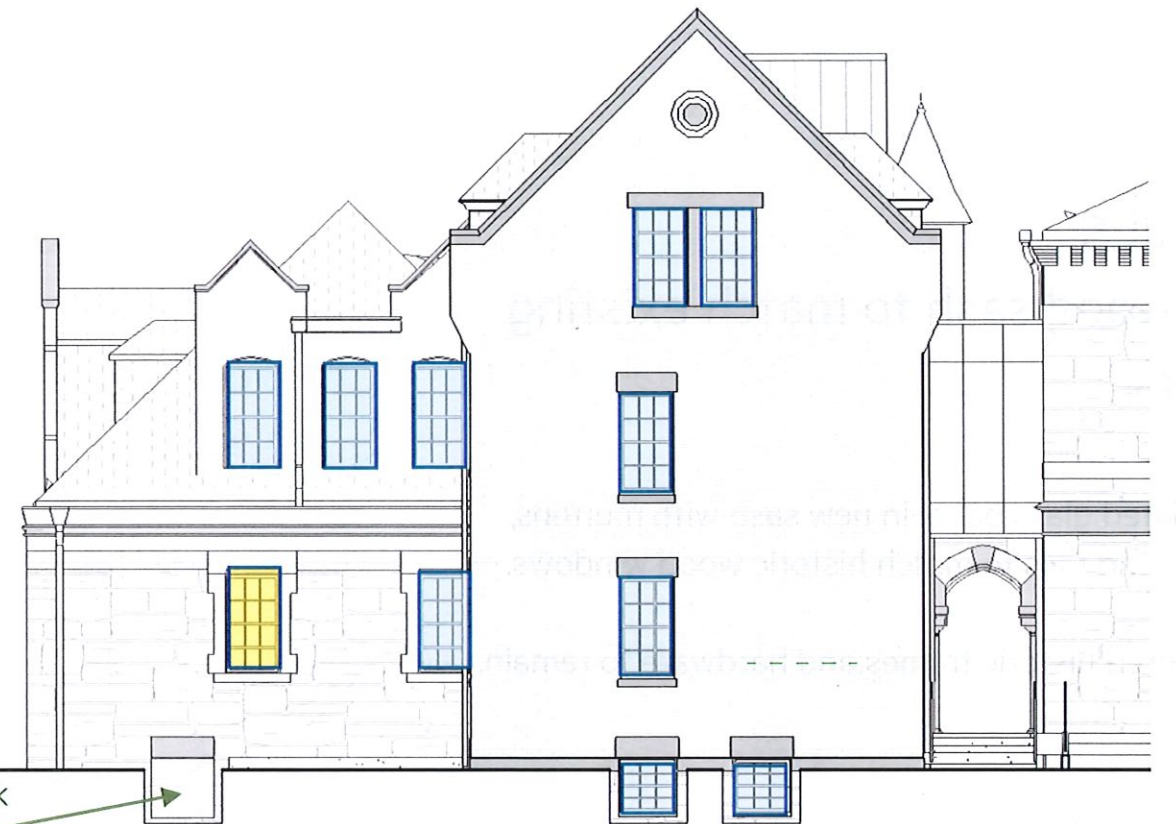
BURNHAM NORTH ELEVATION

**New wood window (sash and frame) to match historic wood window**

- Replacement for existing non-historic aluminum windows.
- Insulated glass panel in new sash with muntins, stiles and rails to match historic wood windows.

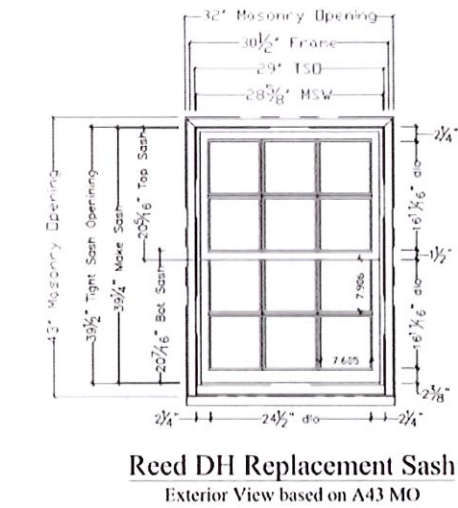
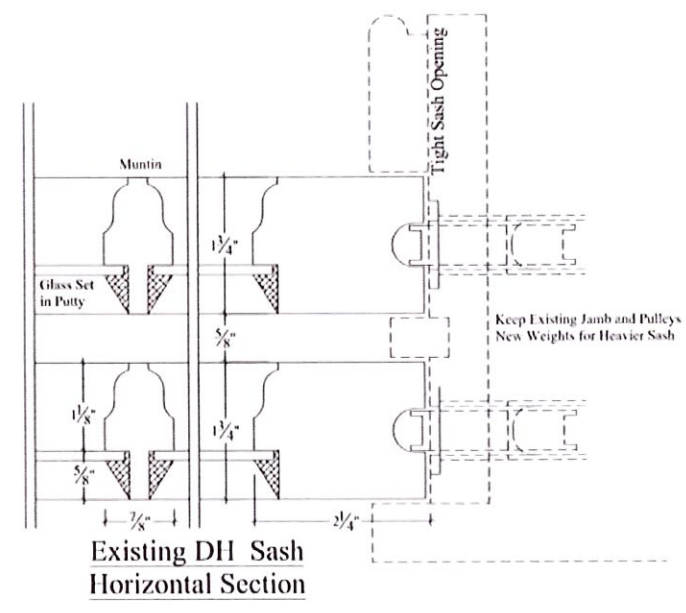
# DETAILS: New wood sash to match existing historic

- Insulated glass panel in new sash with muntins, stiles and rails to match historic wood windows.
- Restored historic frames and hardware to remain.

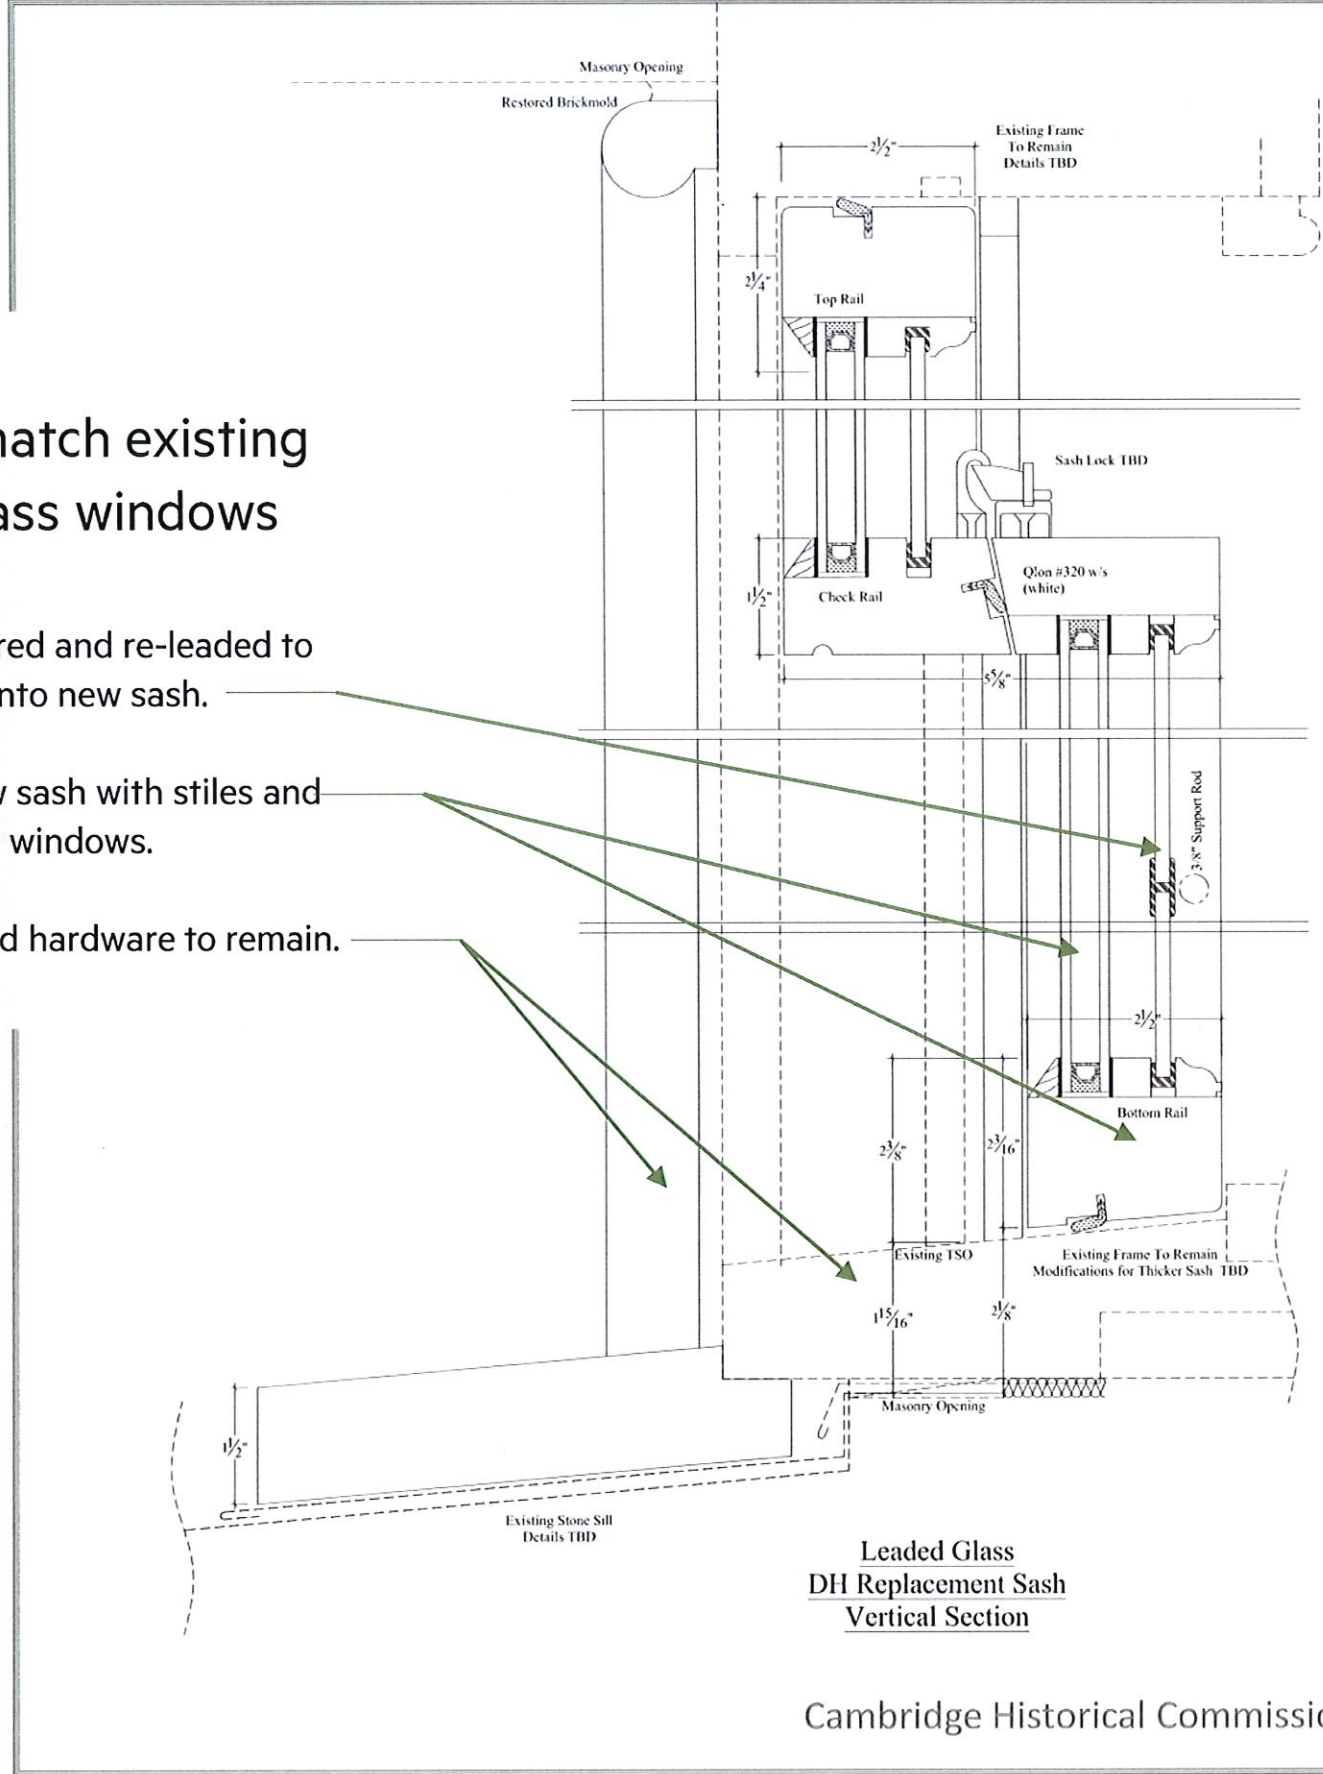
**Leaded Glass  
 DH Replacement Sash  
 Vertical Section**

**DETAILS:**  
**New wood sash to match existing historic at leaded glass windows**

- Original historic glass restored and re-leaded to match existing and glazed into new sash.
- Insulated glass panel in new sash with stiles and rails to match historic wood windows.
- Restored historic frames and hardware to remain.

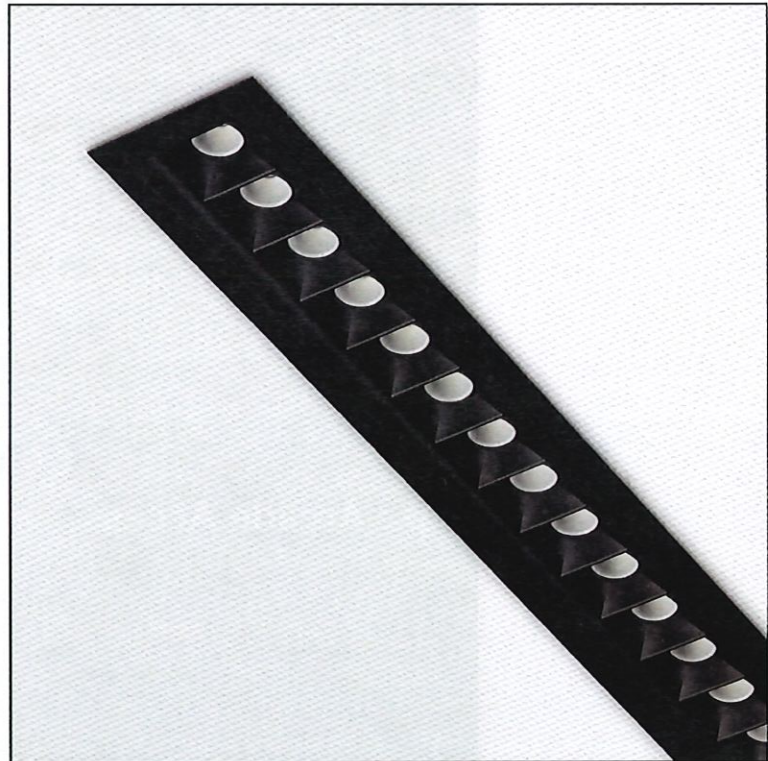
Proposed fixture:  
LED LINEAR "Mars Nano" Recessed  
1 1/2" Wide x 30" Long

Designed for  
Invisible light source  
and anti-glare louver.
