# 99-3 Brattle Reed and Burnham Halls

October 11, 2022

Cambridge Historical Commission

Located on Brattle Street in historic Cambridge, MA, the former campus is a historic landmark located next to the Longfellow house. The chapel was designed by the architectural firm of Ware and Van Brunt, who would later create the Quadrangle of residences, classrooms, and library. The chapel was consecrated on November 16, 1869. [William Robert Ware](#) and [Henry Van Brunt](#) were leading architects of their era, also responsible for Harvard's [Memorial Hall](#) nearby. The school had a close relationship with Harvard's Divinity School, allowing for cross-registration of classes.

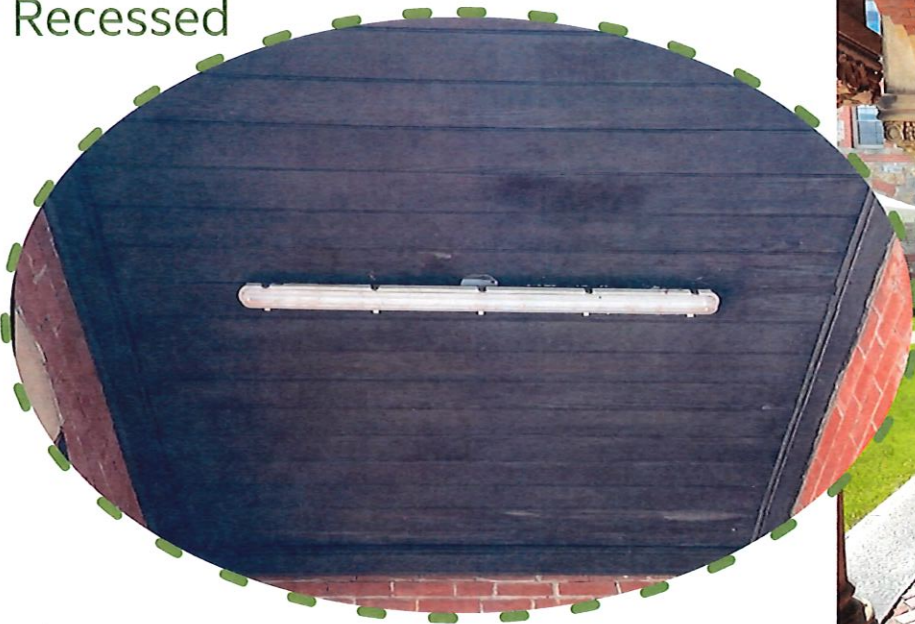
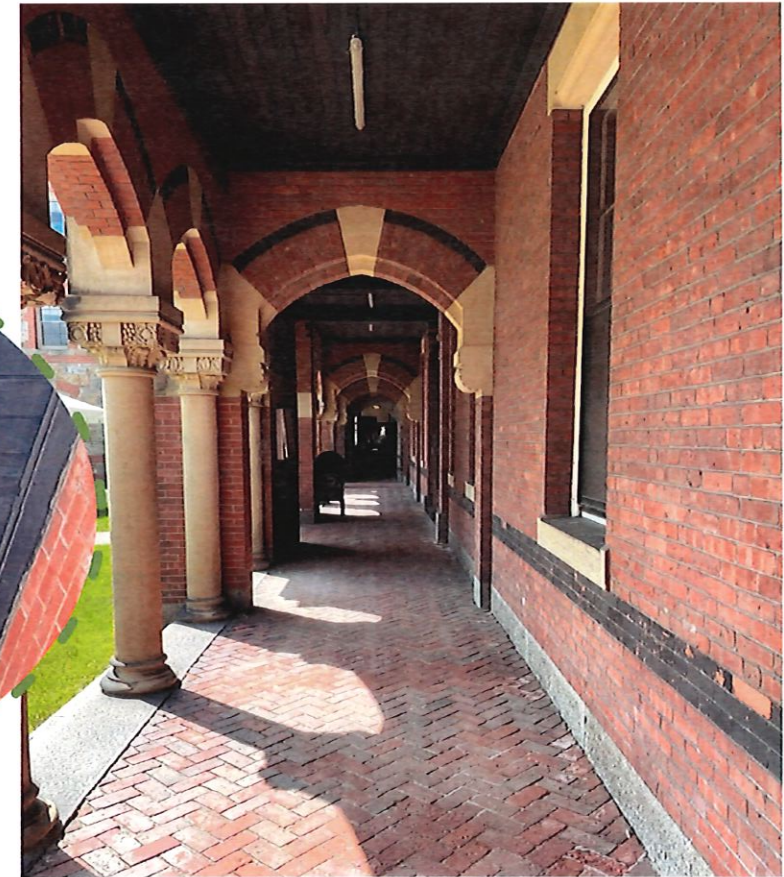
LINEAR LOW BRIGHTNESS RECESSED FIXTURE

Existing fixture

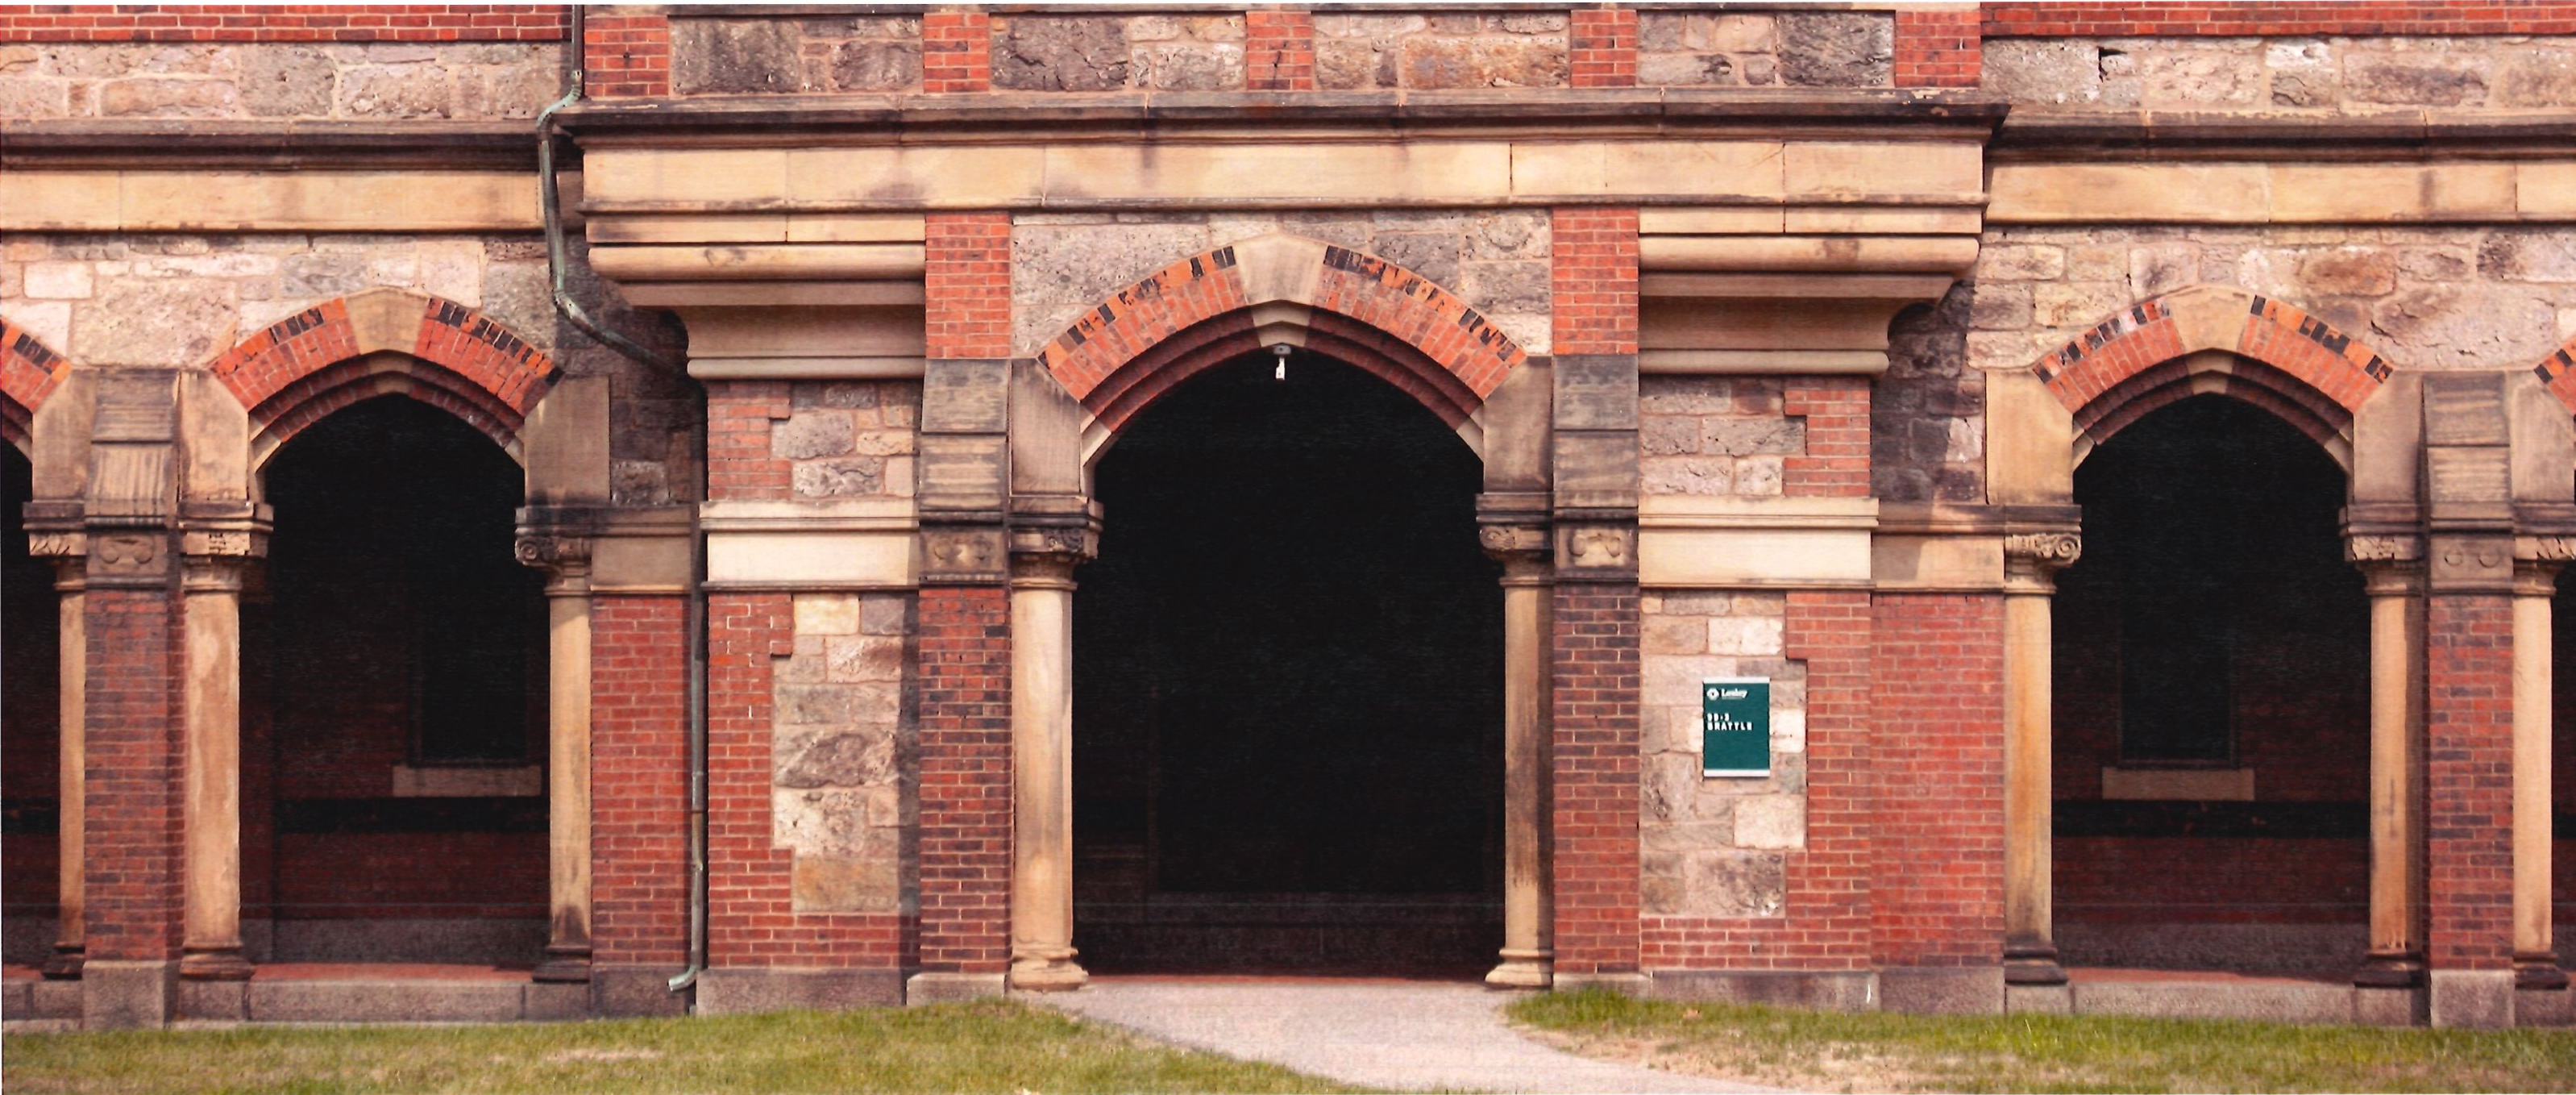
EXISTING ARCADE

**CODE REFERENCE: 780 CMR 34.00 Section 1014.9**

*Stairways shall have intermediate handrails located in such a manner that all portions of the stairway minimum width or required capacity are within 30 inches (762 mm) of a handrail. On monumental stairs, handrails shall be located along the most direct path of egress travel.*

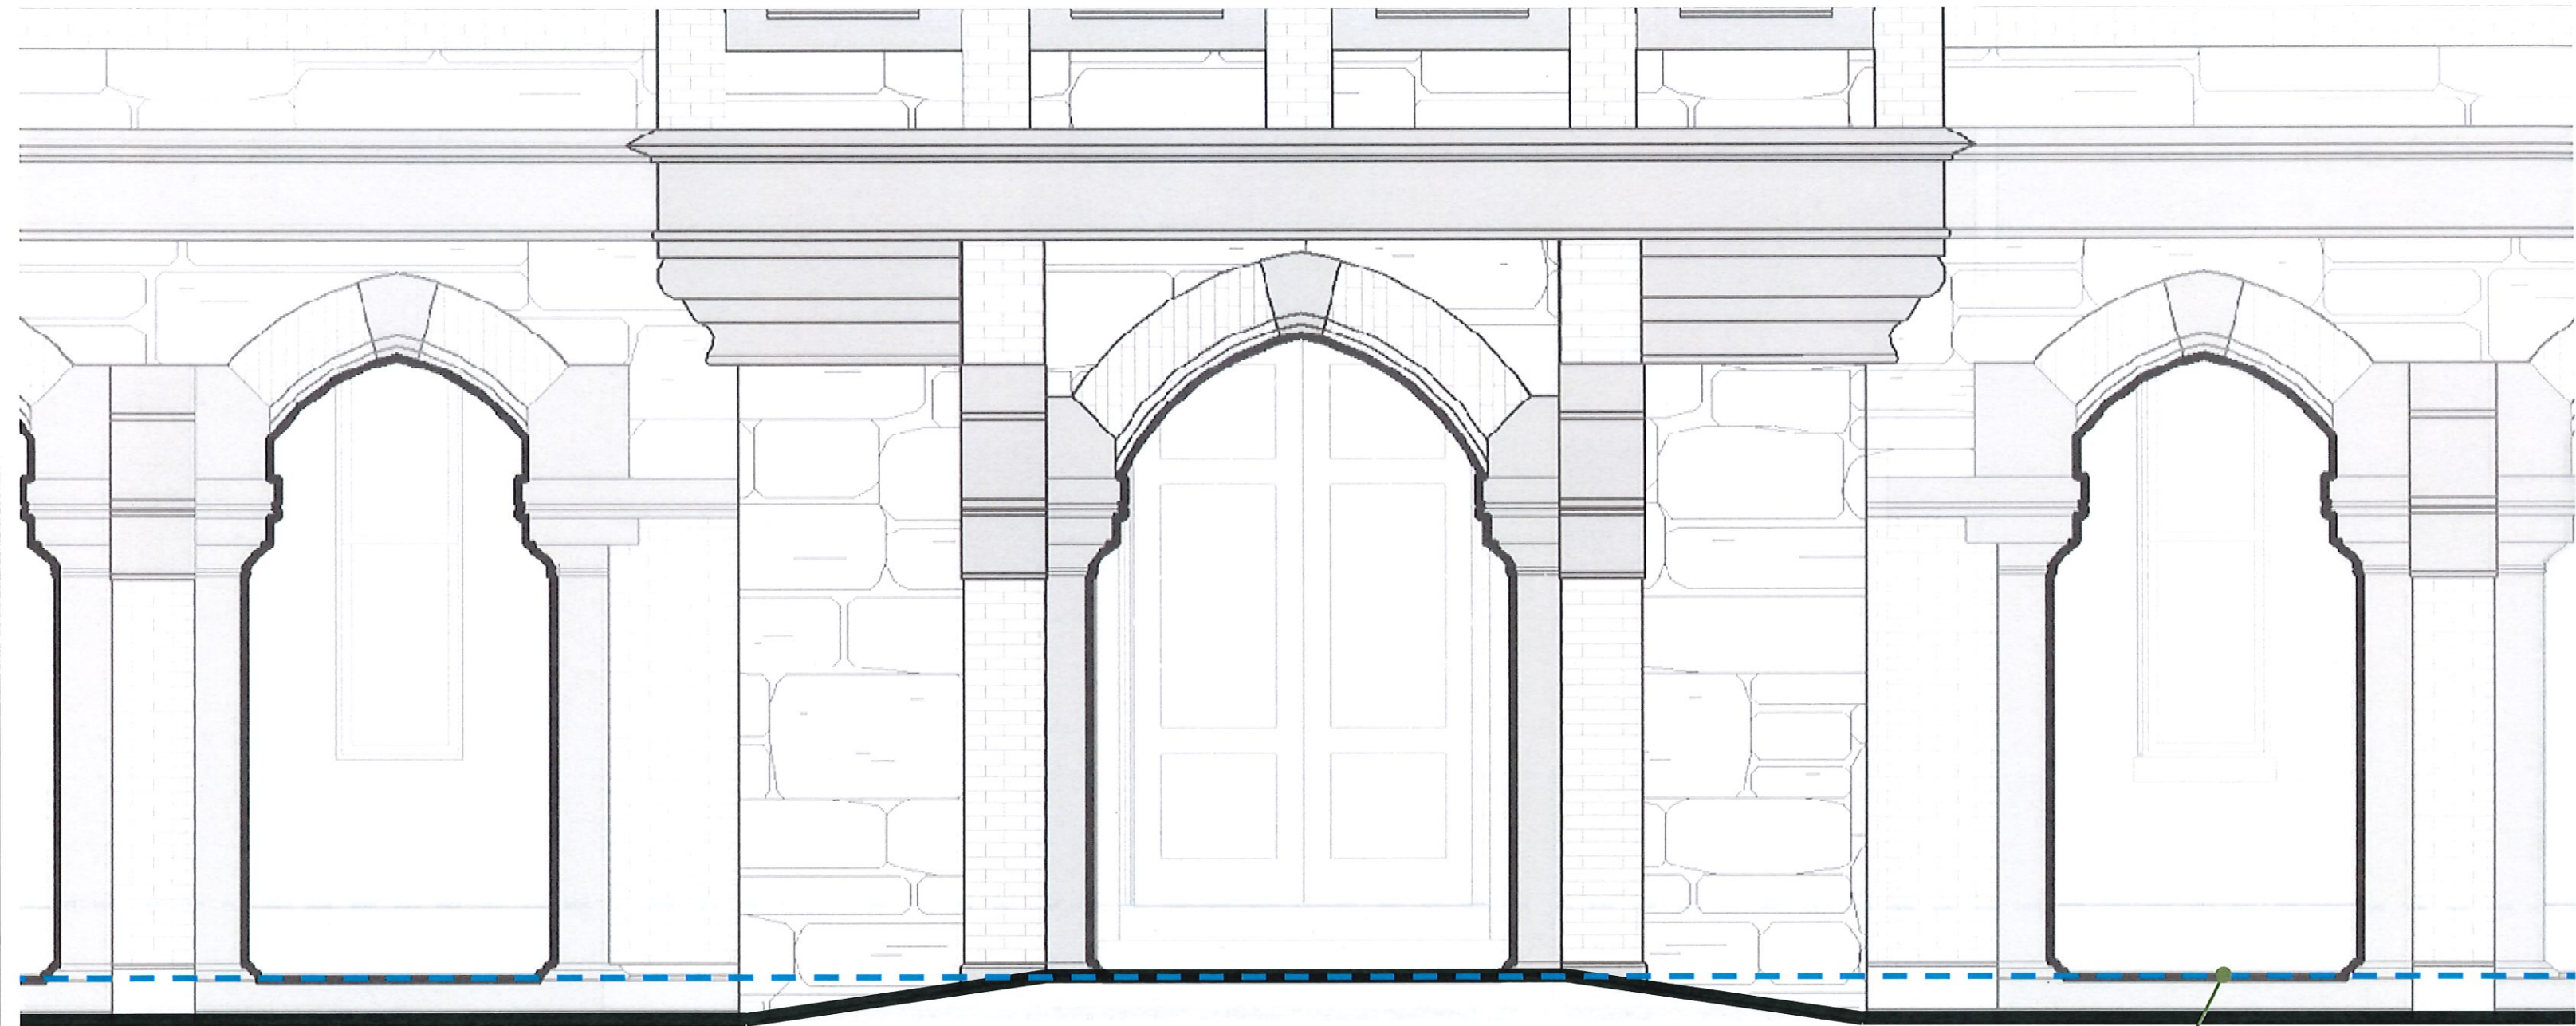
EXISTING ARCADE

ARCADE FINISHED  
FLOOR ELEVATION

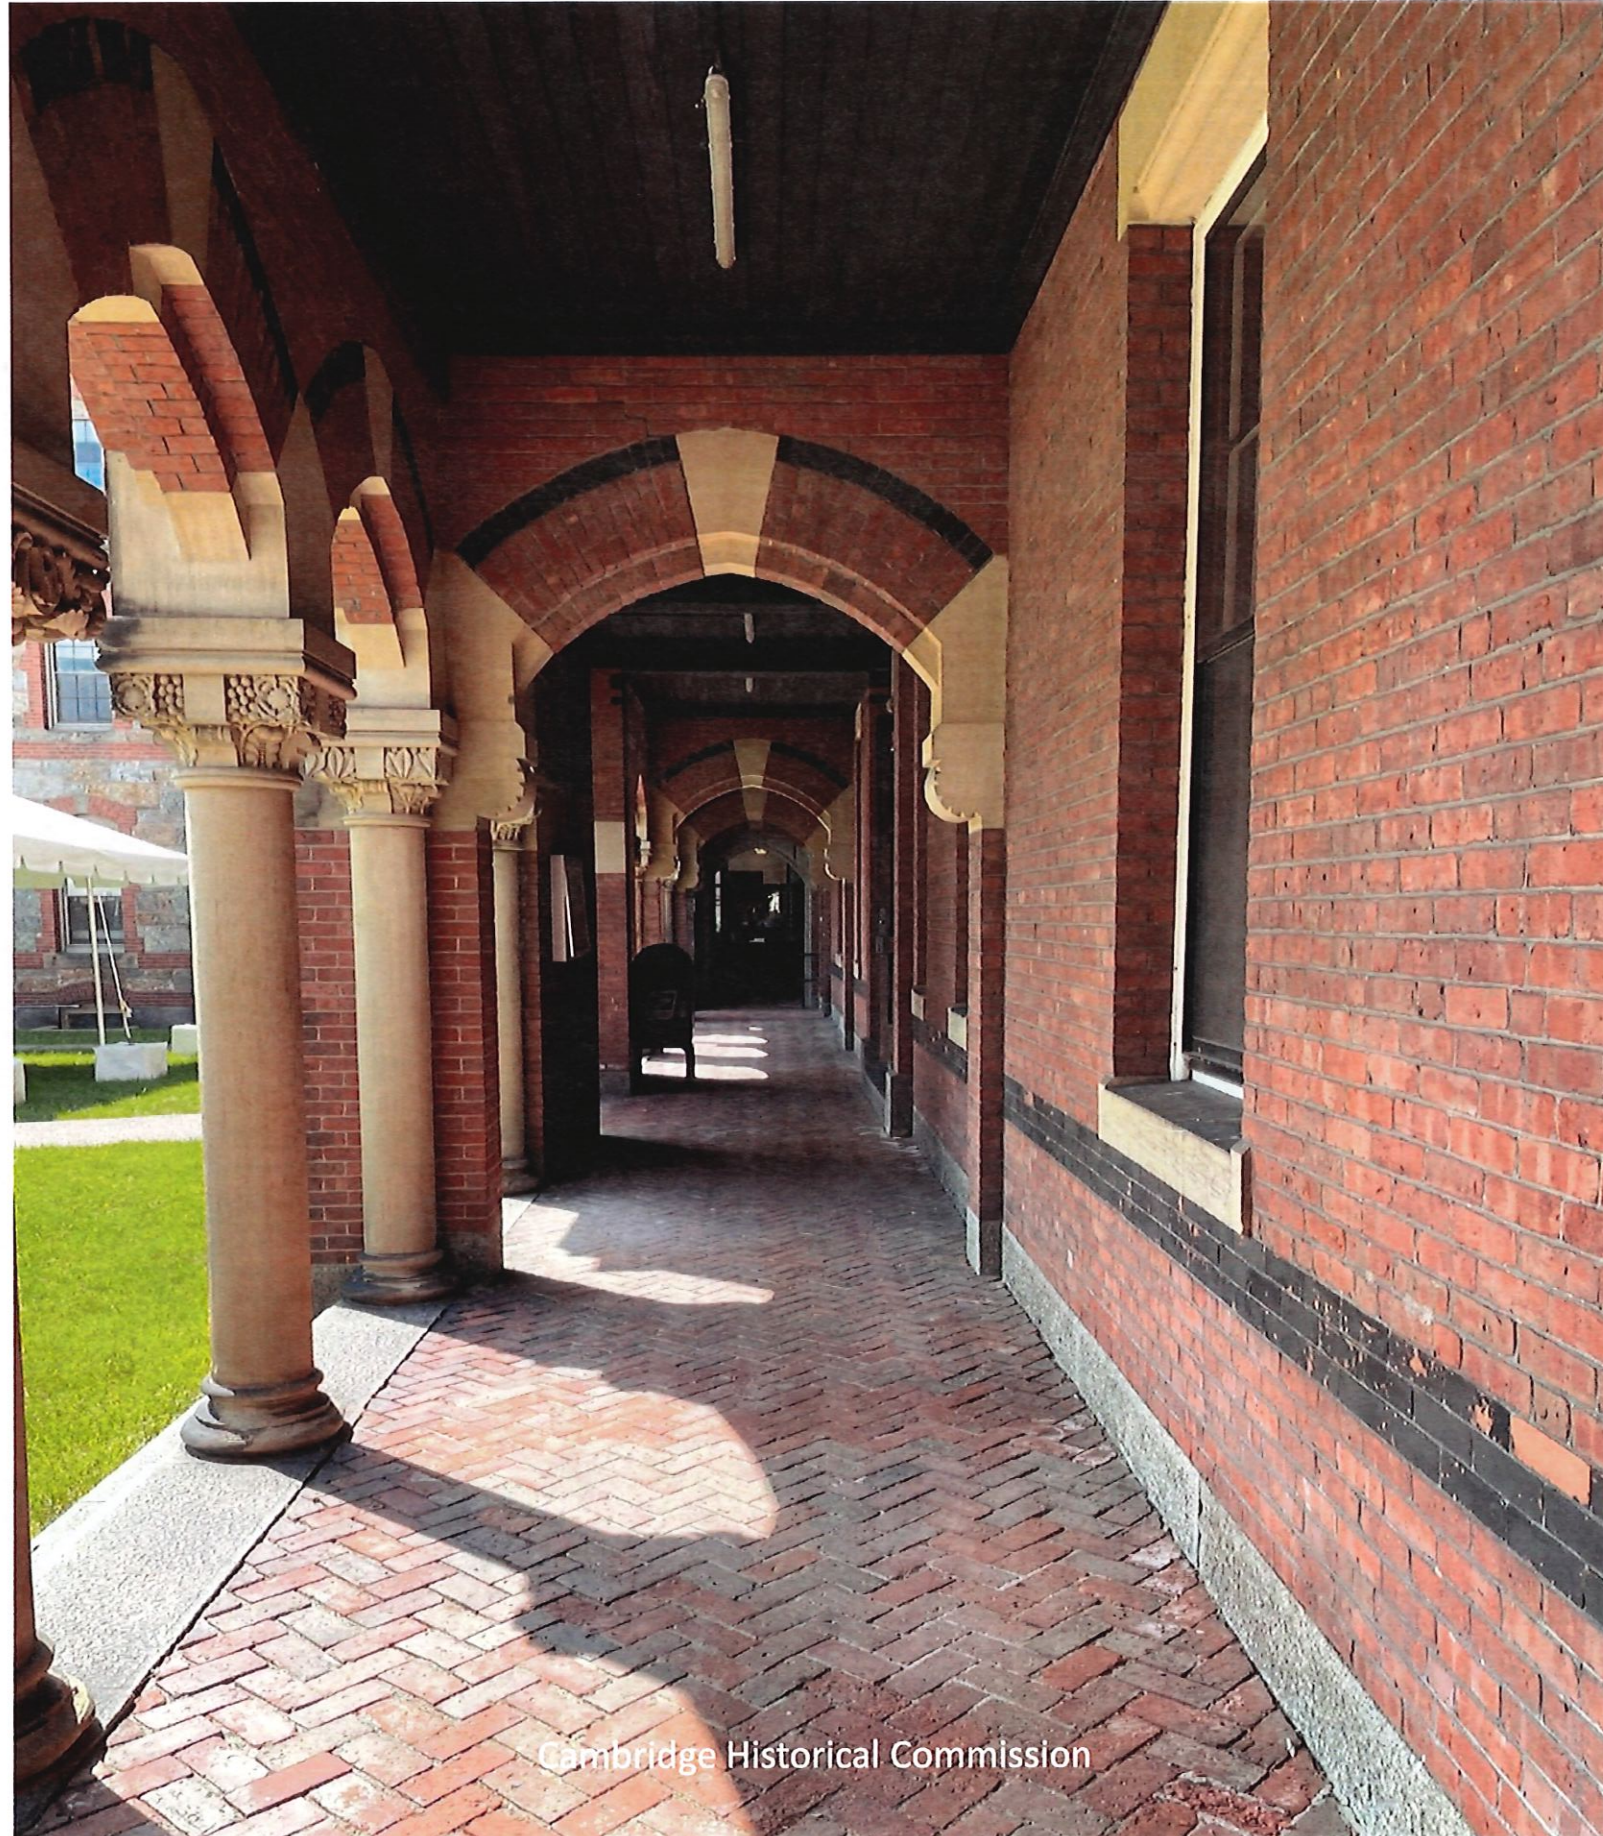
ARCADE WITH RAISED WALKWAY

PROPOSED ARCADE FINISHED  
FLOOR ELEVATION

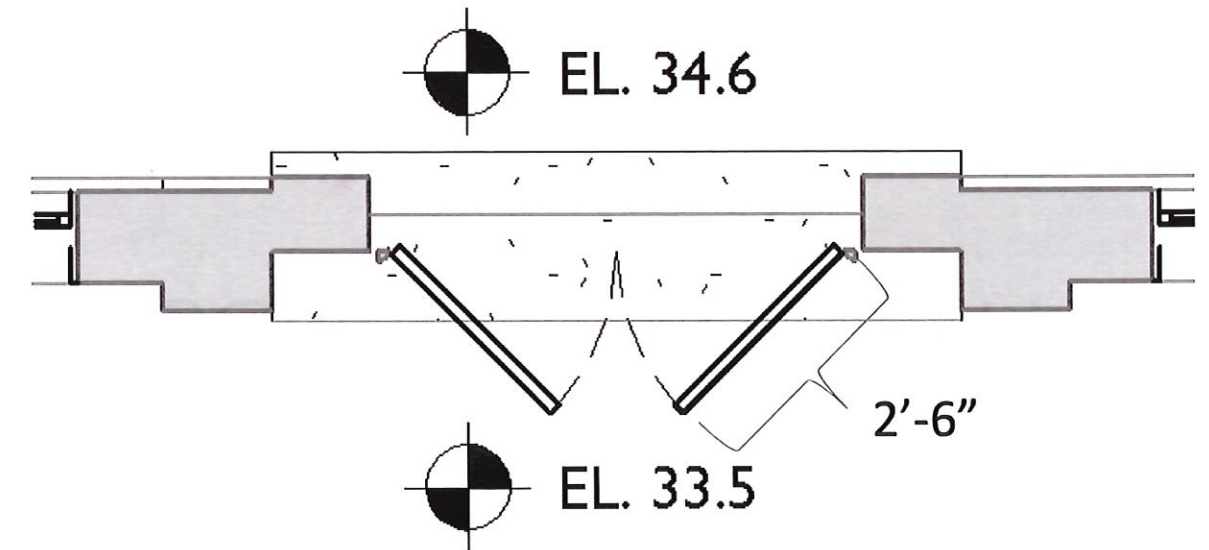
EXISTING FRONT DOOR  
SOUTH ELEVATION

*The existing historic doors do not meet accessibility per 521 CMR: Leaf is too narrow*

All doorways and openings that are required to be accessible shall have a clear opening of not less than 32 inches. Clear opening of a door is measured from the face of the stop on the latch side to the face of the door when the door is open 90 degrees. For door types such as bifold, accordion, and pocket, the clear opening is measured when the door is in its most fully open position.

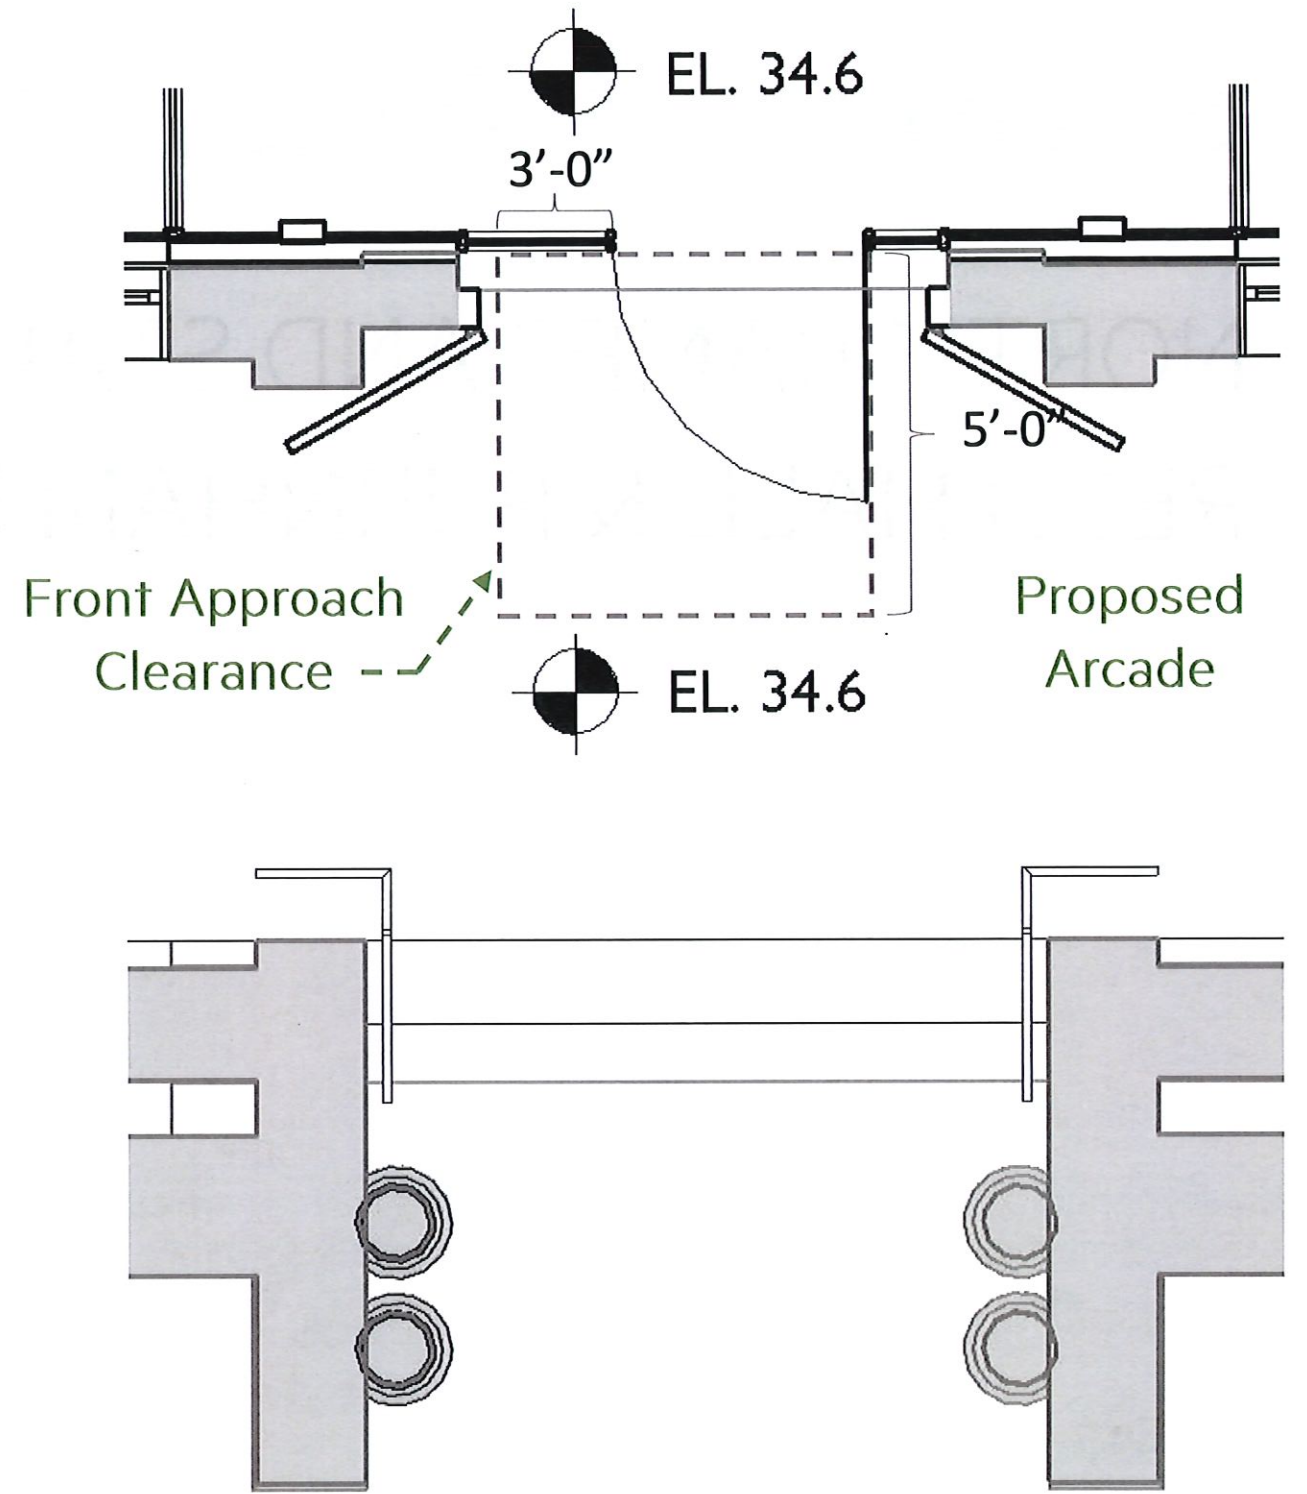
PROPOSED INNER  
FRONT DOOR

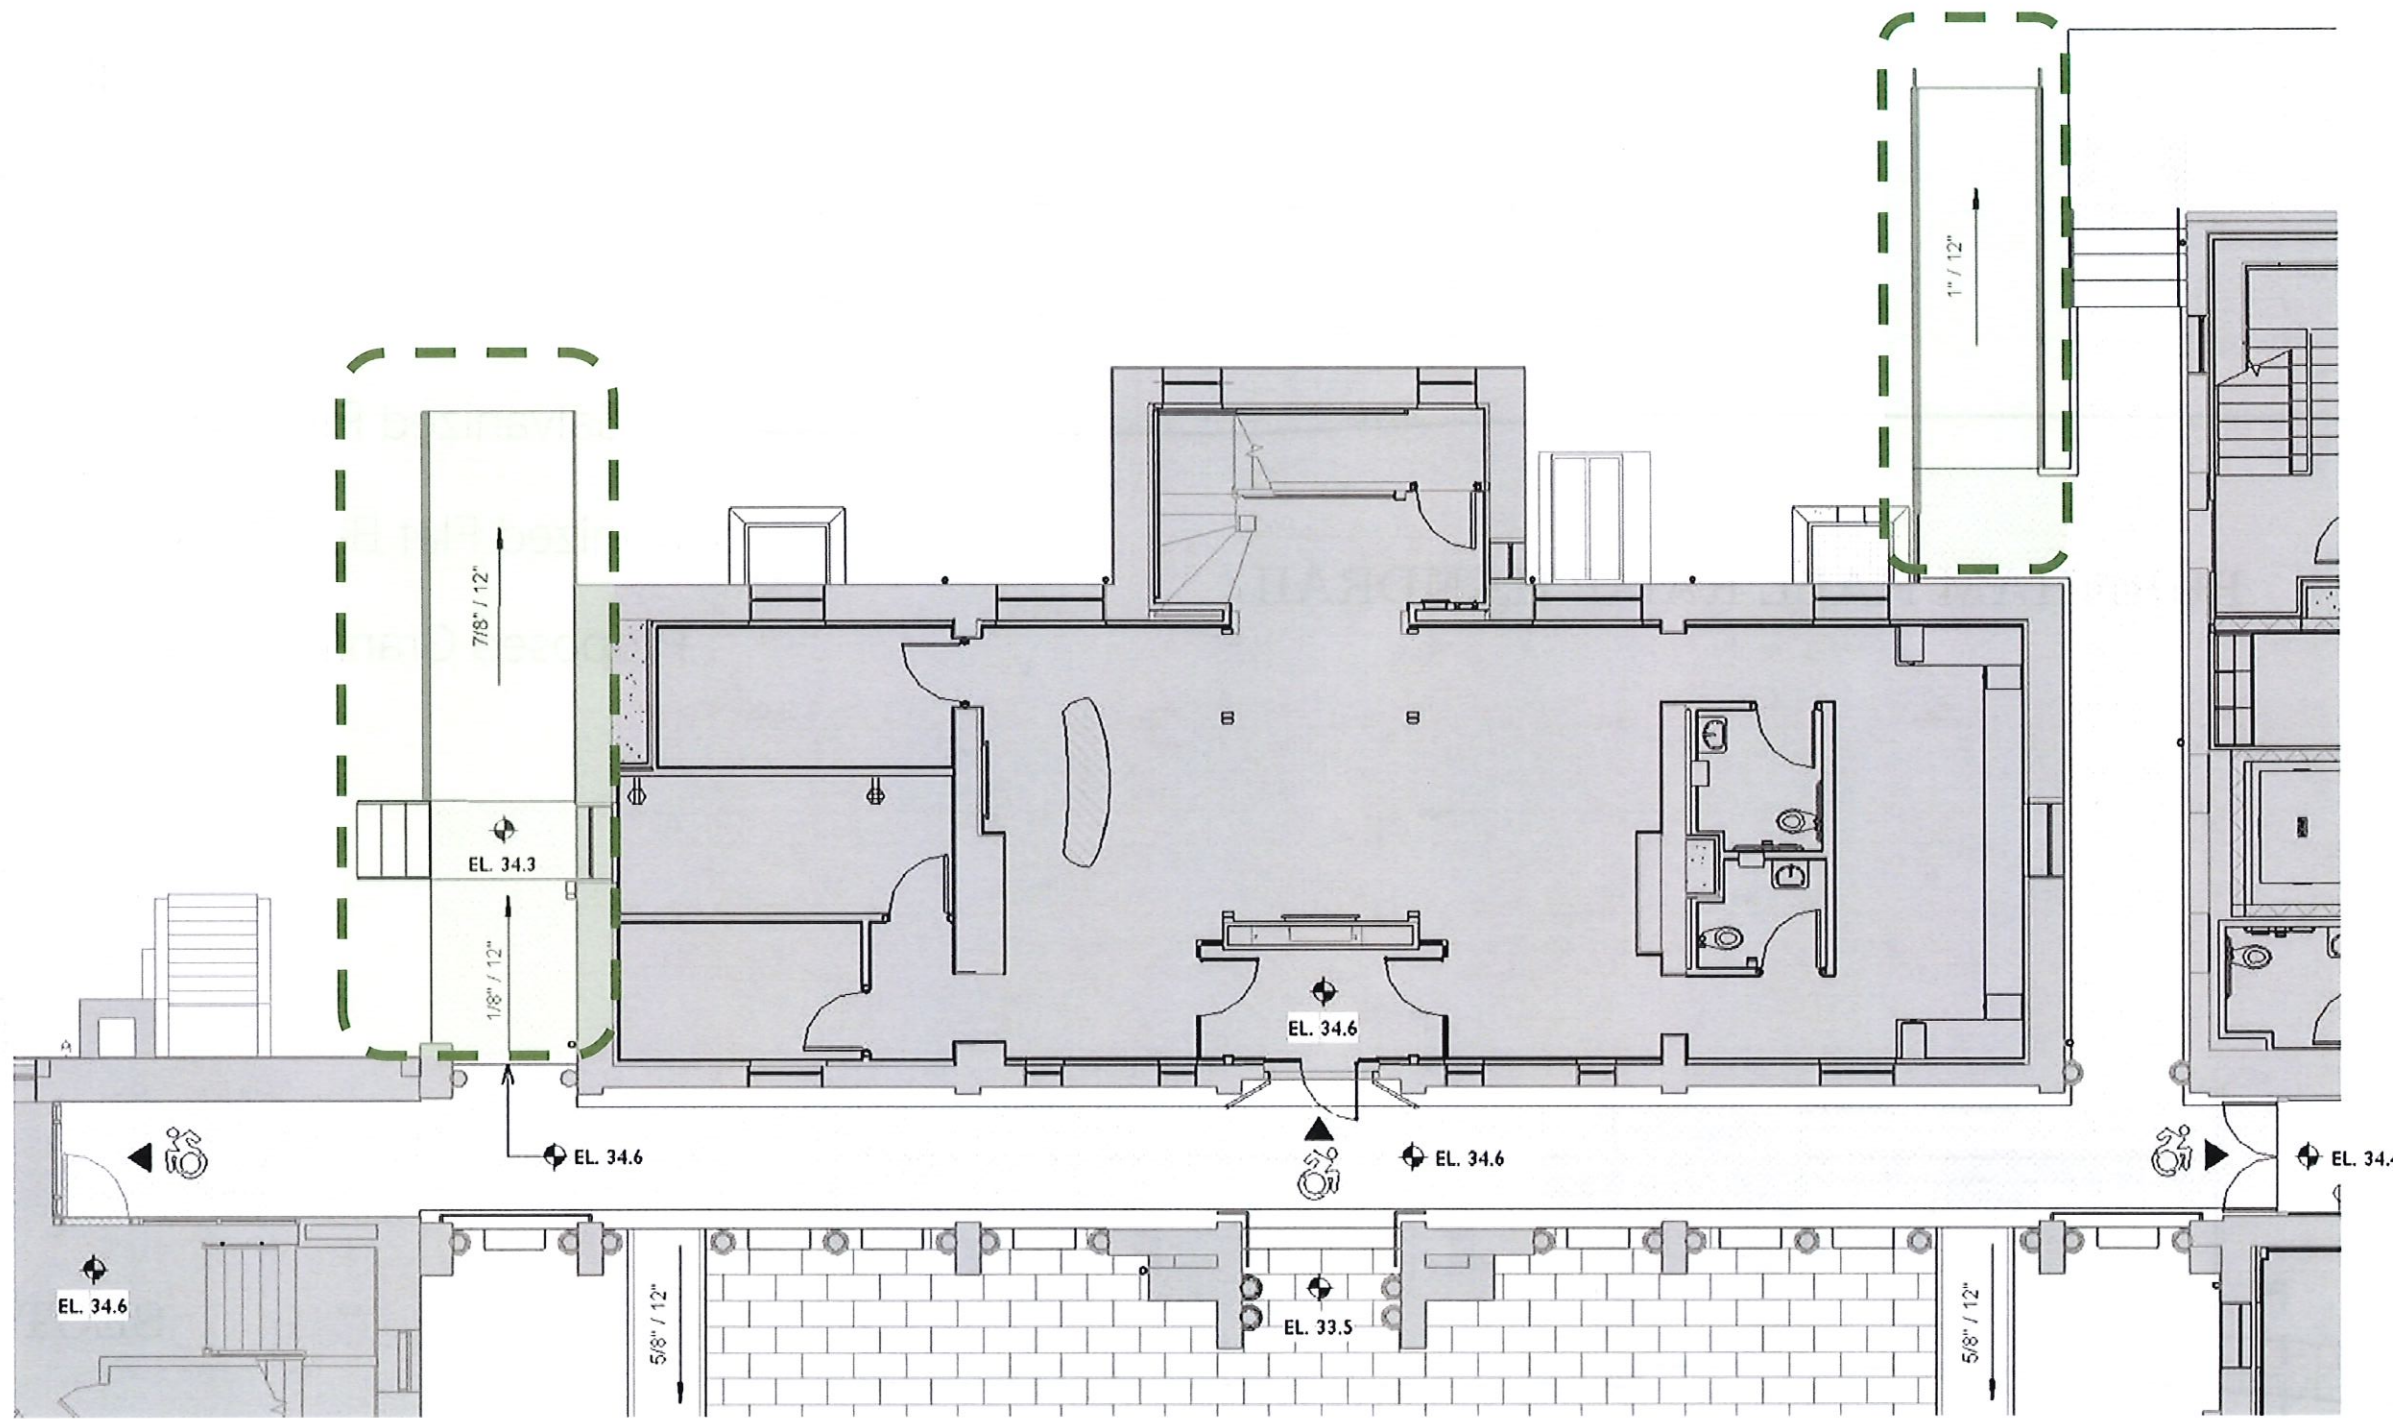
LAWRENCE HALL

REED HALL

BURNHAM HALL

PROPOSED NORTH RAMPS

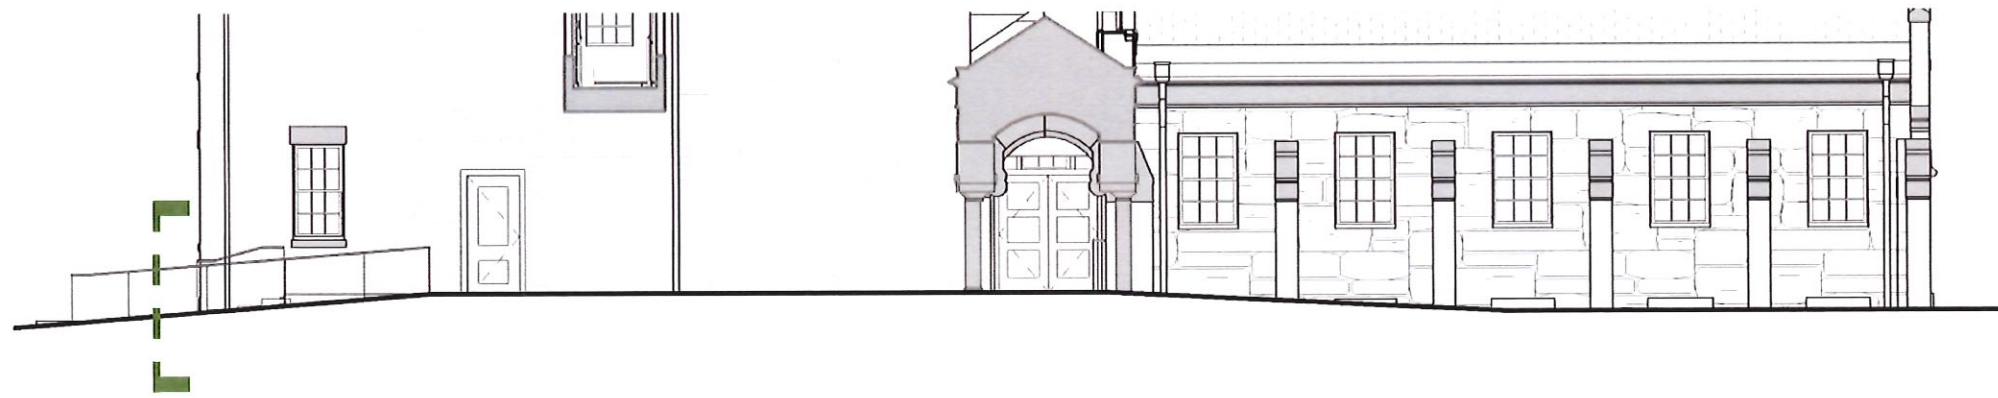
BURNHAM HALL RAMP HANDRAIL

All railing elements  
To be painted black

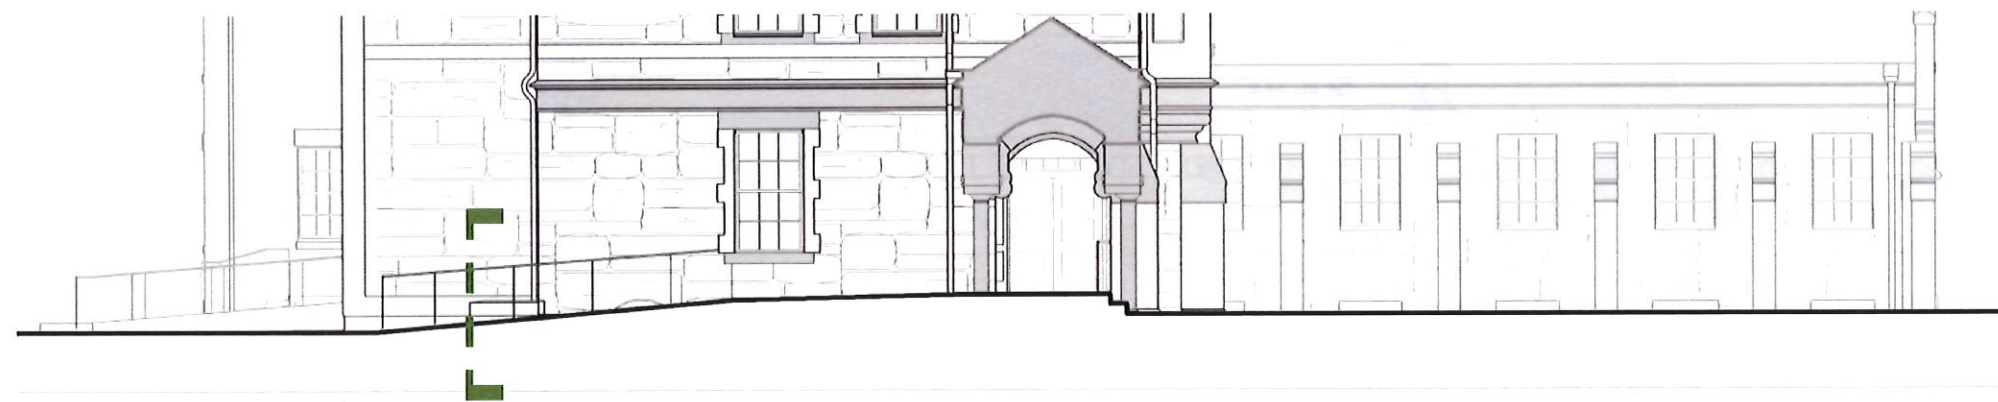
REED HALL RAMP HANDRAIL

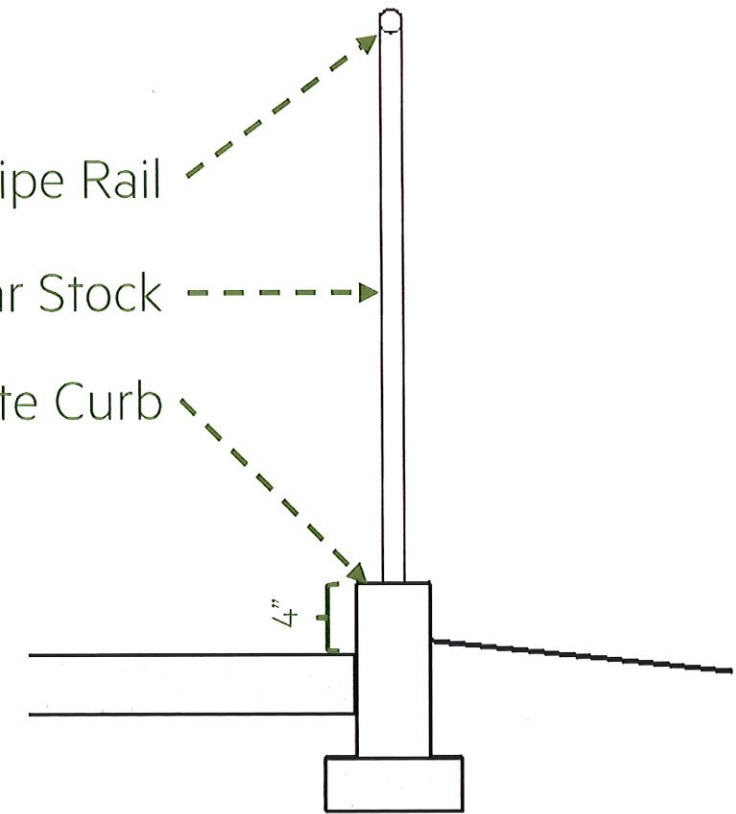
Galvanized Flat Bar Stock

Proposed Granite Curb

SECTION DETAIL
