Source: FXFWLE  
**Vanasse Hangen Brustlin, Inc.**

Ames Street Residences  
Cambridge, MA

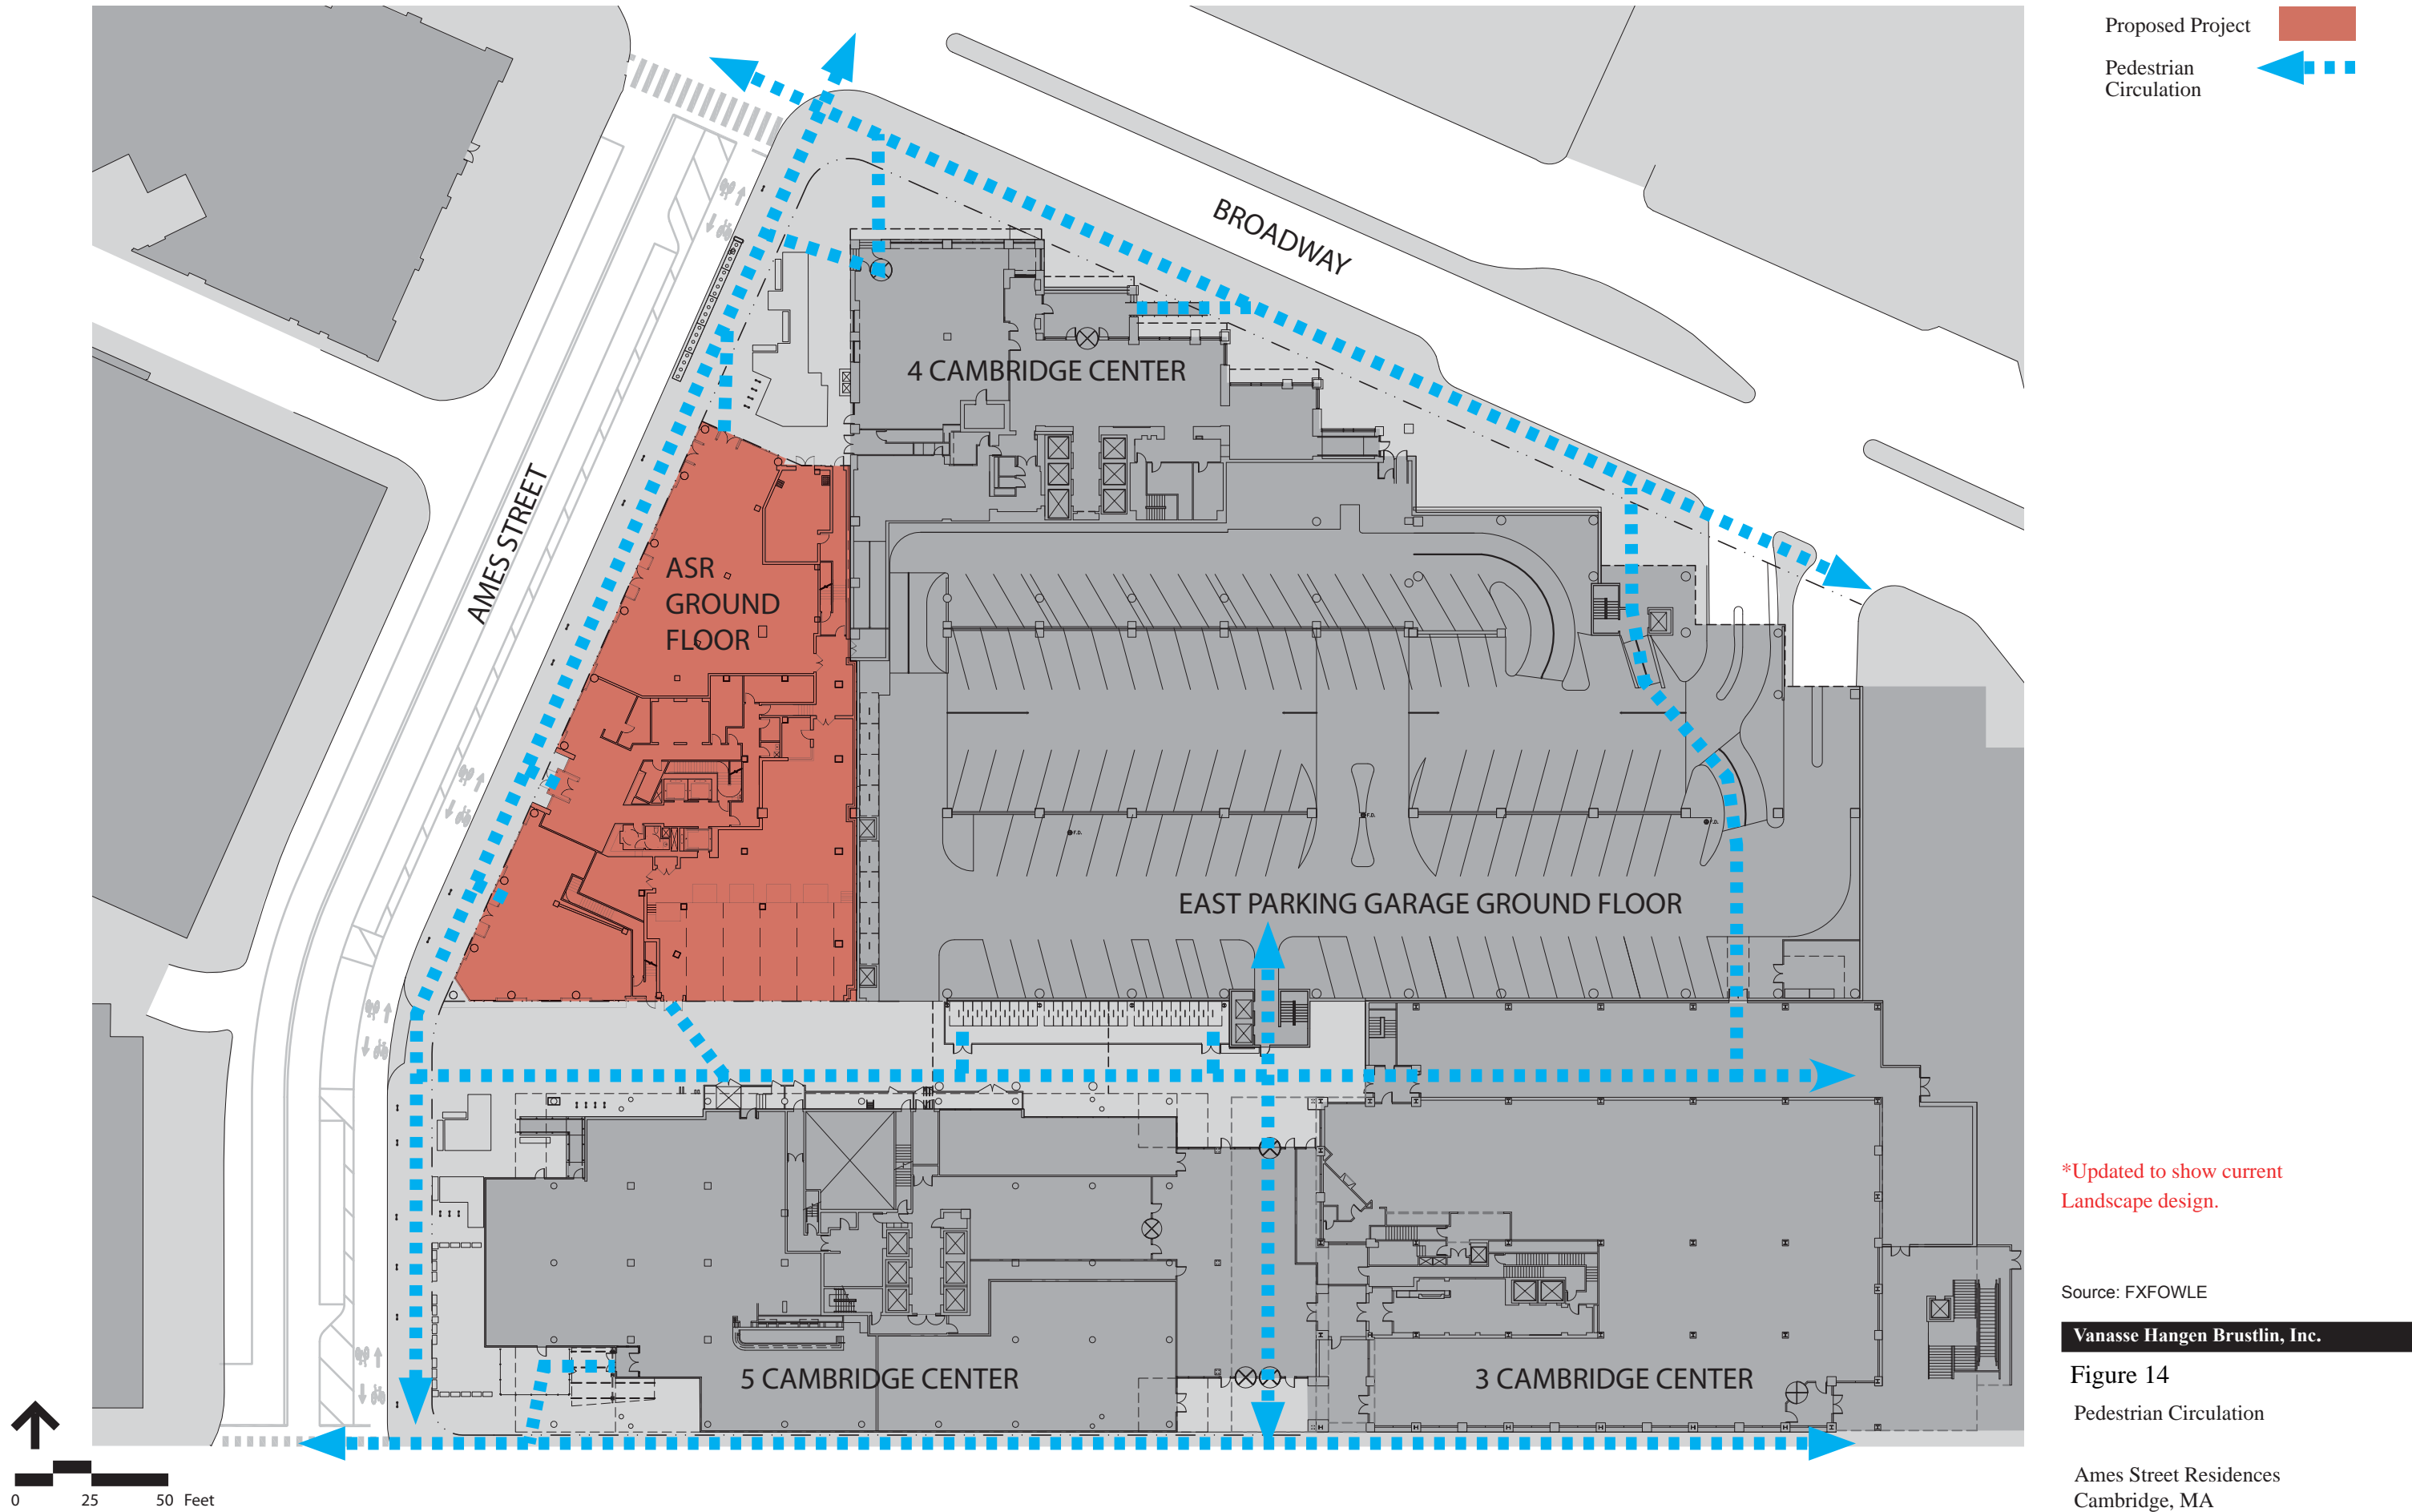
Figure 14  
Pedestrian Circulation

\*Updated to show current Landscape design.

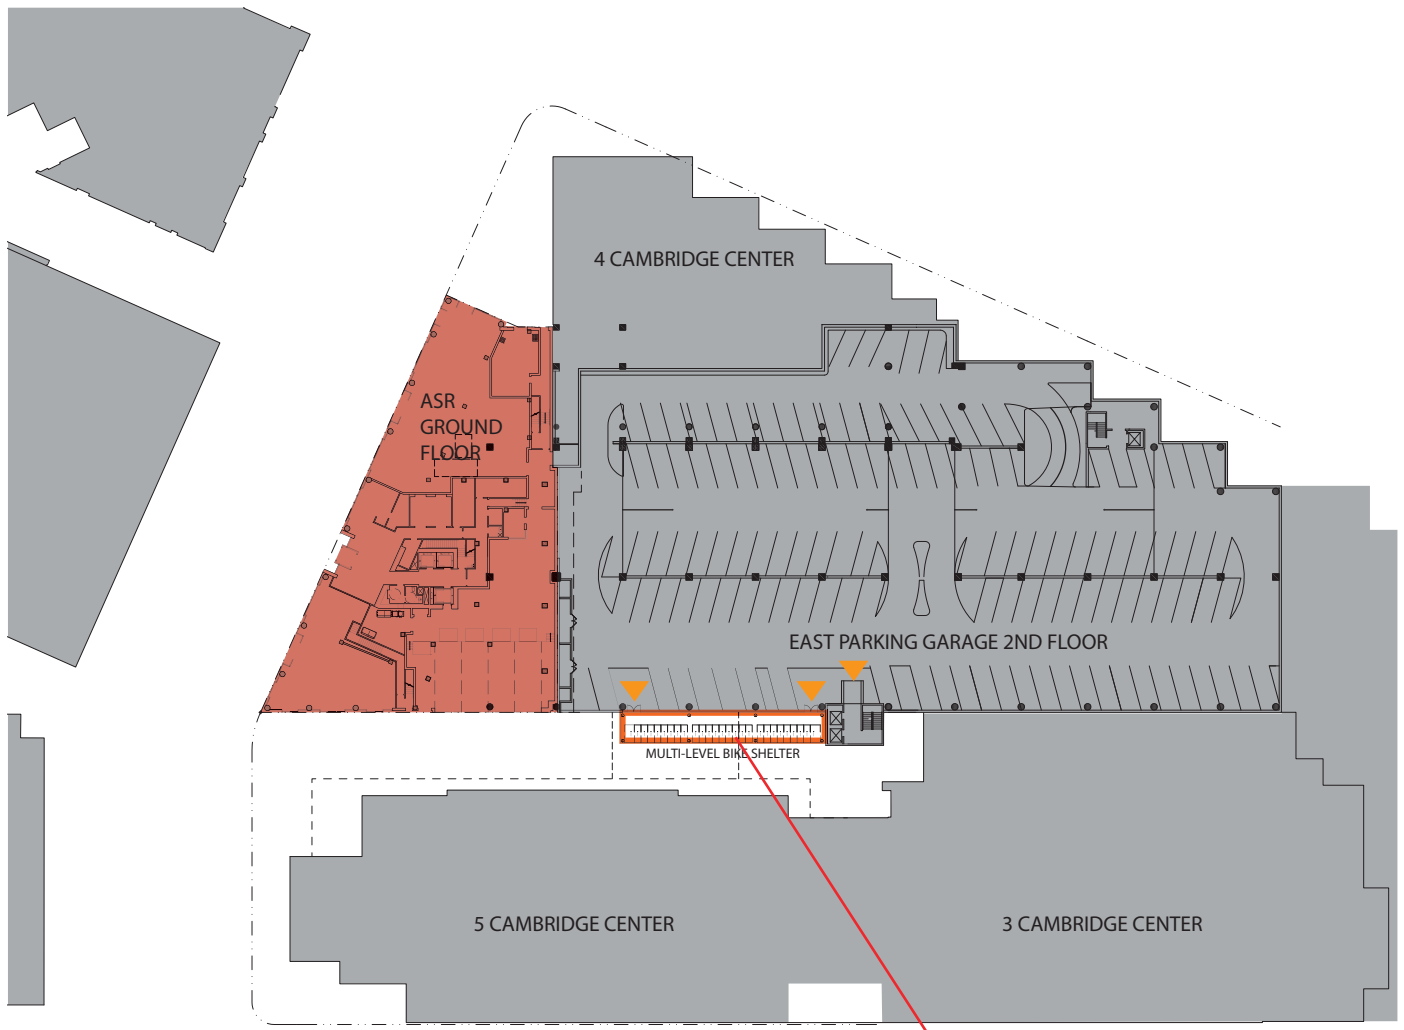
Figure 15b

Long term bike parking rack spacing increased to 36".

Proposed Bicycle Parking Layout  
(Garage 2nd Floor)

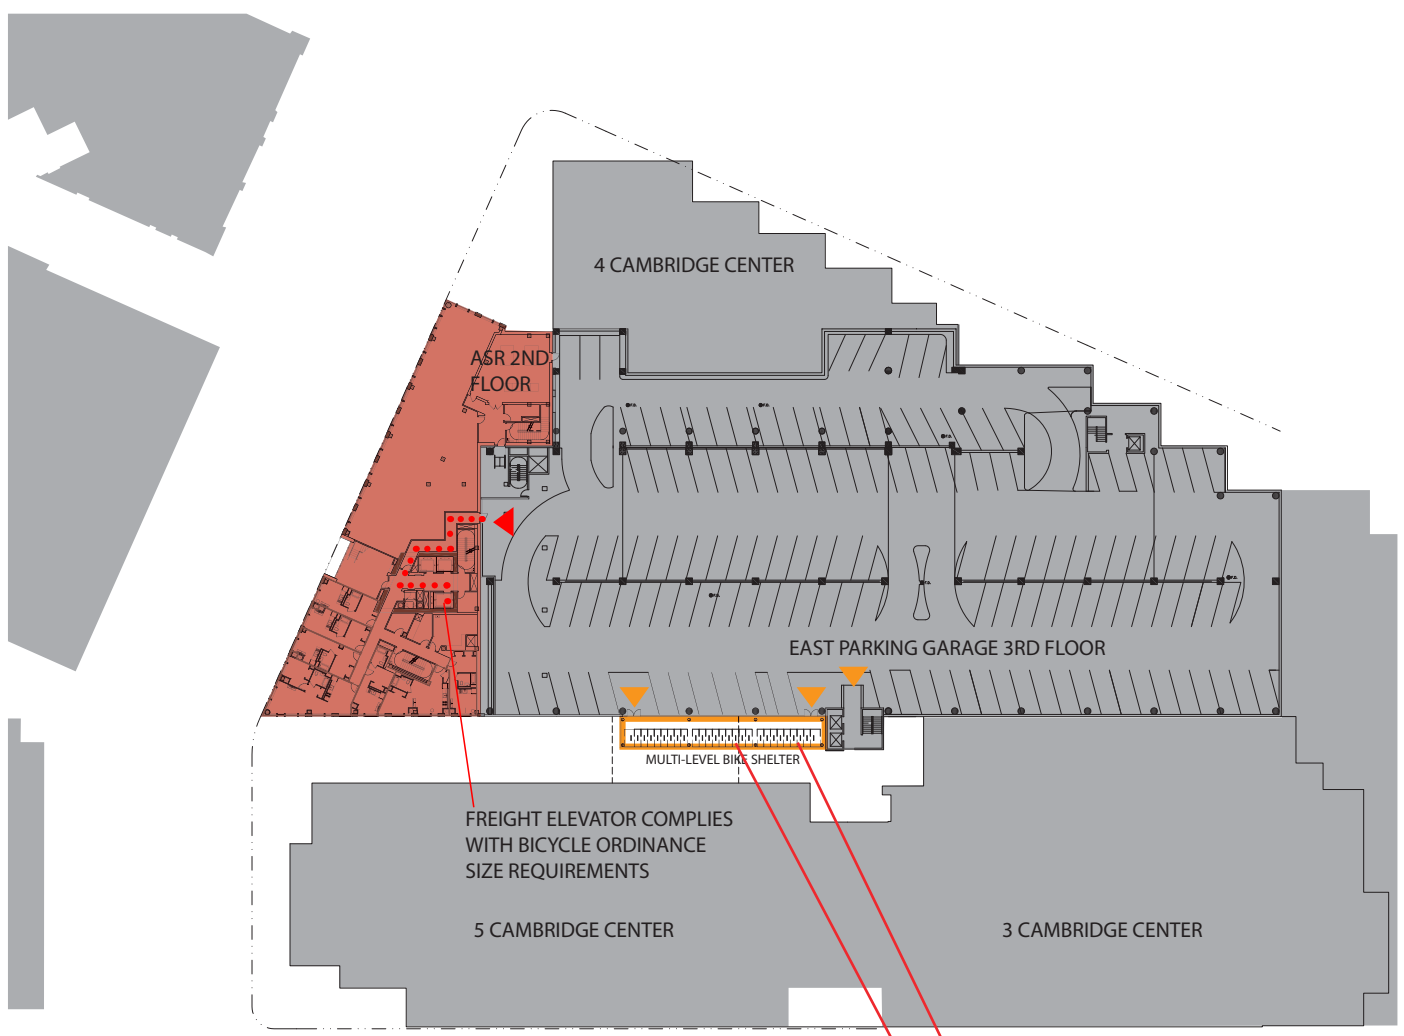
Figure 15c

Third floor added to multi-level bike shelter.

Long term bike parking rack spacing increased to 36".

Proposed Bicycle Parking Layout  
(Garage 3rd Floor)

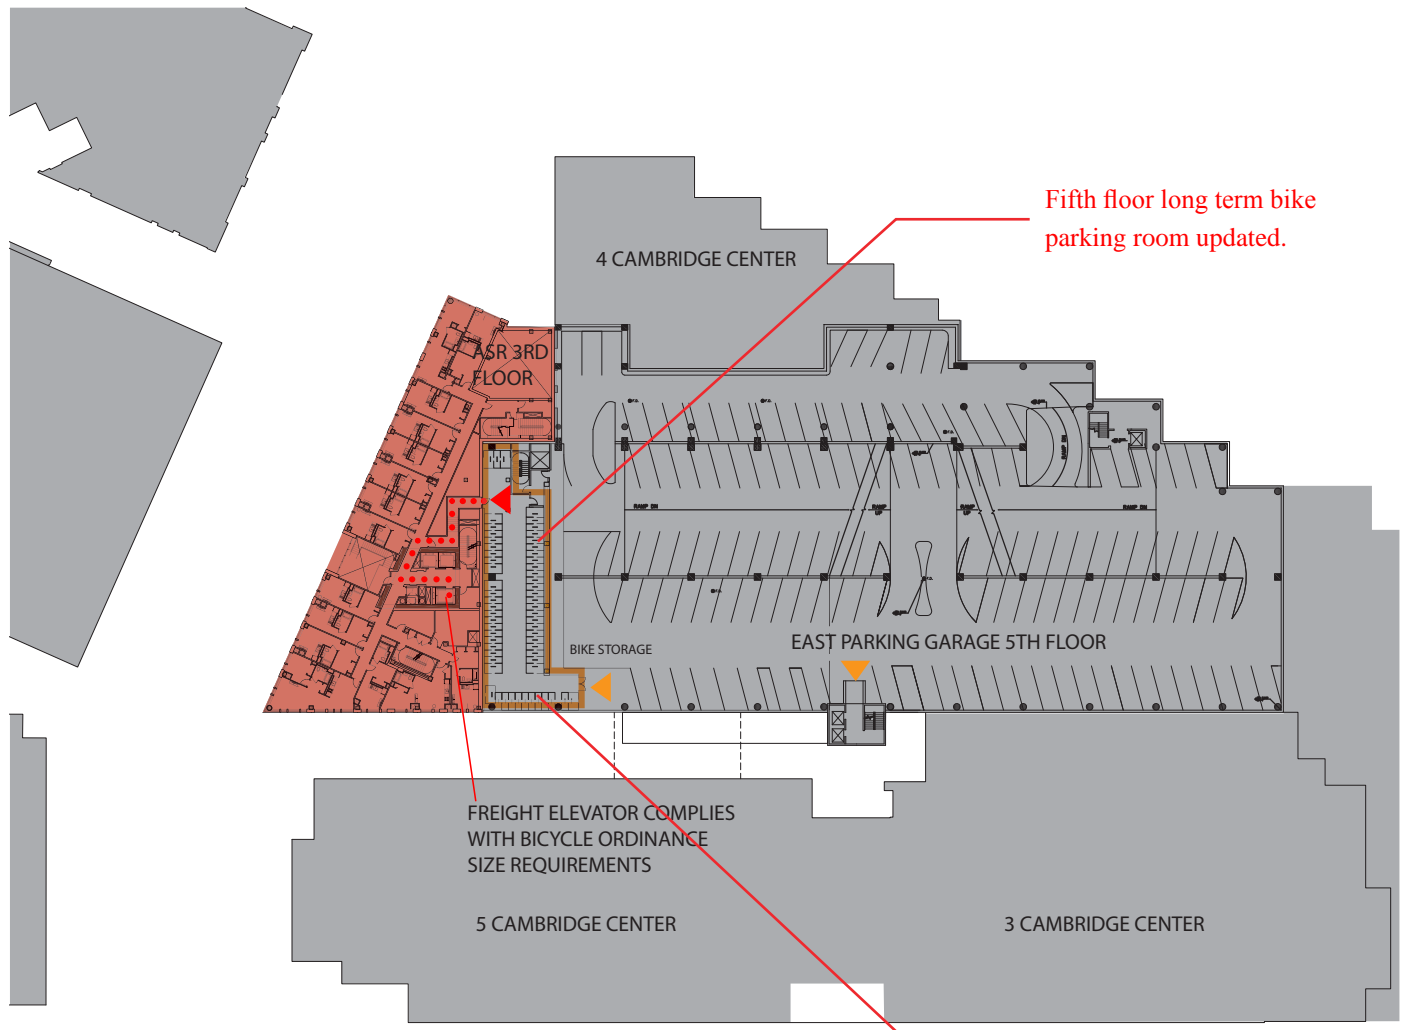
Figure 15d

Proposed Bicycle Parking Layout  
(Garage 5th Floor)

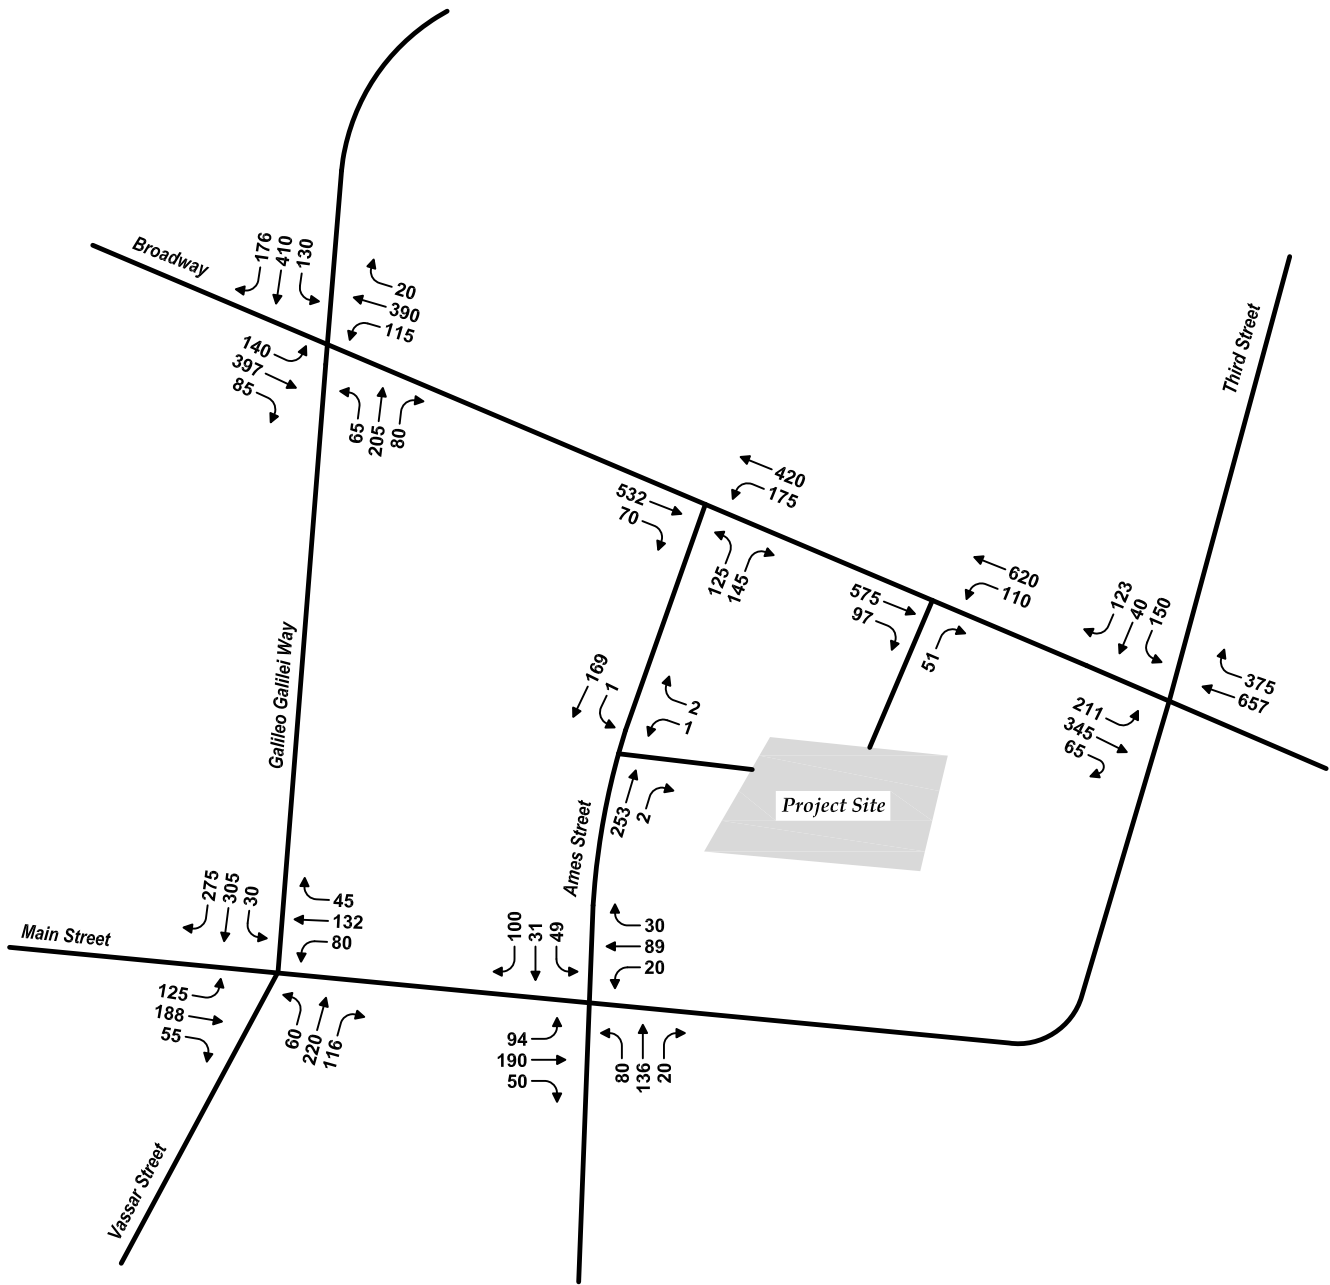
Figure 20

2014 Build Condition  
Traffic Volumes  
Pioneer Way Closed to Exiting Vehicles  
AM Peak Hour (8:15 - 9:15 AM)  
Ames Street Residences  
Kendall Square, Cambridge MA

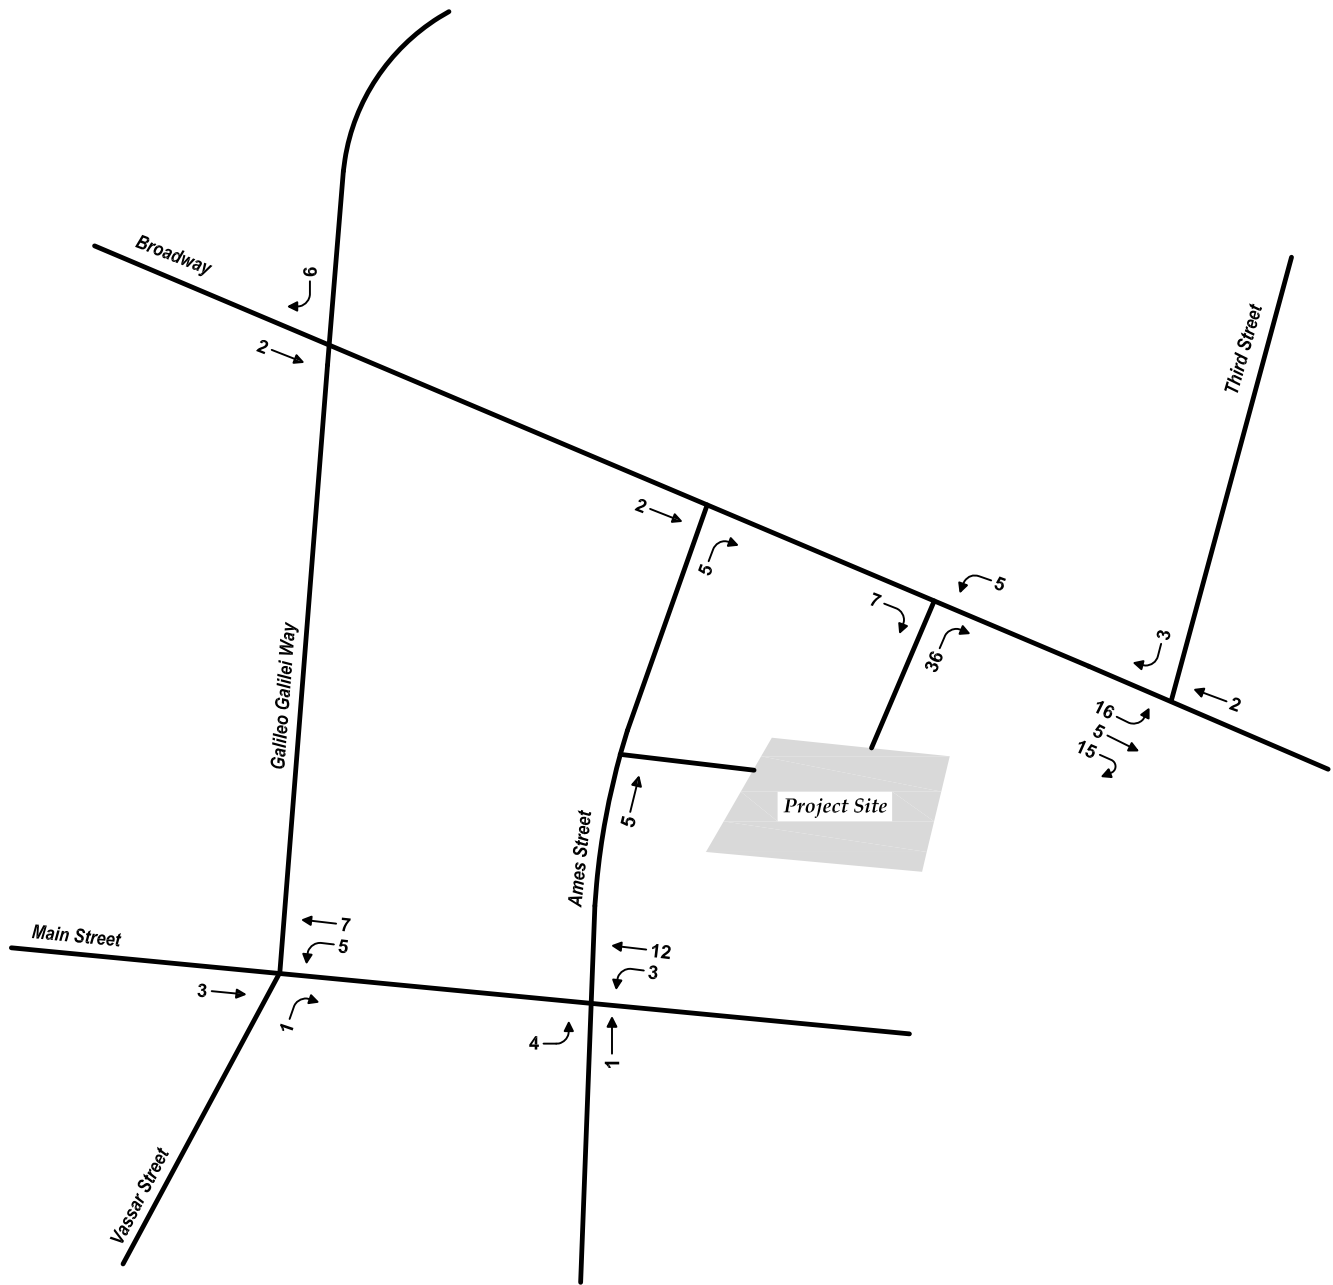
Figure 21

Project Generated Trips  
Traffic Volumes  
Pioneer Way Closed to Exiting Vehicles  
AM Peak Hour (8:15 - 9:15 AM)  
Ames Street Residences  
Kendall Square, Cambridge MA

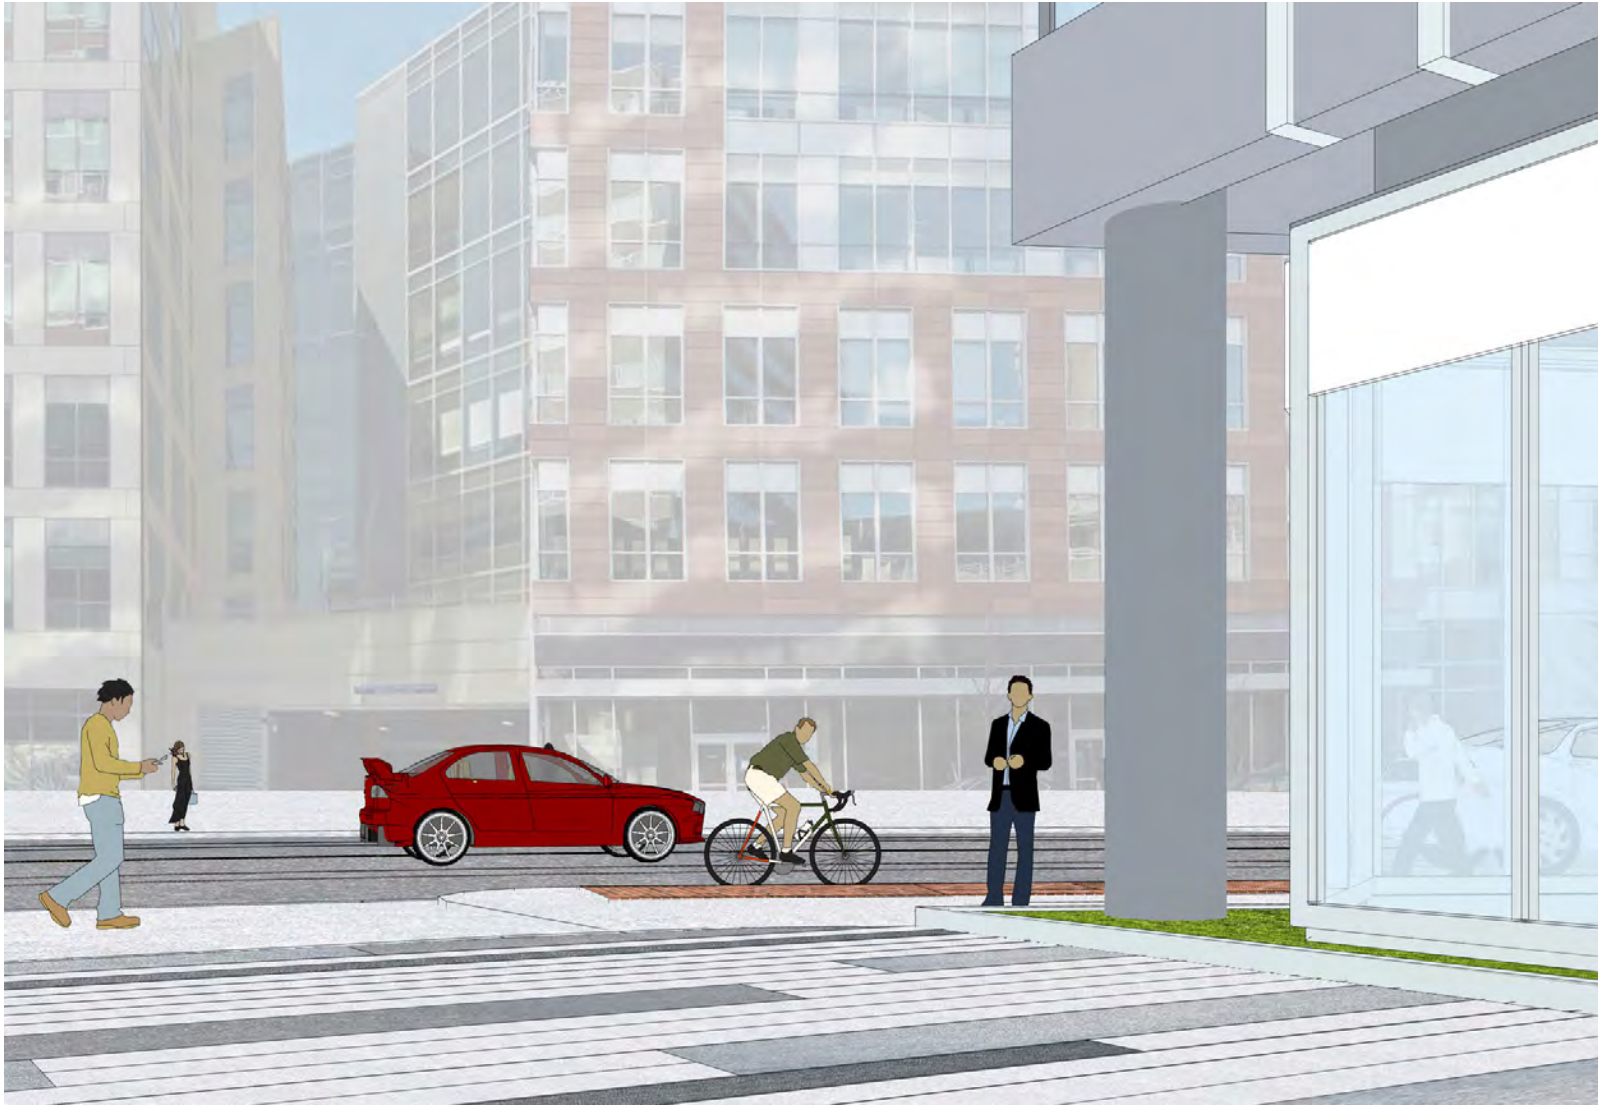
**Figure 23**

Vehicular Sightline at Pioneer Way Exit
