12" Blow-off
Magazine St. near Hamilton St. - Cambridge

Detail Record 4-7

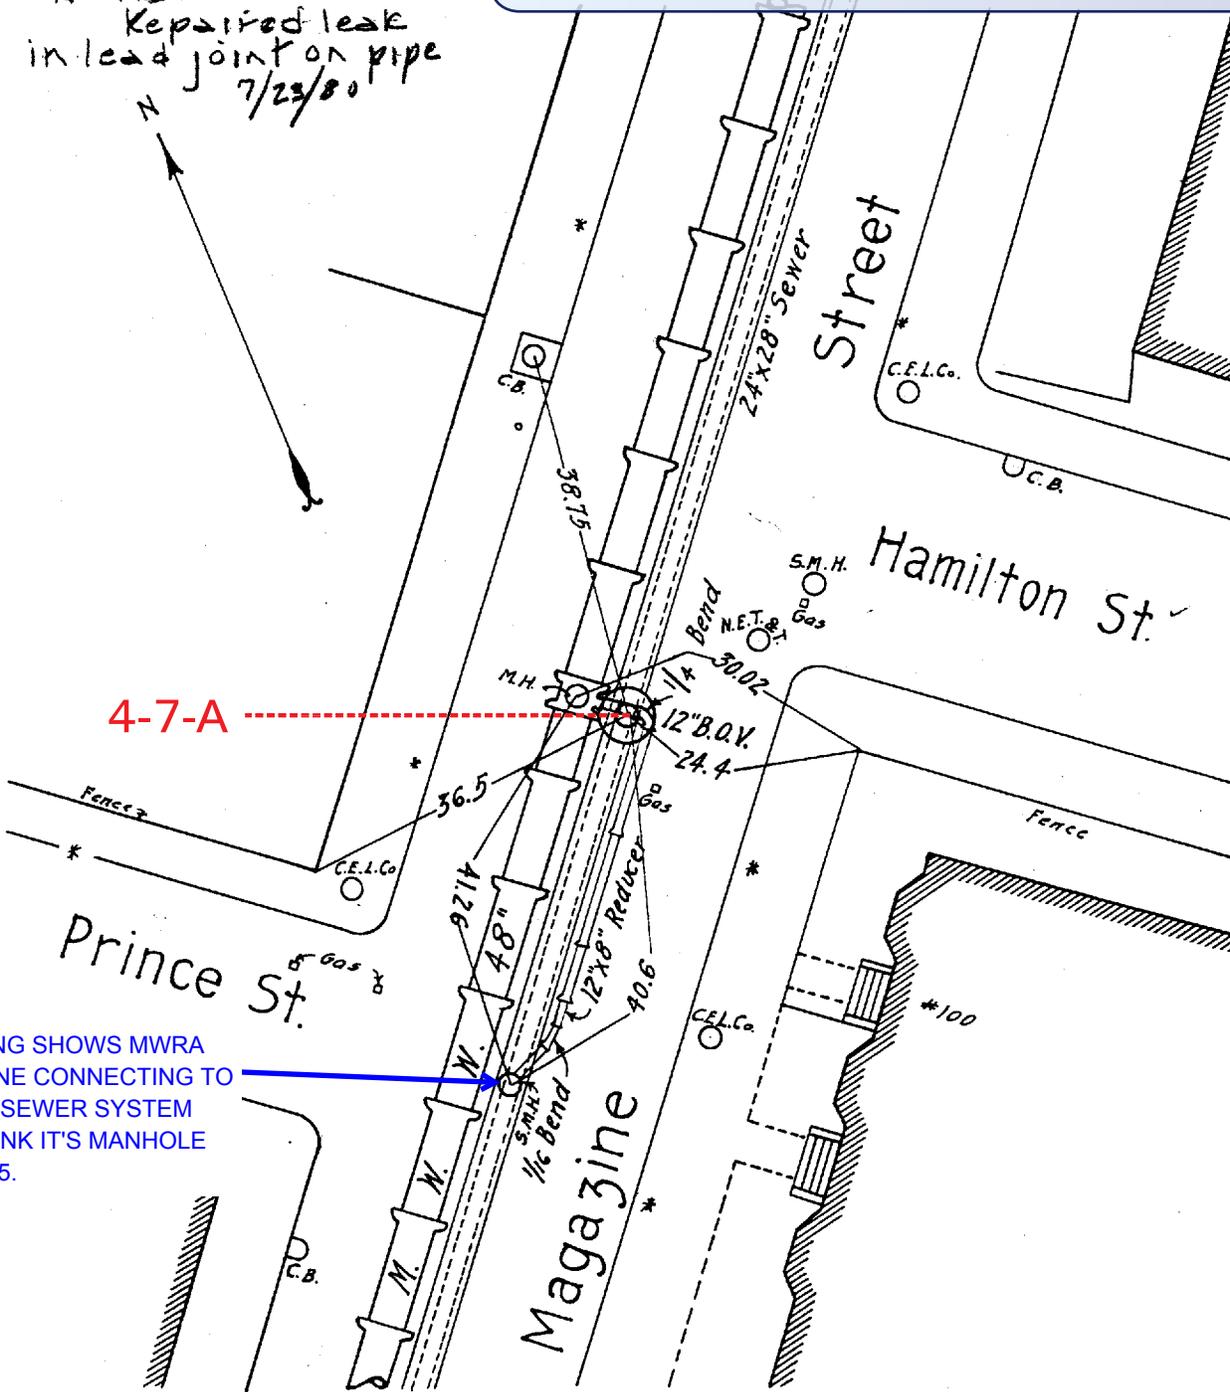
NOTE:
Repaired leak
in lead joint on pipe
7/23/80

THIS DRAWING SHOWS MWRA
BLOWOFF LINE CONNECTING TO
CAMBRIDGE SEWER SYSTEM
HERE ... I THINK IT'S MANHOLE
S30SMH15555.

From Chestnut Hill Res. Sta. 178+54
" Spot Pond Sta. 442+60
