Project 200609.05 – Vibration Monitoring Data Report – 1 to 7 February 2026, Riverview
Condominiums, 221 Mt. Auburn Street, Cambridge, MA

APPENDIX A

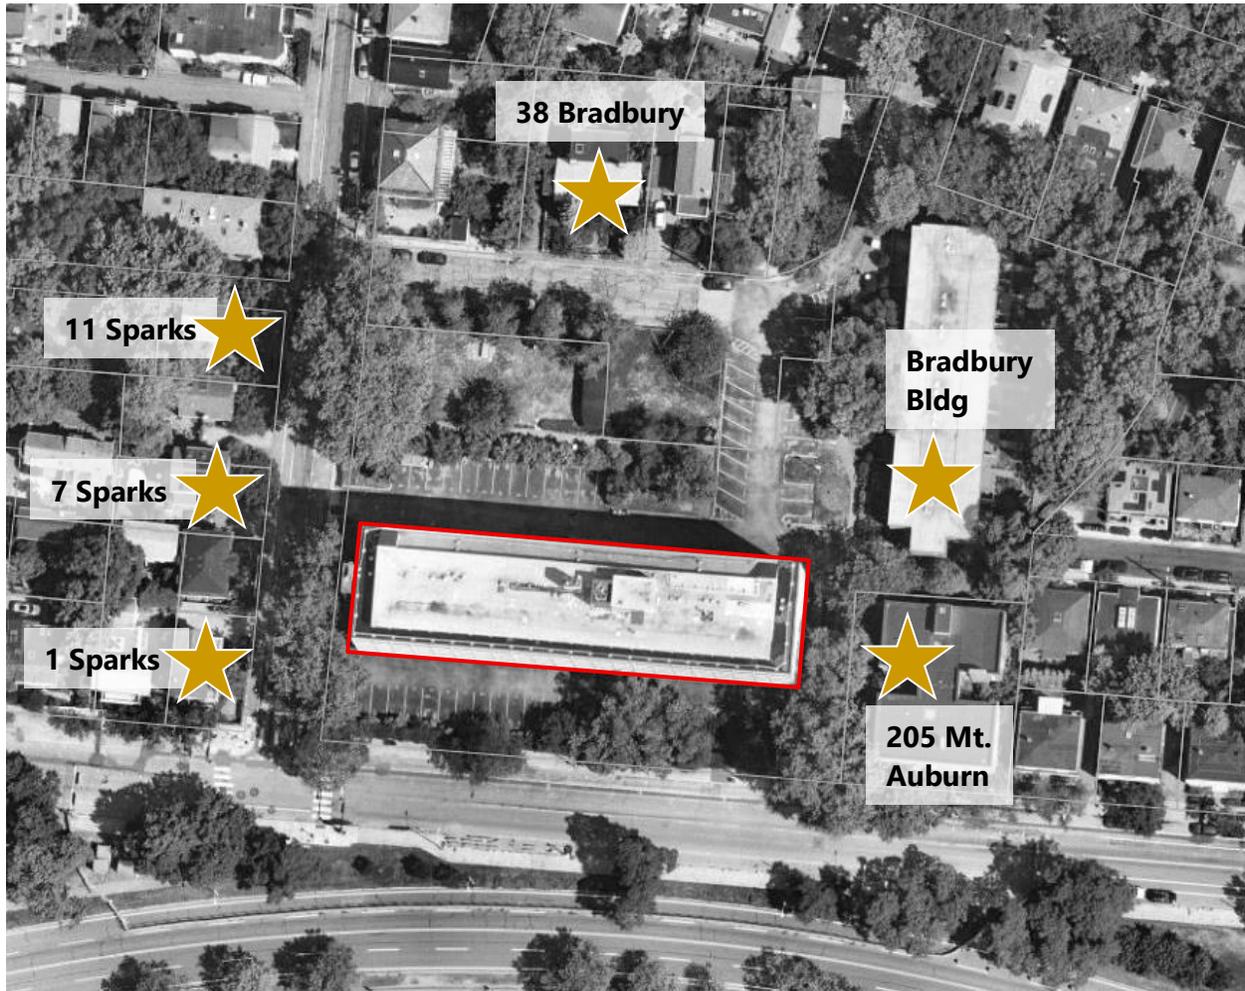
Figure 1

Aerial view of the Riverview Condominiums structure (outlined in red) and the abutting properties selected for vibration monitor installation (marked with yellow stars).

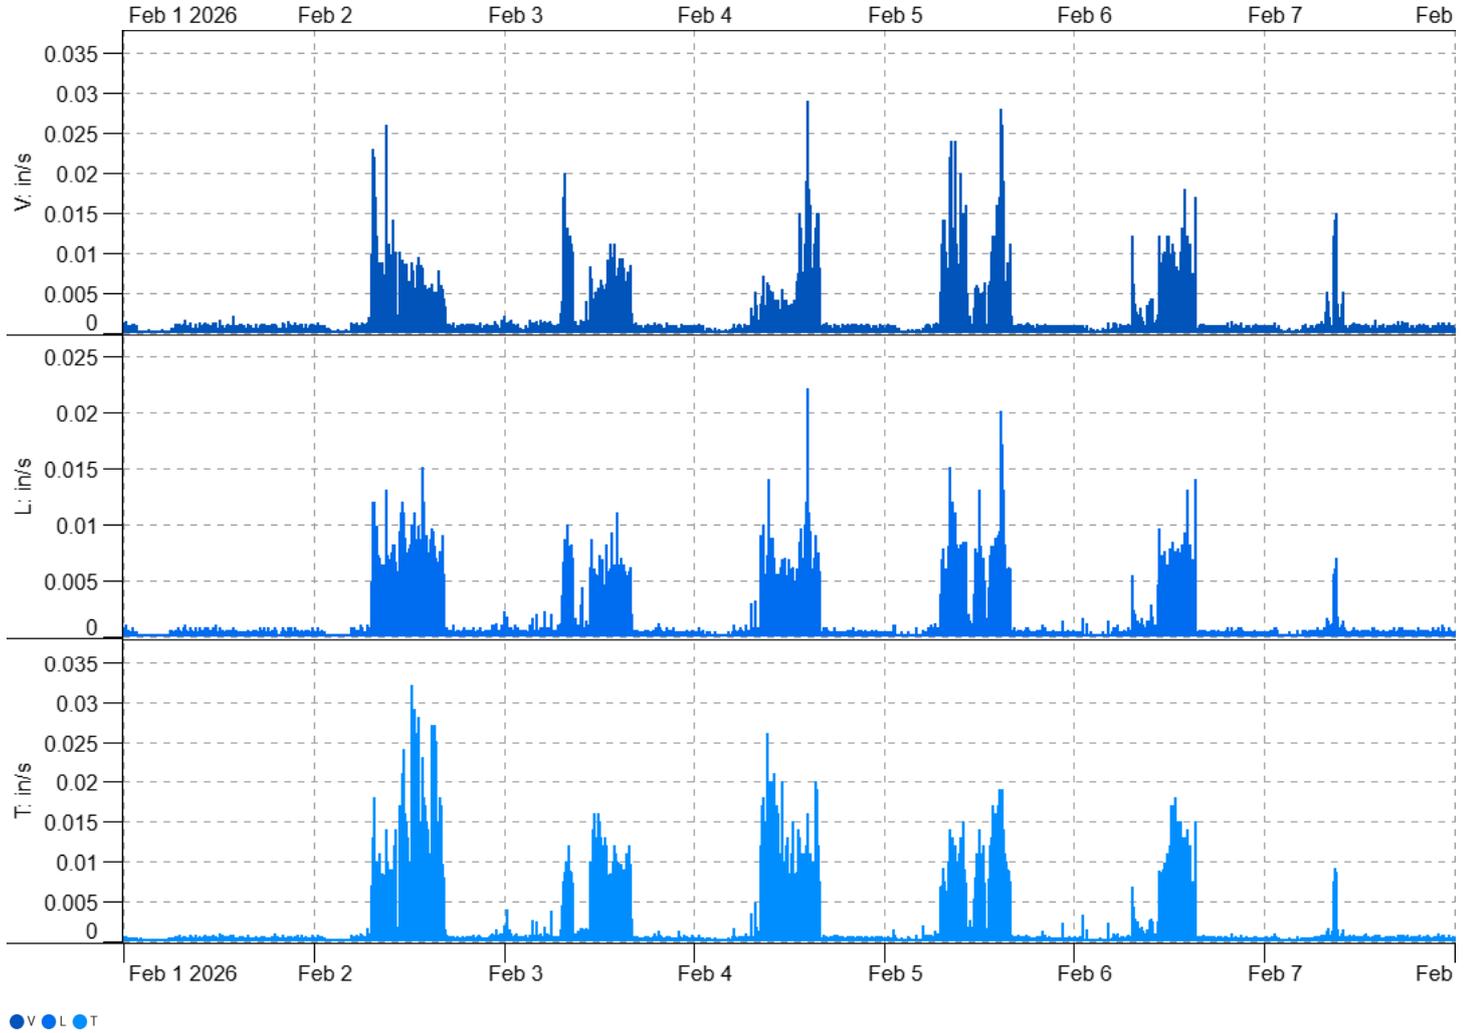
Riv1, Bradbury Building [22 Bradbury St.], C22, Serial number: 110294, Calibrated: 2025-07-30,

X-span 2026-02-01 00:00 - 2026-02-08 00:00
 Y-span V: 0 - 0.03 in/s, L: 0 - 0.02 in/s, T: 0 - 0.03 in/s

V	L	T
Max	0.03 in/s	0.02 in/s	0.03 in/s
Date	2026-02-04	2026-02-04	2026-02-02
Time	14:17:30	14:17:30	12:27:30
Hz	6.3	5.15	2.85

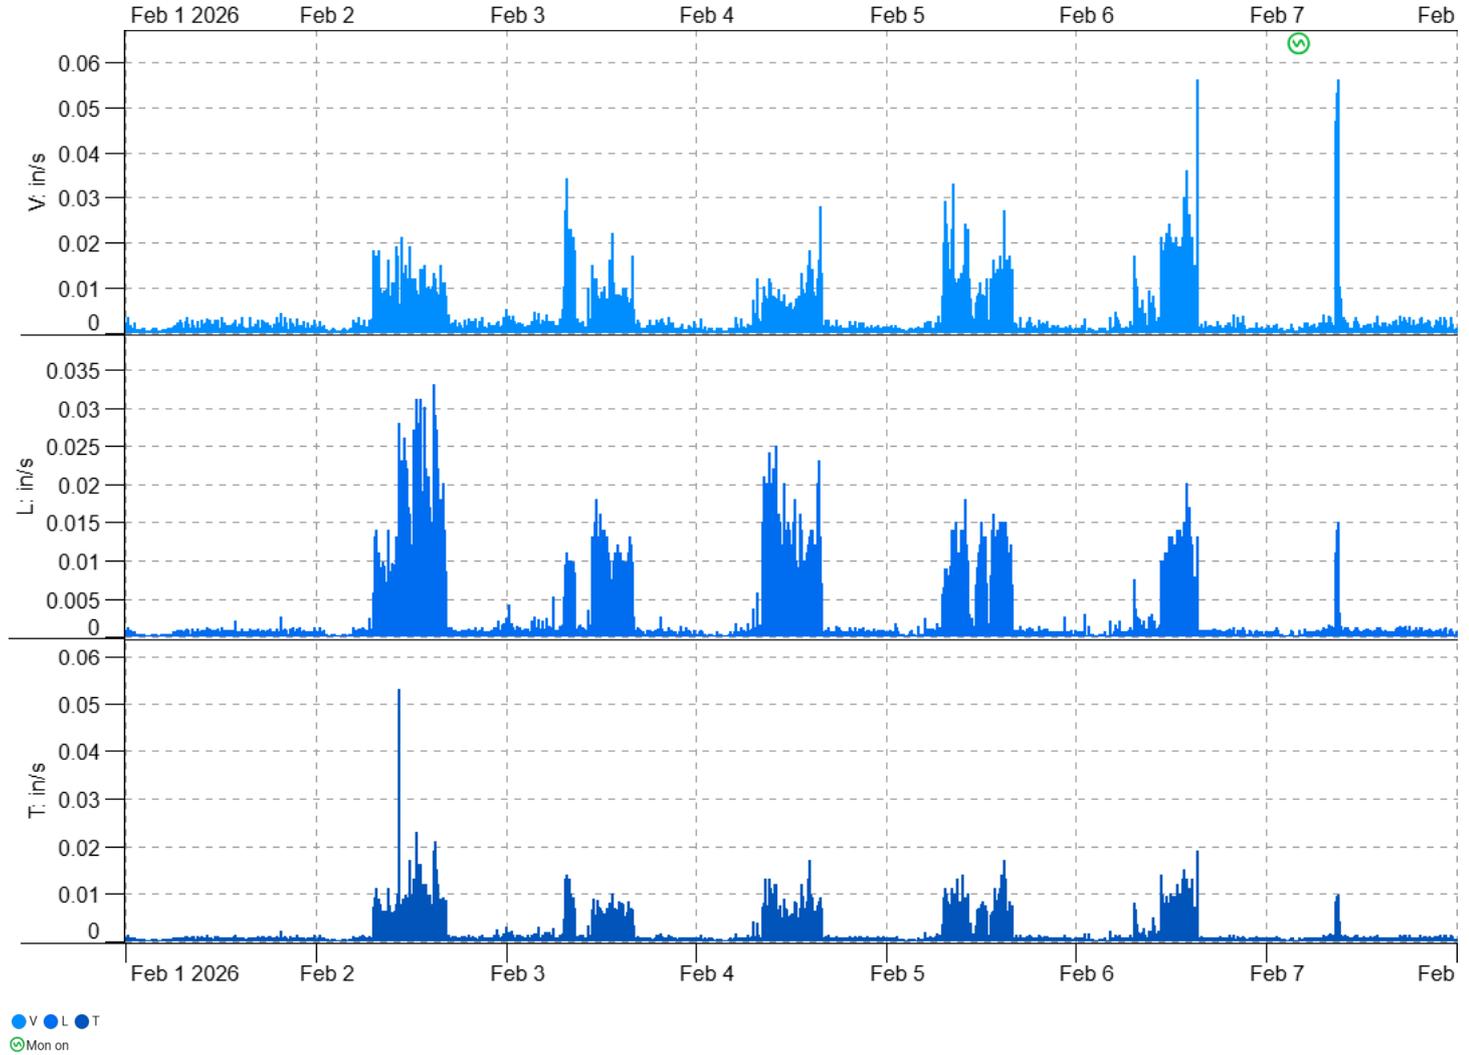
Riv2, 205 Mt. Auburn St., Cambridge, MA, C22, Serial number: 102013, Calibrated: 2025-07-23,

X-span 2026-02-01 00:00 - 2026-02-08 00:00

Y-span V: 0 - 0.06 in/s, L: 0 - 0.03 in/s, T: 0 - 0.05 in/s

V	L	T
Max	0.06 in/s	0.03 in/s	0.05 in/s
Date	2026-02-06	2026-02-02	2026-02-02
Time	15:17:30	14:57:30	10:27:30
Hz	5.5	2.35	205

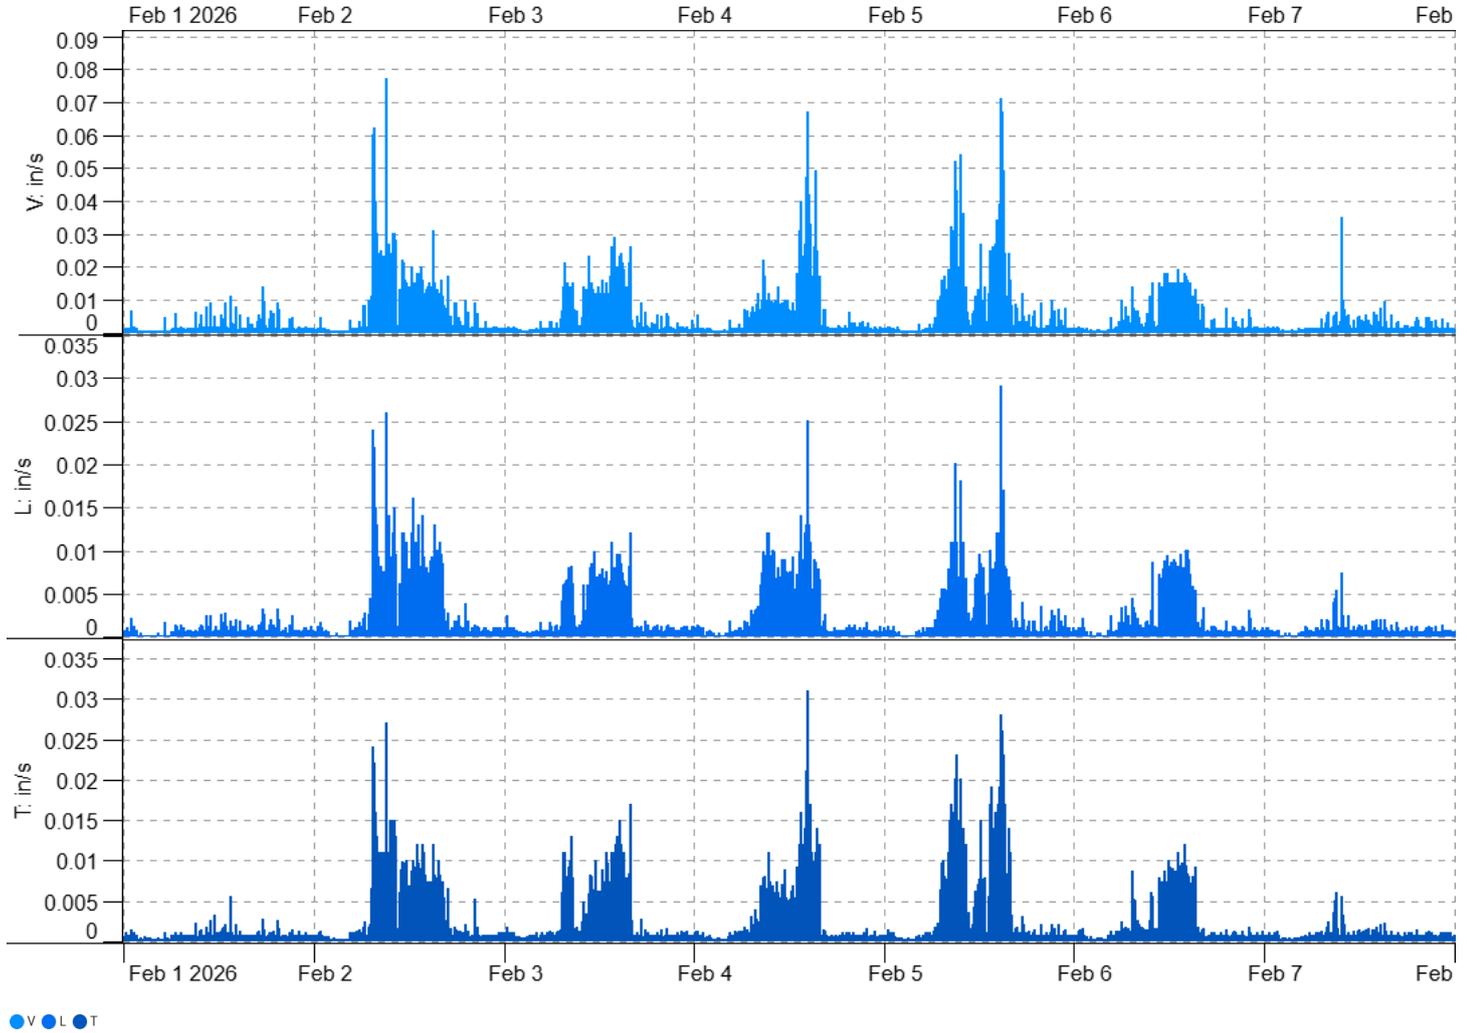
Riv3, 38 Bradbury St., Cambridge, MA, C22, Serial number: 103199, Calibrated: 2025-06-09,

X-span	2026-02-01 00:00 - 2026-02-08 00:00		
Y-span	V: 0 - 0.08 in/s, L: 0 - 0.03 in/s, T: 0 - 0.03 in/s		
	V	L	T
Max	0.08 in/s	0.03 in/s	0.03 in/s
Date	2026-02-02	2026-02-05	2026-02-04
Time	09:12:30	14:42:30	14:17:30
Hz	6.4	6.85	6.2

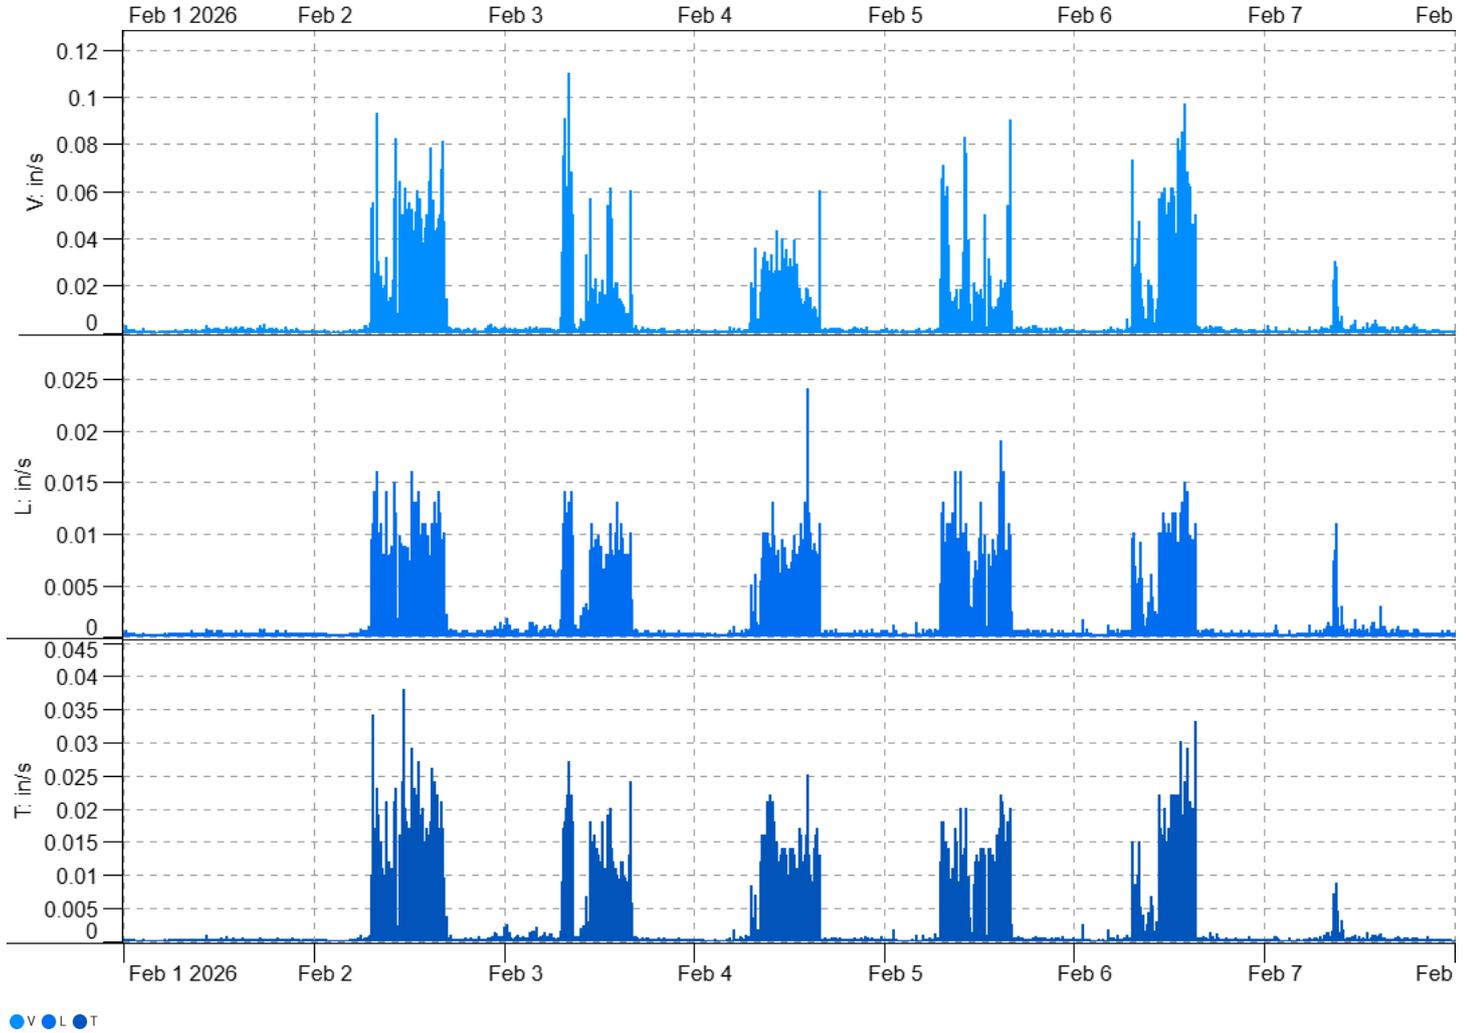
Riv4, 1 Sparks St., Cambridge, MA, C22, Serial number: 102403, Calibrated: 2025-07-02,

X-span 2026-02-01 00:00 - 2026-02-08 00:00

Y-span V: 0 - 0.11 in/s, L: 0 - 0.02 in/s, T: 0 - 0.04 in/s

V	L	T
Max	0.11 in/s	0.02 in/s	0.04 in/s
Date	2026-02-03	2026-02-04	2026-02-02
Time	08:17:30	14:17:30	11:22:30
Hz	8	5.25	5

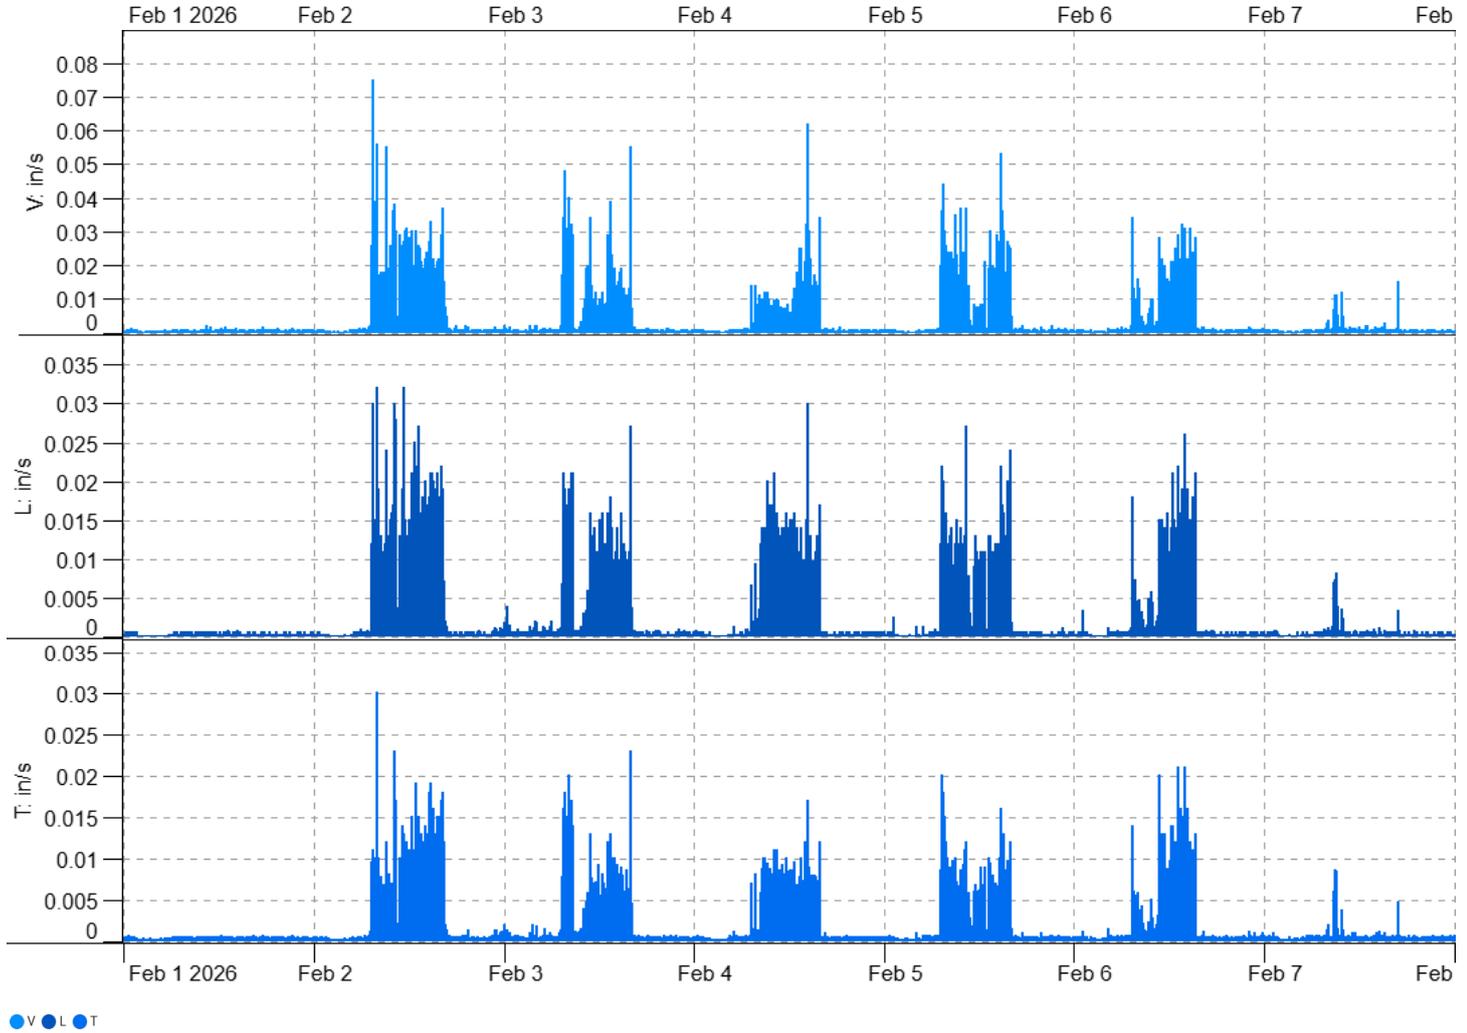
Riv5, 7 Sparks St., Cambridge, MA, C22, Serial number: 104002, Calibrated: 2025-07-02,

X-span 2026-02-01 00:00 - 2026-02-08 00:00
 Y-span V: 0 - 0.08 in/s, L: 0 - 0.03 in/s, T: 0 - 0.03 in/s

V	L	T
Max	0.08 in/s	0.03 in/s	0.03 in/s
Date	2026-02-02	2026-02-02	2026-02-02
Time	07:32:30	07:57:30	07:57:30
Hz	6.7	8.3	8.95

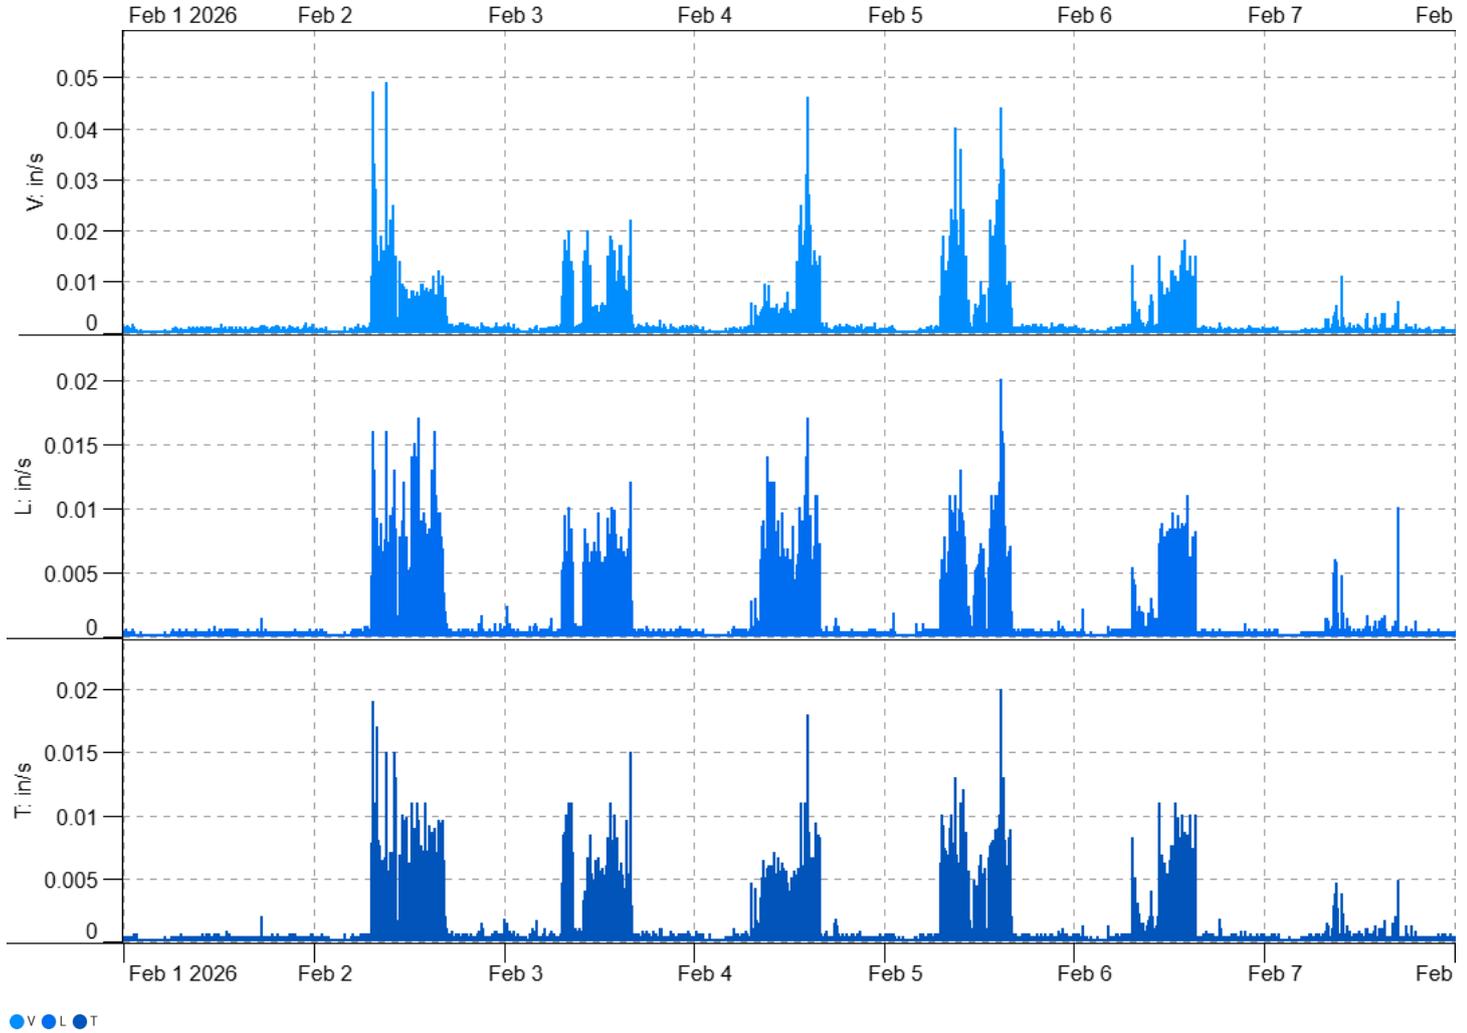
Riv6, 11 Sparks St., Cambridge, MA, C22, Serial number: 110329, Calibrated: 2025-07-02,

X-span 2026-02-01 00:00 - 2026-02-08 00:00

Y-span V: 0 - 0.05 in/s, L: 0 - 0.02 in/s, T: 0 - 0.02 in/s

V	L	T
Max	0.05 in/s	0.02 in/s	0.02 in/s
Date	2026-02-02	2026-02-05	2026-02-05
Time	09:12:30	14:42:30	14:42:30
Hz	5.6	7.75	8
