Project 200609.05 – Vibration Monitoring Data Report – 8 to 14 February 2026, Riverview  
Condominiums, 221 Mt. Auburn Street, Cambridge, MA

# Multi report

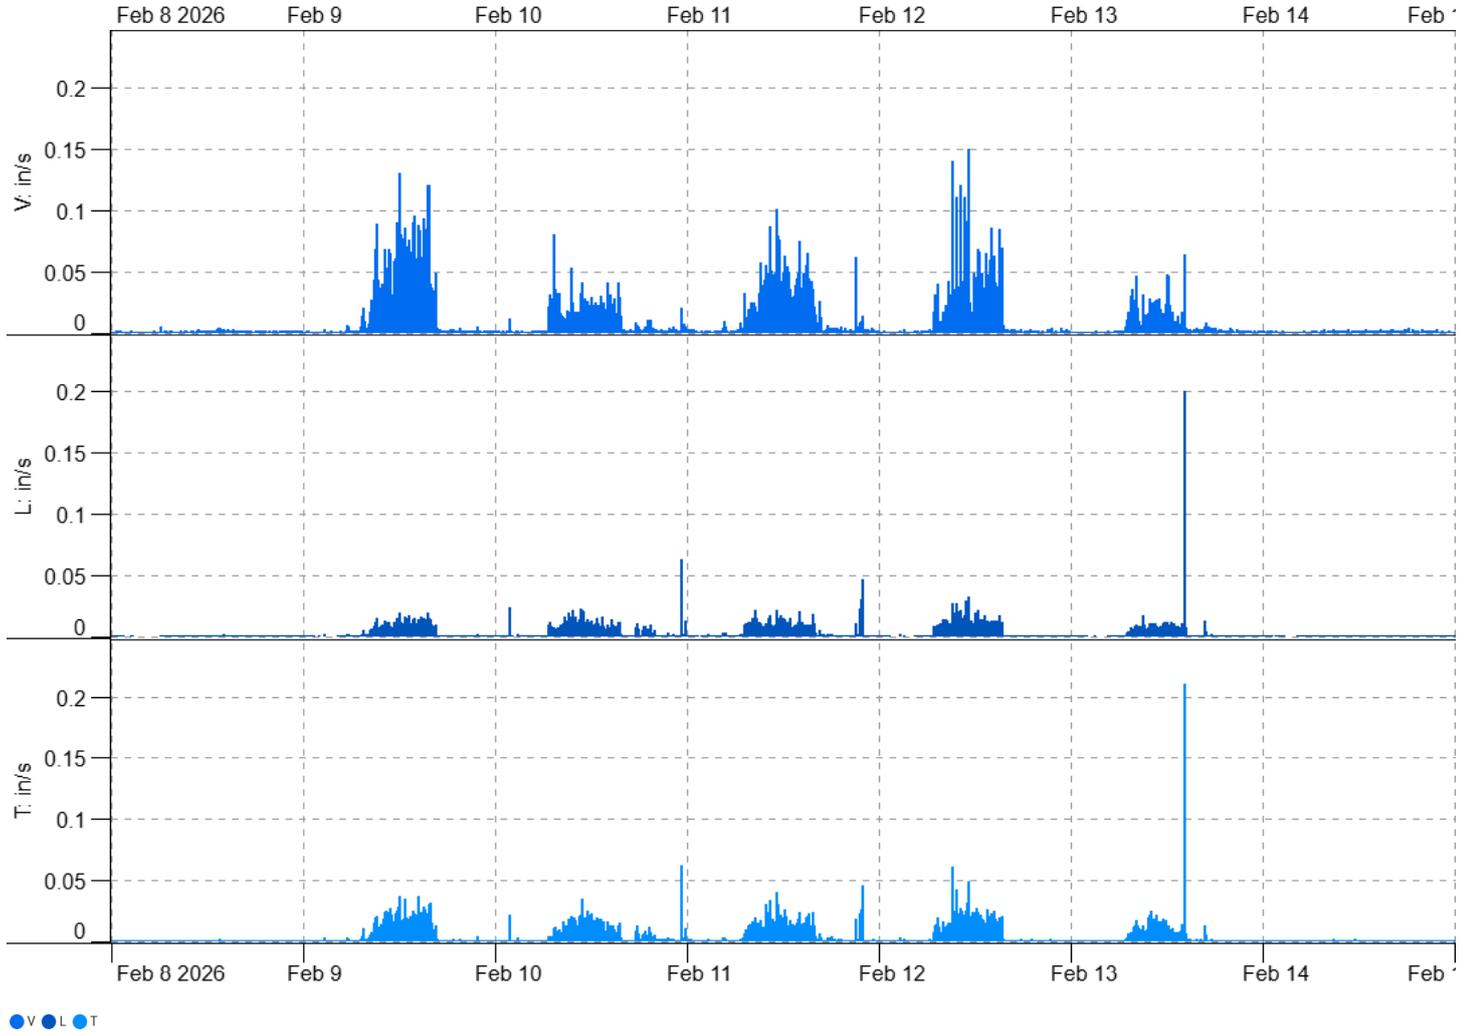
Riv4, 1 Sparks St., Cambridge, MA, C22, Serial number: 102403, Calibrated: 2025-07-02,

X-span 2026-02-08 00:00 - 2026-02-15 00:00

Y-span V: 0 - 0.15 in/s, L: 0 - 0.2 in/s, T: 0 - 0.21 in/s

| | V | L | T |
|---|---|---|---|
| Max | 0.15 in/s | 0.2 in/s | 0.21 in/s |
| Date | 2026-02-12 | 2026-02-13 | 2026-02-13 |
| Time | 11:17:30 | 14:12:30 | 14:12:30 |
| Hz | 6.7 | 2.1 | 2.1 |
