Project 200609.05 – Vibration Monitoring Data Report – 4 to 10 January 2026, Riverview  
Condominiums, 221 Mt. Auburn Street, Cambridge, MA

At your request, we installed vibration monitors at six properties abutting Riverview Condominiums (Riverview) to document vibrations during the Riverview building demolition. The purpose of this letter is to summarize the weekly vibration records and report “triggering” events if the vibration threshold is exceeded.

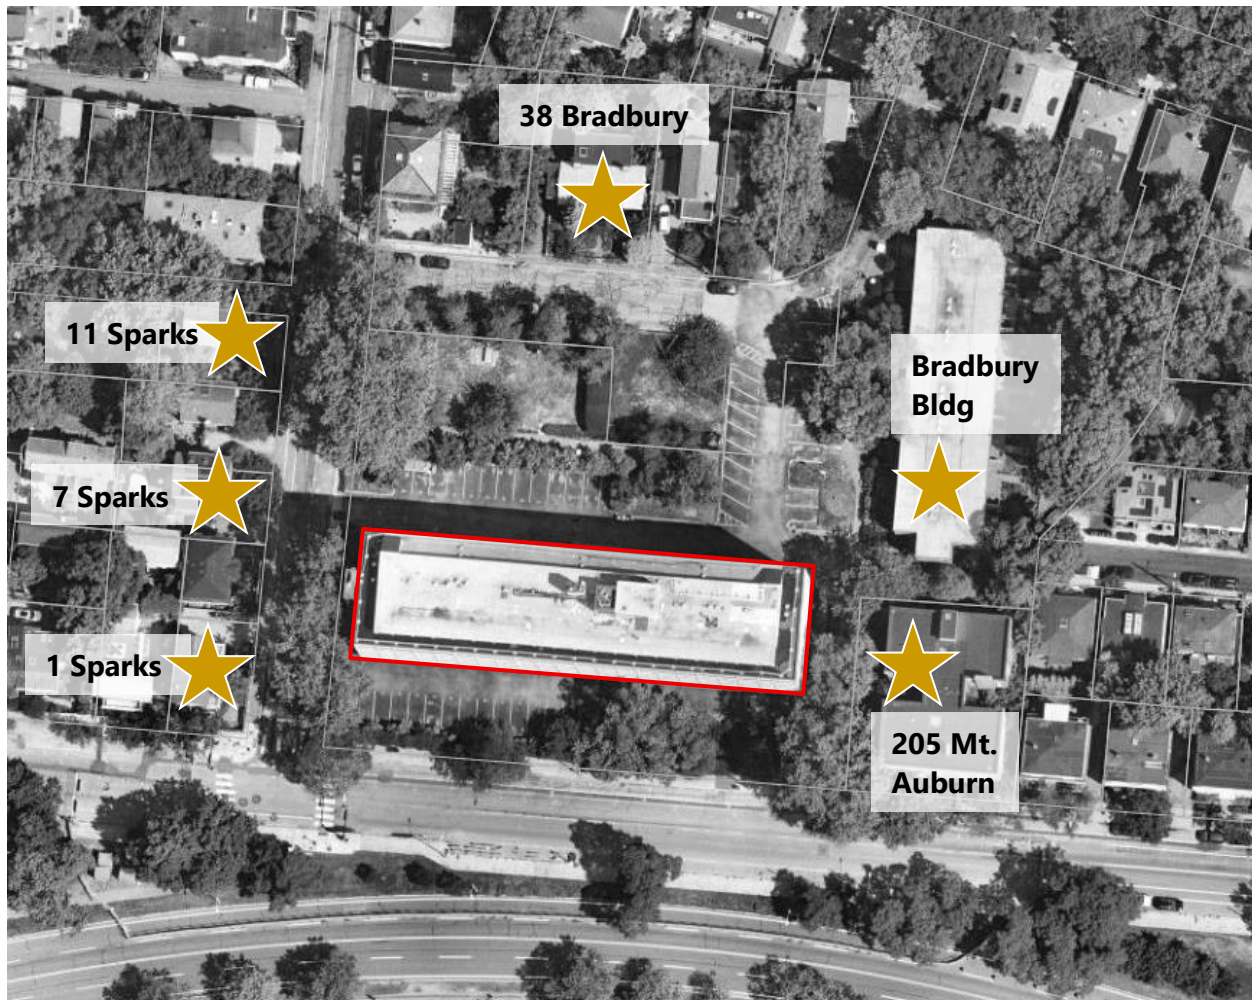
**Figure 1**

Aerial view of the Riverview Condominiums structure (outlined in red) and the abutting properties selected for vibration monitor installation (marked with yellow stars).

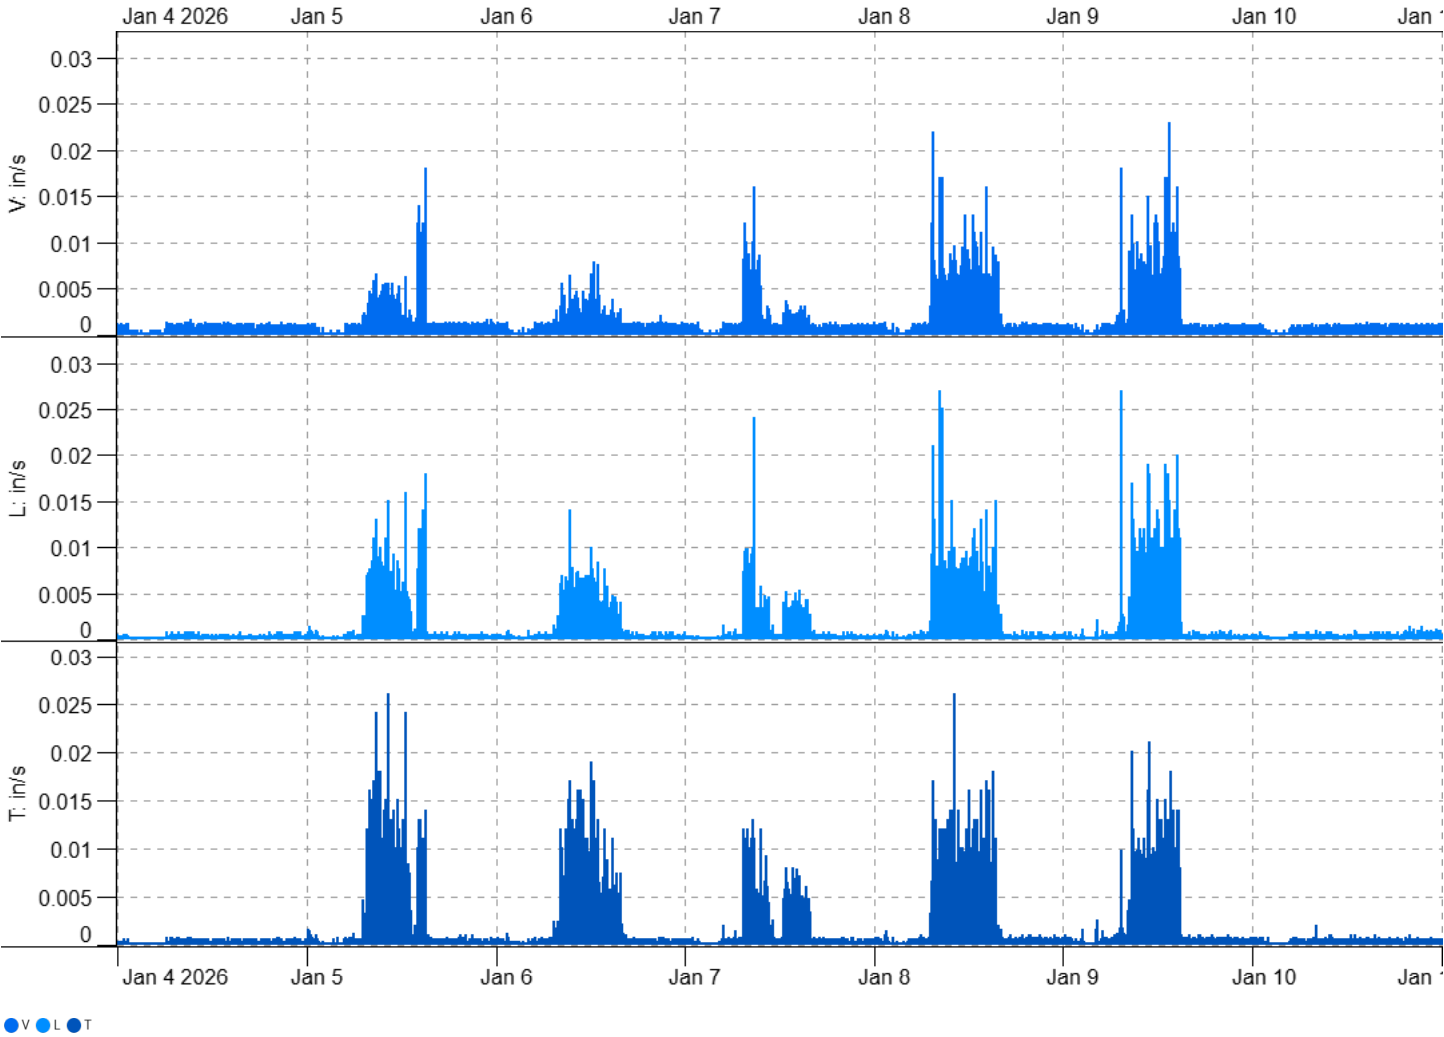
Riv1, Bradbury Building [22 Bradbury St.], C22, Serial number: 110294, Calibrated: 2025-07-30,

| Max | 0.02 in/s | 0.03 in/s | 0.03 in/s |
| Date | 2026-01-09 | 2026-01-08 | 2026-01-05 |
| Time | 13:27:30 | 08:17:30 | 10:22:30 |
| Hz | 6.7 | 4.75 | 2.25 |

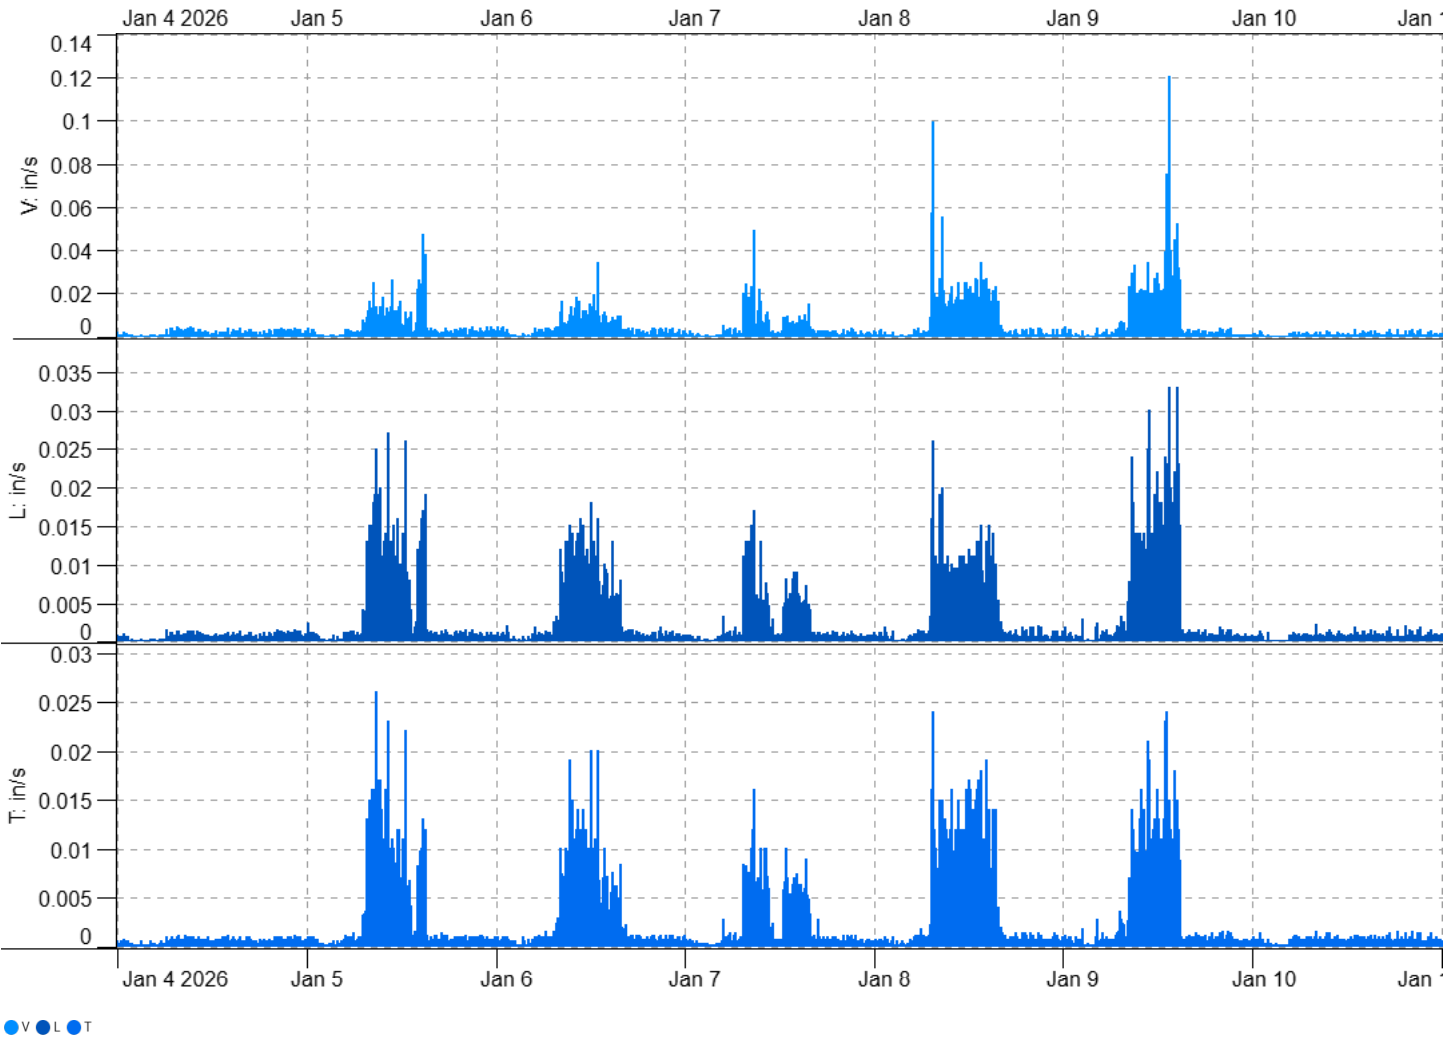
Riv2, 205 Mt. Auburn St., Cambridge, MA, C22, Serial number: 102013, Calibrated: 2025-07-23,

| Max | 0.12 in/s | 0.03 in/s | 0.03 in/s |
| Date | 2026-01-09 | 2026-01-09 | 2026-01-05 |
| Time | 13:27:30 | 13:27:30 | 08:52:30 |
| Hz | 8.05 | 9.6 | 2.6 |

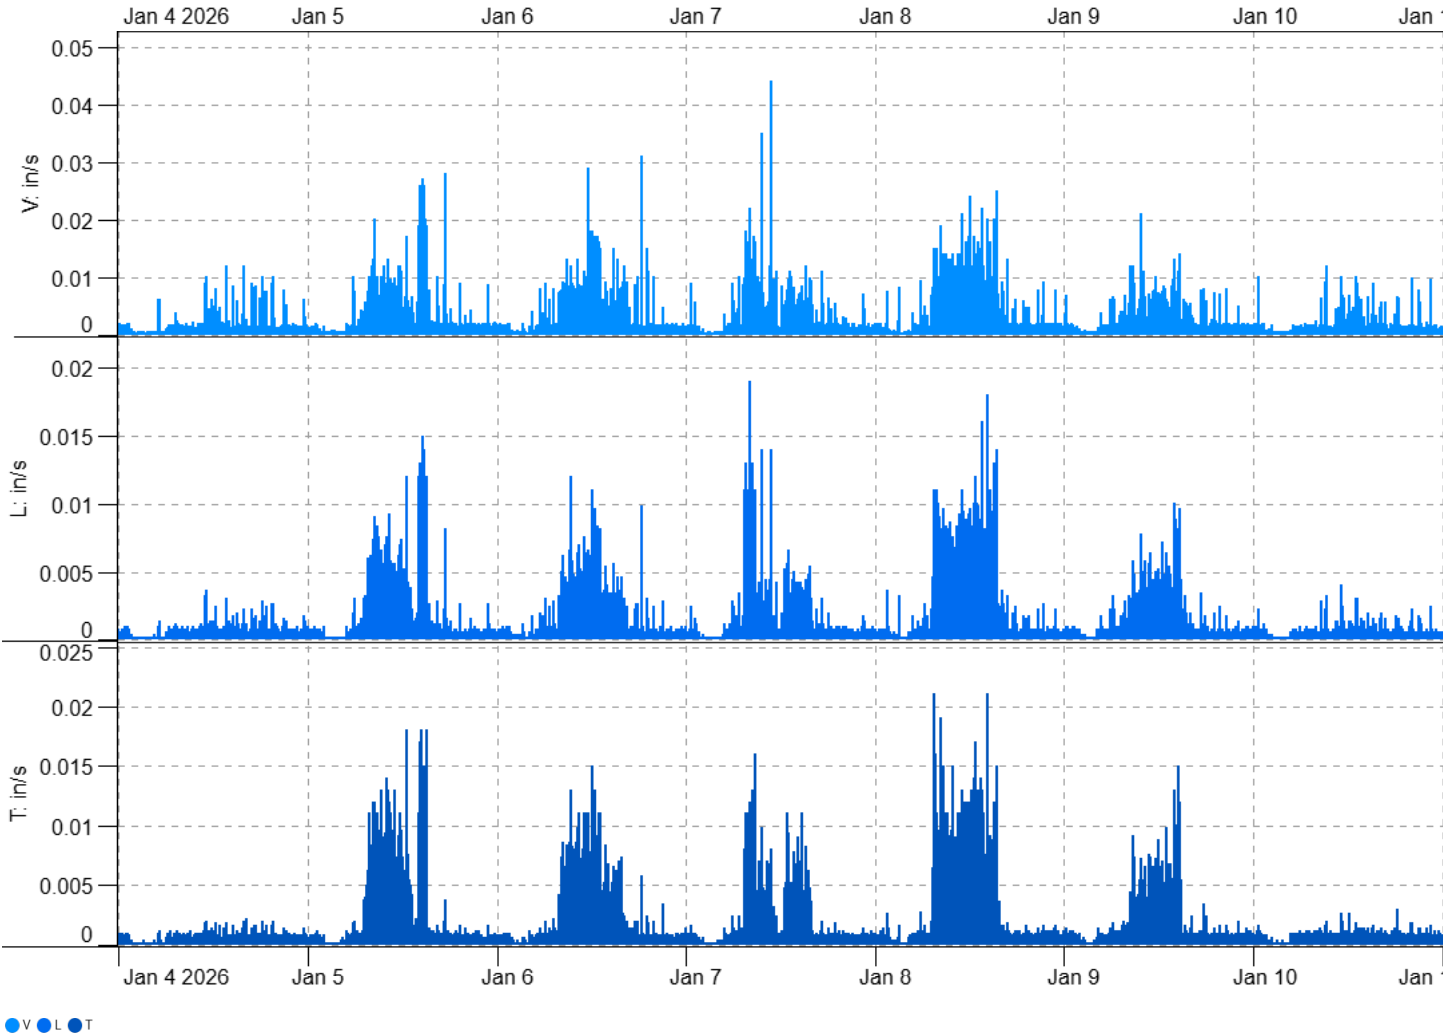
Riv3, 38 Bradbury St., Cambridge, MA, C22, Serial number: 103199, Calibrated: 2025-06-09,

| Max | 0.04 in/s | 0.02 in/s | 0.02 in/s |
| Date | 2026-01-07 | 2026-01-07 | 2026-01-08 |
| Time | 10:52:30 | 08:07:30 | 07:32:30 |
| Hz | 12 | 5 | 4.75 |

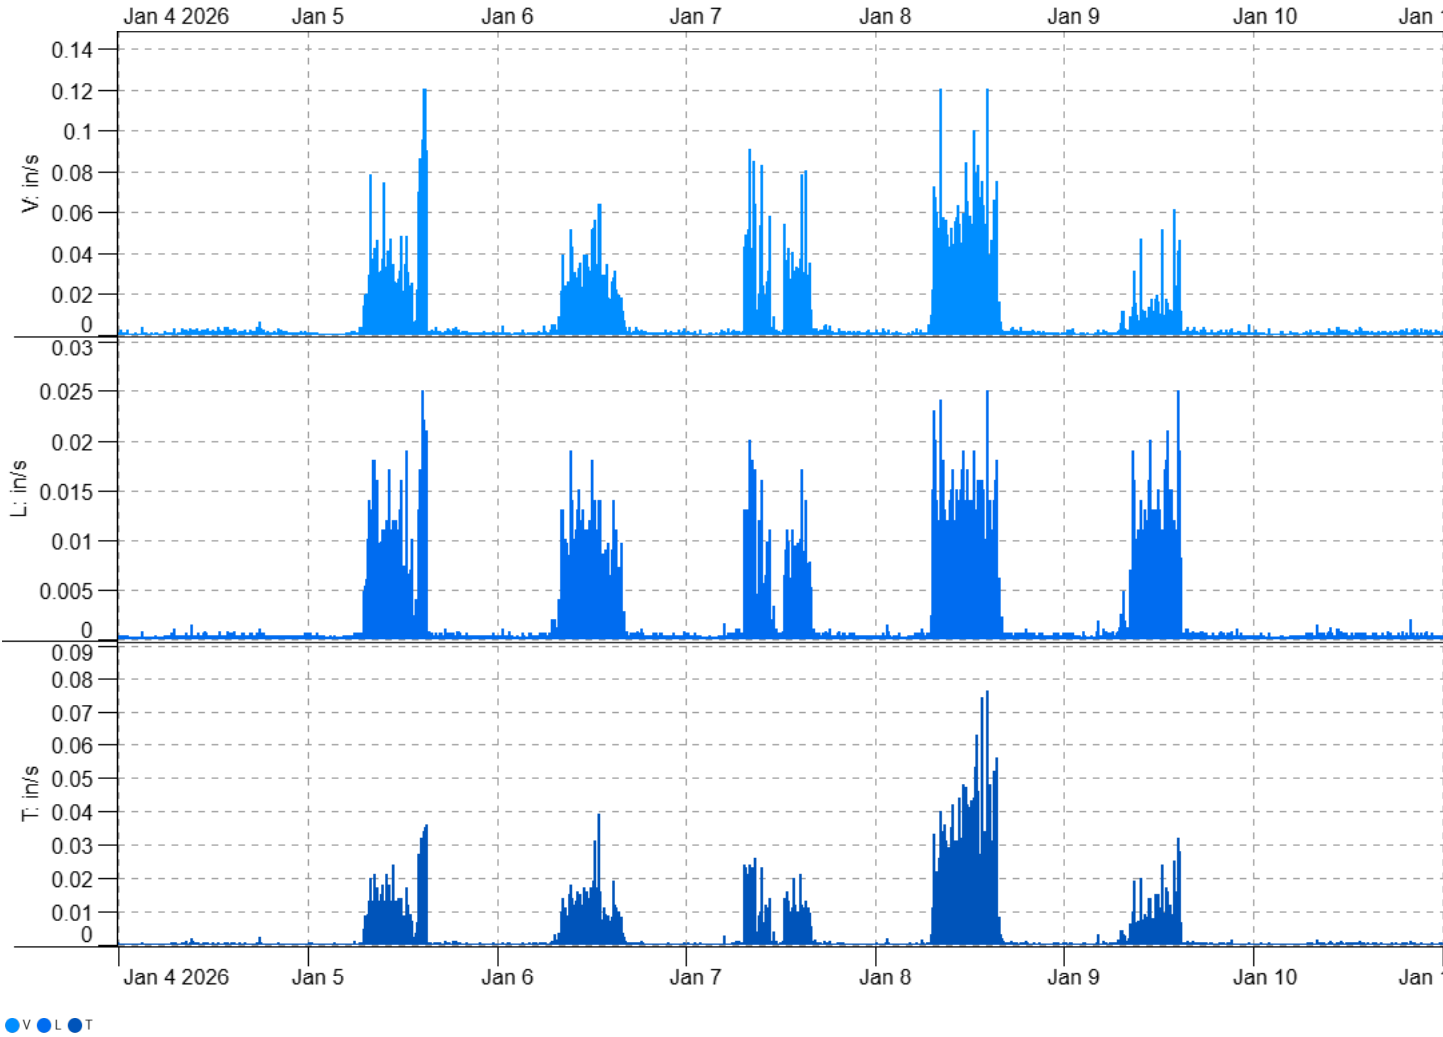
Riv4, 1 Sparks St., Cambridge, MA, C22, Serial number: 102403, Calibrated: 2025-07-02,

| Max | 0.12 in/s | 0.03 in/s | 0.08 in/s |
| Date | 2026-01-05 | 2026-01-05 | 2026-01-08 |
| Time | 14:42:30 | 14:37:30 | 14:12:30 |
| Hz | 11.5 | 9.95 | 4.85 |

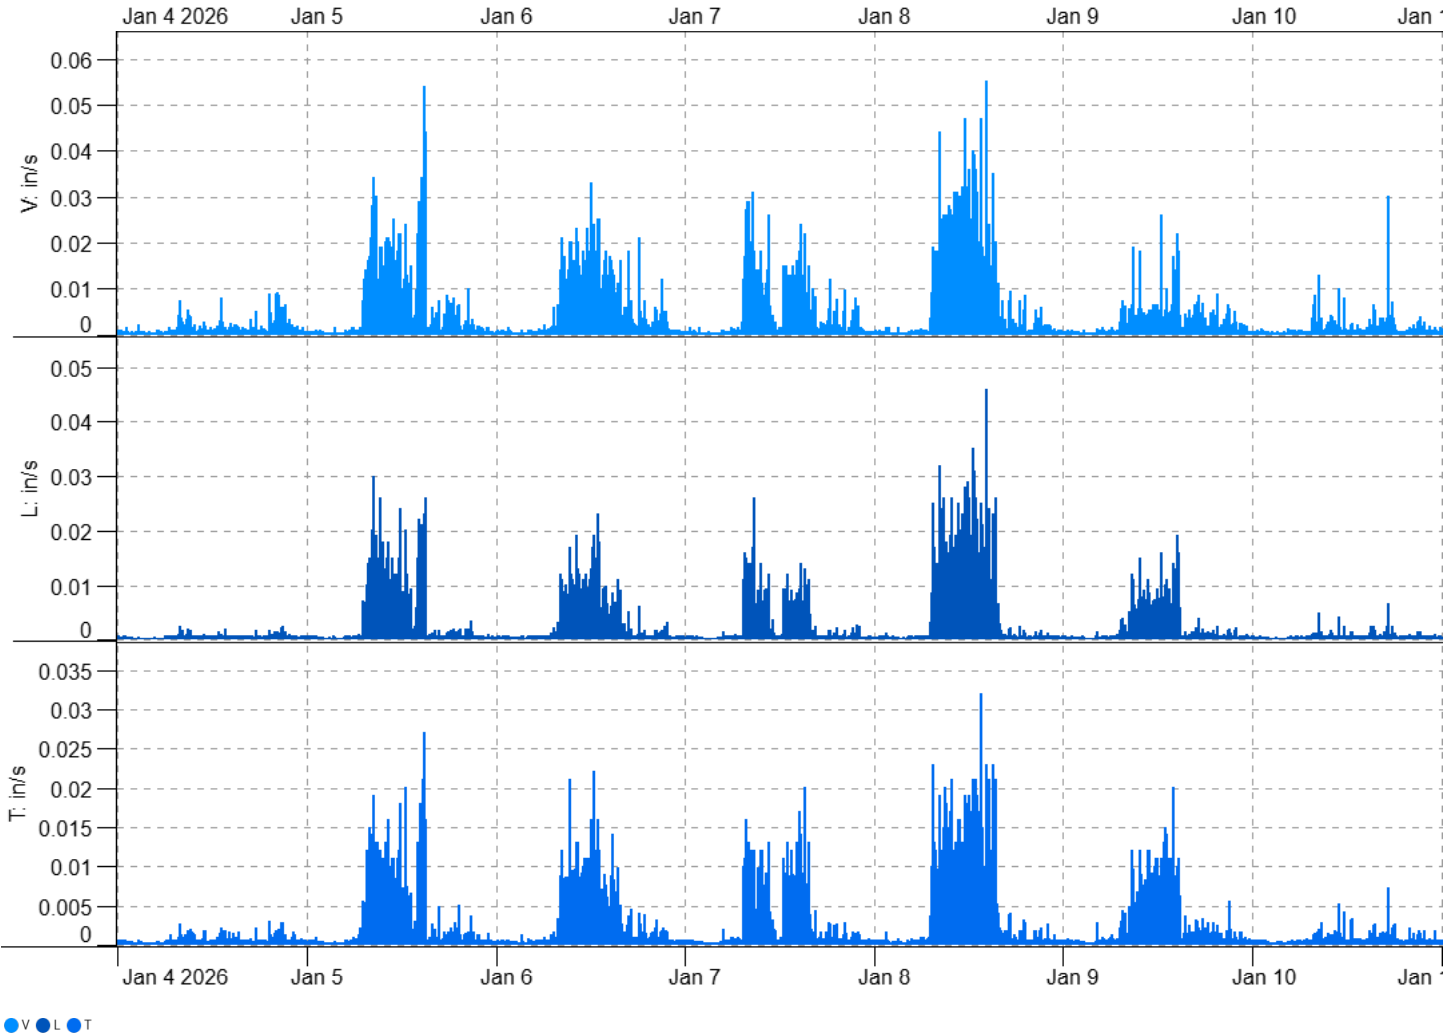
Riv5, 7 Sparks St., Cambridge, MA, C22, Serial number: 104002, Calibrated: 2025-07-02,

| Max | 0.06 in/s | 0.05 in/s | 0.03 in/s |
| Date | 2026-01-08 | 2026-01-08 | 2026-01-08 |
| Time | 14:12:30 | 14:12:30 | 13:37:30 |
| Hz | 5 | 4.85 | 4.2 |

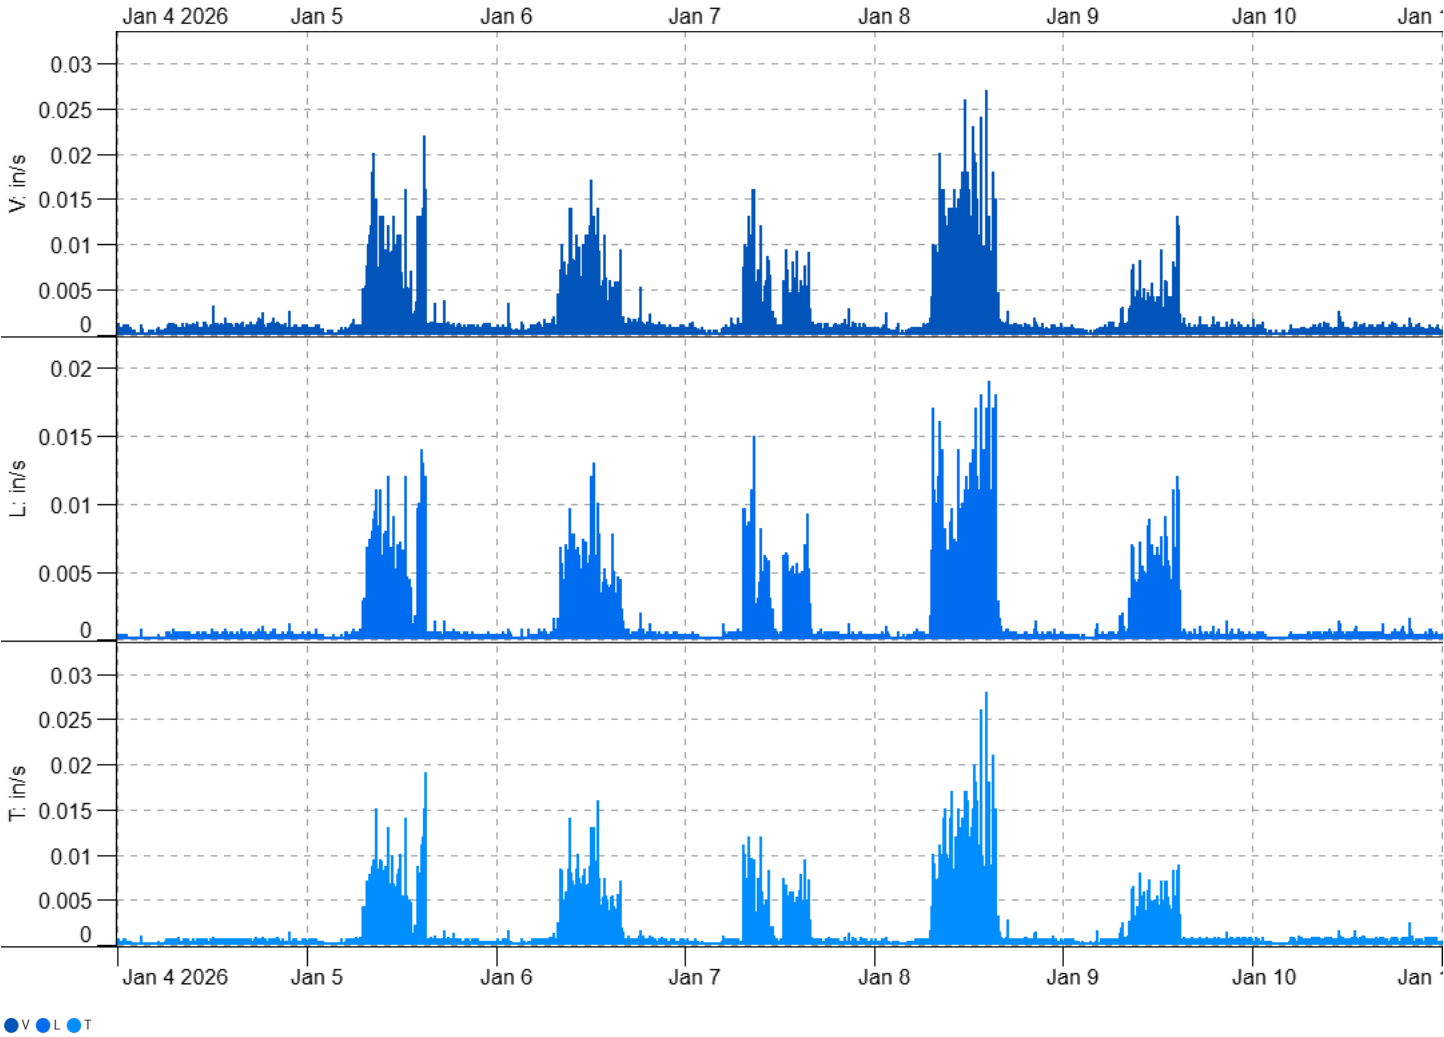
Riv6, 11 Sparks St., Cambridge, MA, C22, Serial number: 110329, Calibrated: 2025-07-02,

| Max | 0.03 in/s | 0.02 in/s | 0.03 in/s |
| Date | 2026-01-08 | 2026-01-08 | 2026-01-08 |
| Time | 14:12:30 | 14:37:30 | 14:12:30 |
| Hz | 4.85 | 4.85 | 4.5 |
