VI. Natural Resources and Current Conditions at Fresh Pond Reservation

In 1997, the City of Cambridge hired Rizzo Associates, Inc. to conduct a Fresh Pond Reservation Natural Resource Inventory and prepare a Fresh Pond Reservation Natural Resource Stewardship Plan as key elements of the Fresh Pond Reservation Master Plan. Published in August, 1998, the Inventory identified, evaluated and mapped the natural resources of the Reservation, described its notable natural assets, and called attention to its major natural resource management issues (See Sections 3.0 and 4.0 of the Inventory and B, C, and D, below).

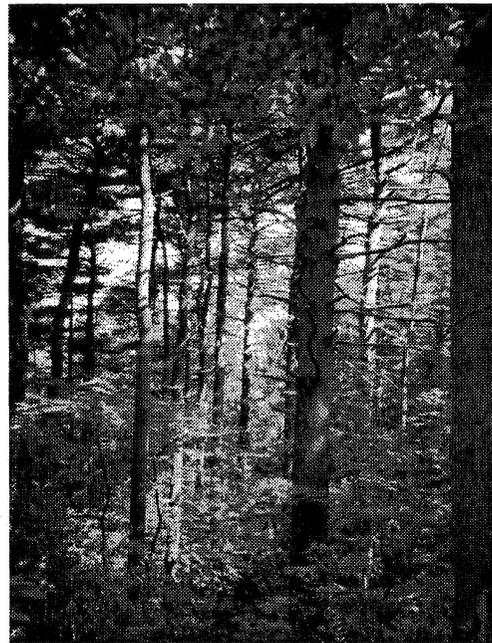
The softwood forest consists principally of evergreen species and includes a grove of hemlock at Kingsley Park and two groves of White Pine, one at the Weir Meadow and the other along Fresh Pond Parkway at the southeast corner of the Reservation. The main ecological problems in these areas are (1) widespread presence of invasive species, notably Norway maples and poison ivy; and (2) widespread soil compaction and reduced understory, resulting from heavy human traffic and leading to erosion (See Figure 9).

Figure 9: Typical Softwood Forest with Understory, 1998 Source: Rizzo Associates, Inc. Summer 1998

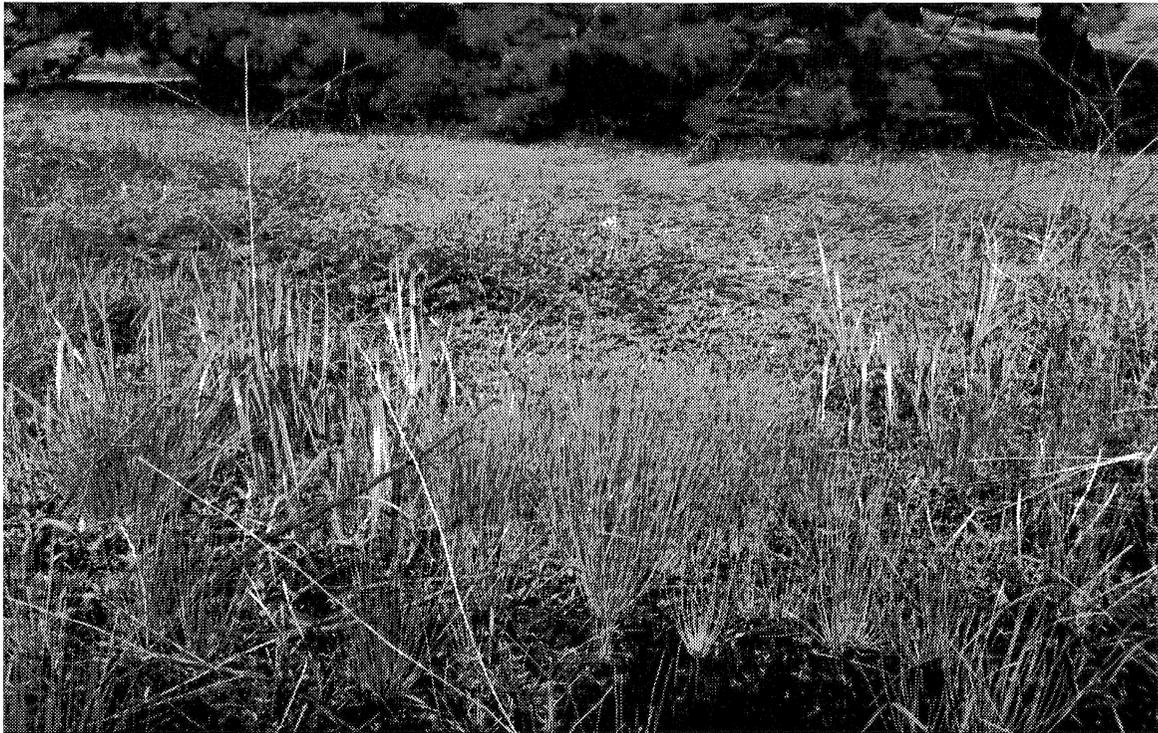
Figure 10: Emergent Wetland, Summer 1998 Source: Rizzo Associates, Inc., Summer 1998

An emergent wetland has been developing at the northern edge of Little Fresh Pond, between the 8th Tee and 8th Green (See Figure 10). Vegetation is predominantly herbaceous consisting of a healthy diversity of grasses and sedges. The center of the wetland remains flooded through much of the spring and fall, supporting the emergent vegetation and an array of migratory songbirds and waterfowl. Aesthetically, this wetland represents an important added feature for the golf course. A rapidly growing problem is the invasion of the wetland by destructive purple loosestrife. A sensitive area, the wetland is also in need of protection.

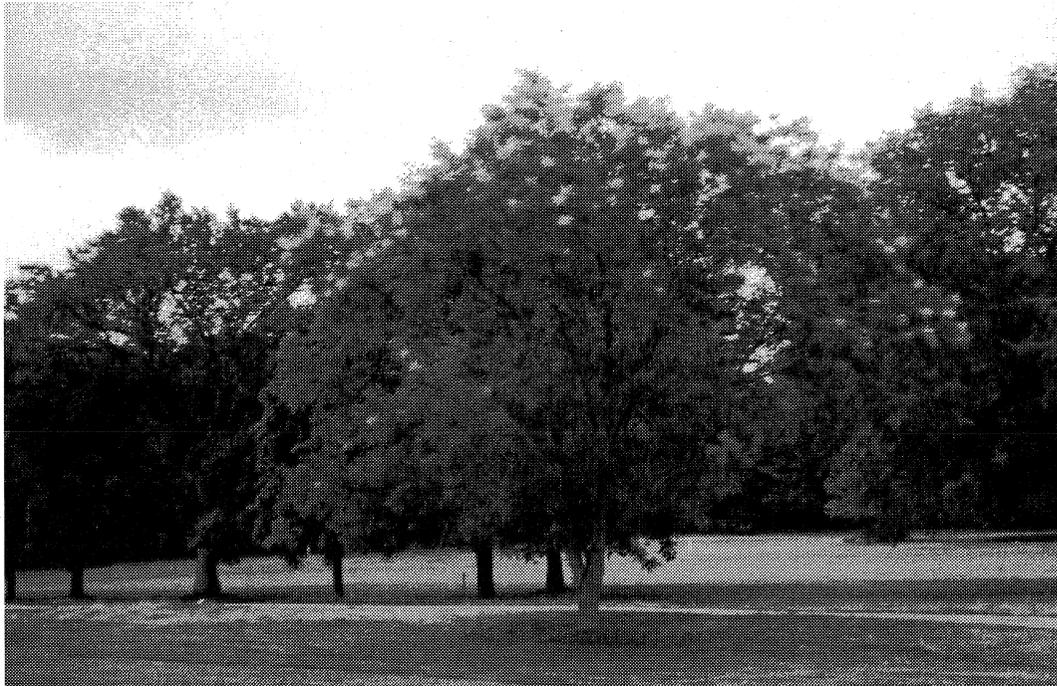
The nine hole public golf course, located on the western side of the Reservation, was found to be rich in specimen trees, unique vegetation and important wildlife habitat (See Figure 11). A major problem with stormwater drainage was noted.

Figure 11: Golf Course, Specimen Chinese Scholar Tree, 1998
Source: Rizzo Associates, Inc., Summer 1998

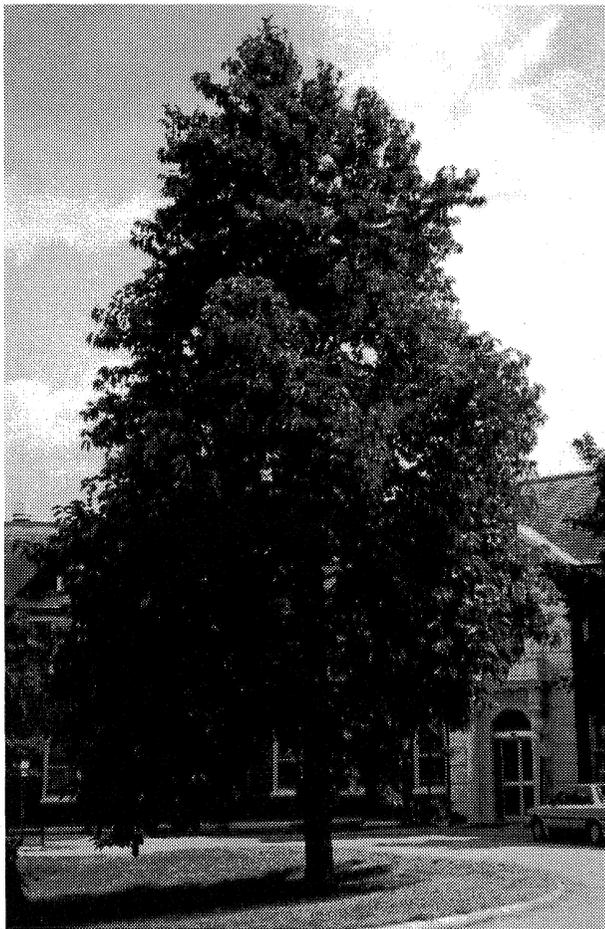
Figure 12: Cucumber Magnolia at Neville Manor, 1998
Source: Rizzo Associates, Inc., Summer 1998

The Water Board and Neville Communities will jointly landscape the entire current site in accordance with the Stewardship Plan, taking care to preserve the many specimen trees to be found on it. The gazebo currently located to the northwest of the Neville Manor building will be moved to the vicinity of the new skilled nursing facility. Twelve park benches on the current Neville Manor site will also be relocated appropriately.

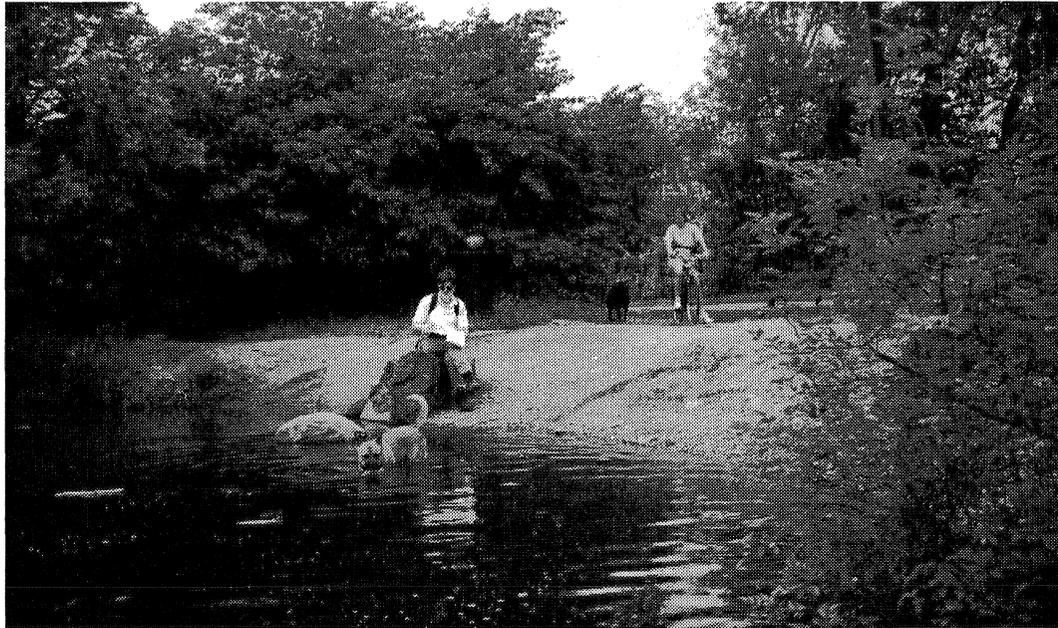
Figure 13: Bank Erosion along Little Fresh Pond, 1998
Source: Rizzo Associates, Inc., Summer 1998

The shoreline is in poor to very bad condition. The extreme erosion of the shoreline along the northern and eastern shoreline along the Perimeter Road, resulting from heavy human and dog traffic, is the worst in the Reservation (See Figure 13). The bank consists of a non-uniform mixture of riprap, gravel and exposed soil. Severe surface erosion, bank sloughing and undercutting are evident. In addition, much of the existing tree canopy around the pond is stressed with dead limbs and dying foliage. The southern shoreline also shows heavy erosion, while more moderate erosion has been taking place on the western shore adjacent to the golf course.

The Stewardship Plan places a very high priority on rehabilitation of the Little Fresh Pond shoreline, which will likely require a major effort.
