LANDSCAPE ARCHITECTURAL LEGEND 585 THIRD ST

RWDI was retained to conduct a pedestrian wind assessment for the proposed 585 Third Street project in Cambridge, MA (Image 1). The potential wind conditions have been assessed based on wind tunnel testing of the project under the No Build, Build and Full Build configurations (Images 2A through 2C) and the local wind records (Image 3), and compared to the Mean Speed and Effective Gust criteria adopted by the Boston Planning and Development Agency (BPDA). The results of the assessment are shown on site plans in Figures 1A through 2C, and the associated wind speeds are listed in Tables 1 and 2. The key findings are summarized as follows:

PEDESTRIAN WIND STUDY
585 THIRD STREET

RWDI #2102562
July 13, 2021

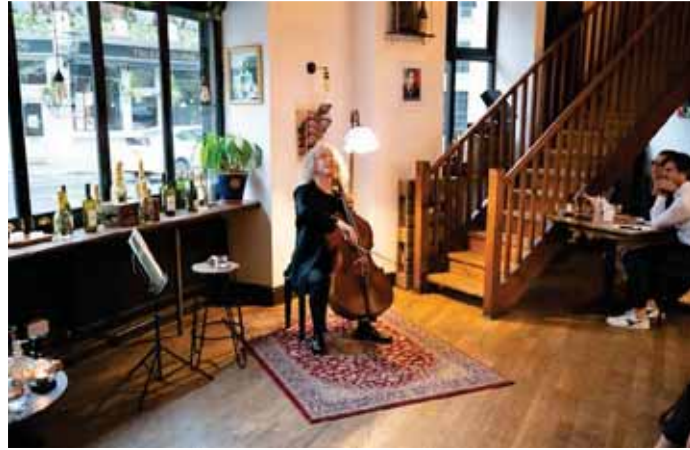
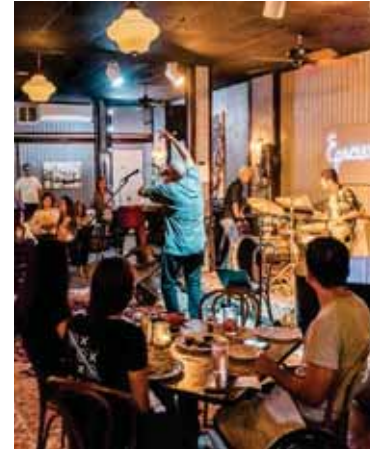
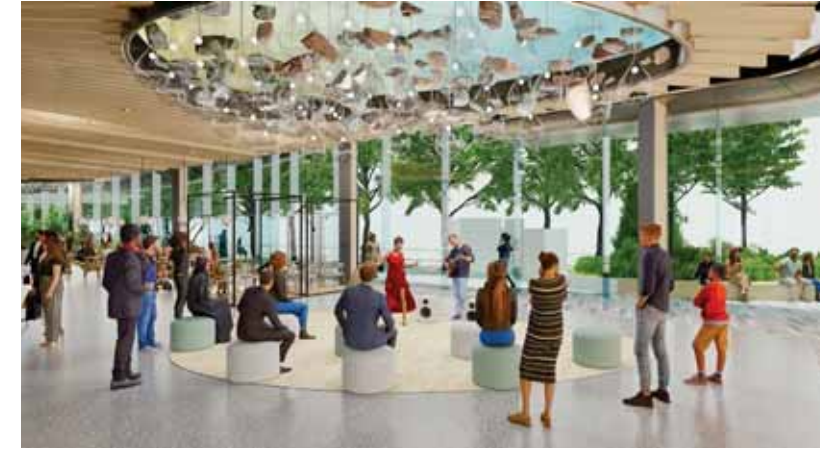
A.15 Ground Floor Corner Flex - Performance

Reference for performance space

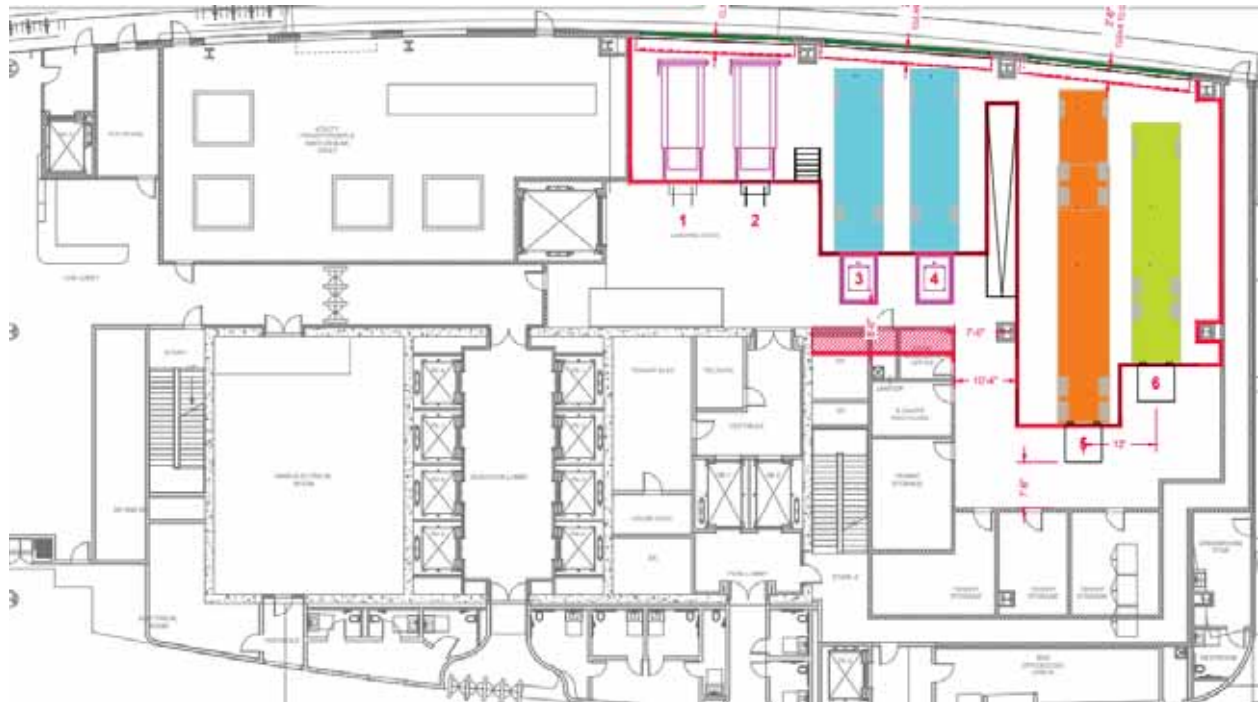
Figure 2: Dock Design B – Compactors at 1 & 2

- A. Design B shows compactor locations in bays 1 & 2 with bays 3 through 6 reserved for loading vehicles of various sizes. This design relegates the compactors to the same bay and allows the remaining dock bays to be utilized for loading.

While the theatre program must travel slightly further to reach the freight elevator, the safety concern regarding the clearance between the leveler and ramp is mitigated. While slight changes are required to the program on the dock level (hashed red area below bays 3 & 4), the overall flow of the dock is improved.

St. Onge advises against the separation of the compactors and recommends that Design B become the standard design philosophy moving forward. As adjustments to the design continue, Design B may change, but fundamentally the relegation of the compactors to bays 1 & 2 should carry forward in all designs.

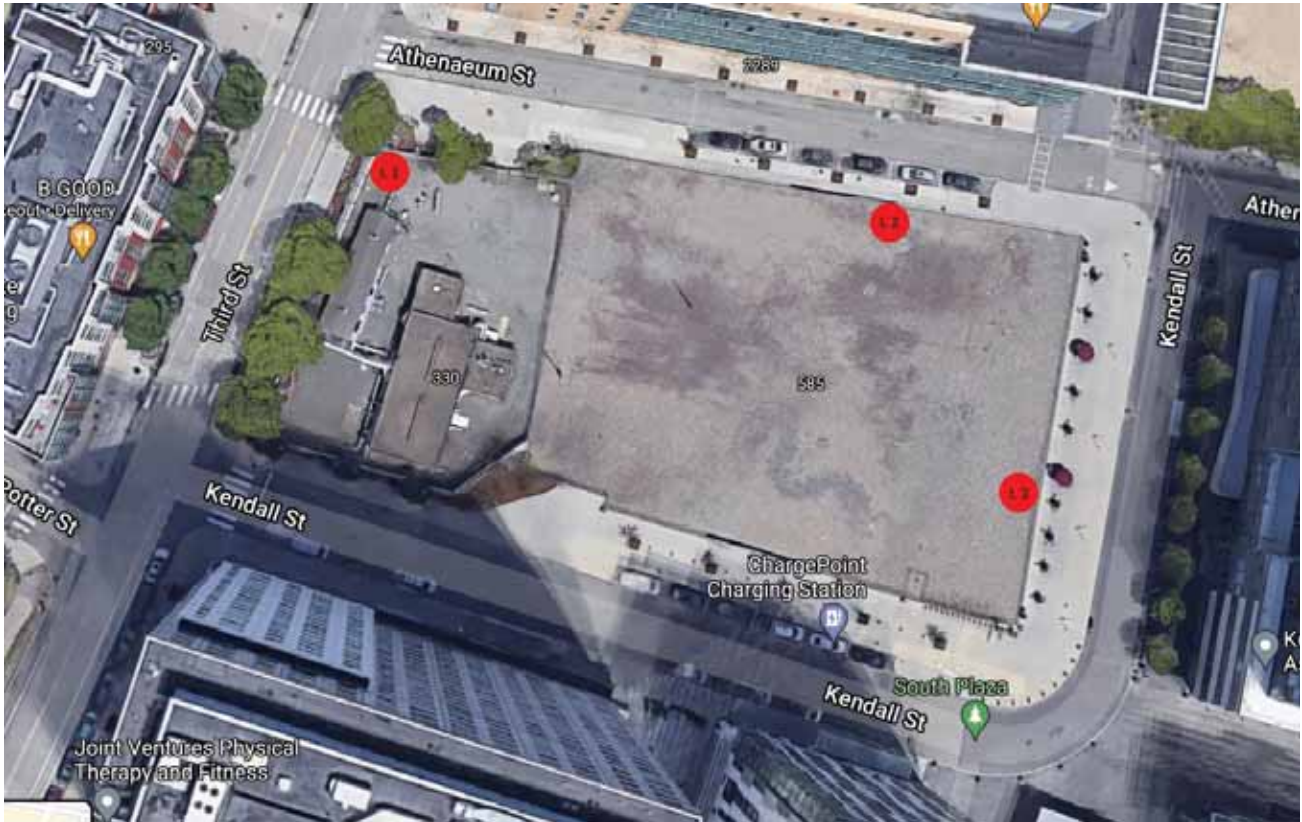
Figure 1: Measurement locations at project site

Acentech conducted a survey of existing sound levels at three representative locations at the project site, as shown in Figure 1. Measurements were conducted from June 10 to June 17, 2021, throughout which sounds were continuously monitored.

Acoustic measurements for this project were conducted with Rion NL-52 sound level meters which conform to ANSI S.14-1961 for Type 1 precision sound level meters. All equipment was field-calibrated before and after the measurement period using a Pulsar Model 105 acoustic calibrator. Measurements were conducted at heights of five to eight feet above grade elevation.

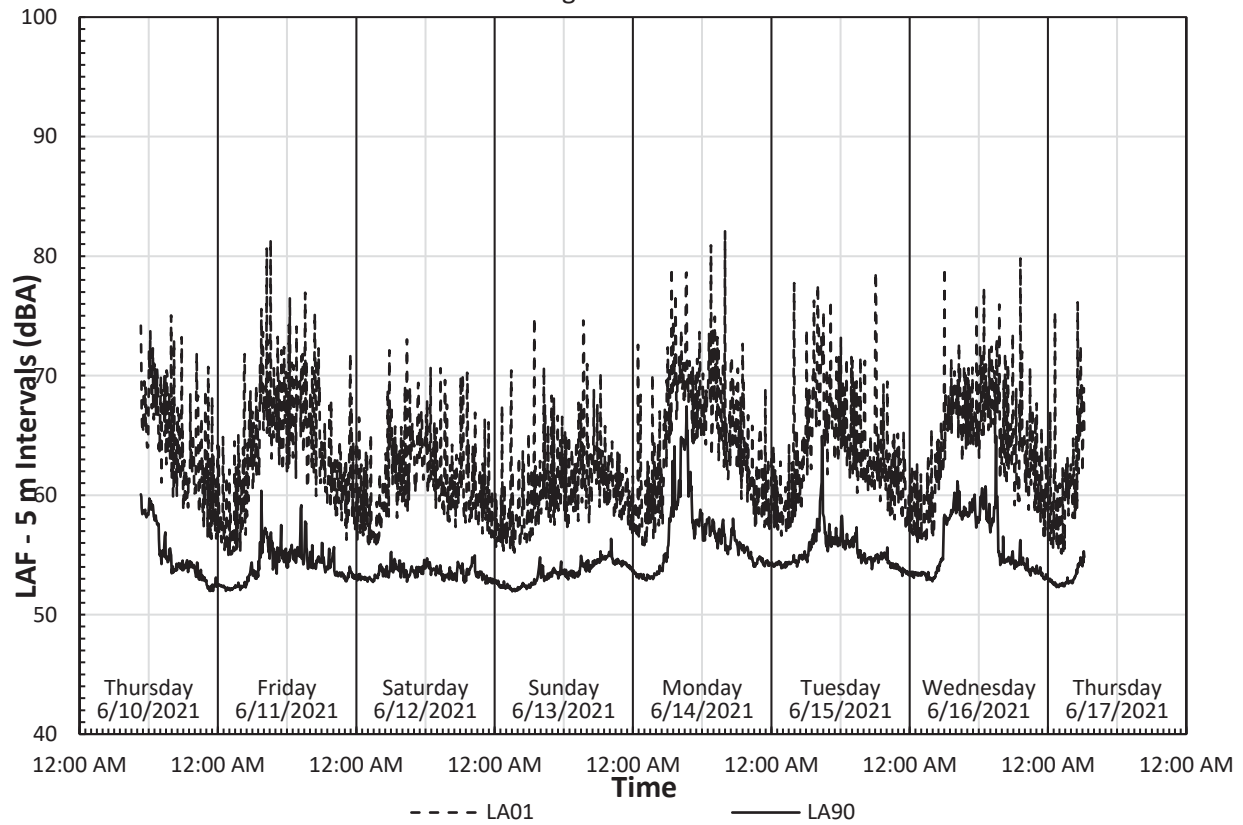
Figure 3: Measurements at Location 2

Sound Levels Measured at North Side of Site

Along Athenaeum St

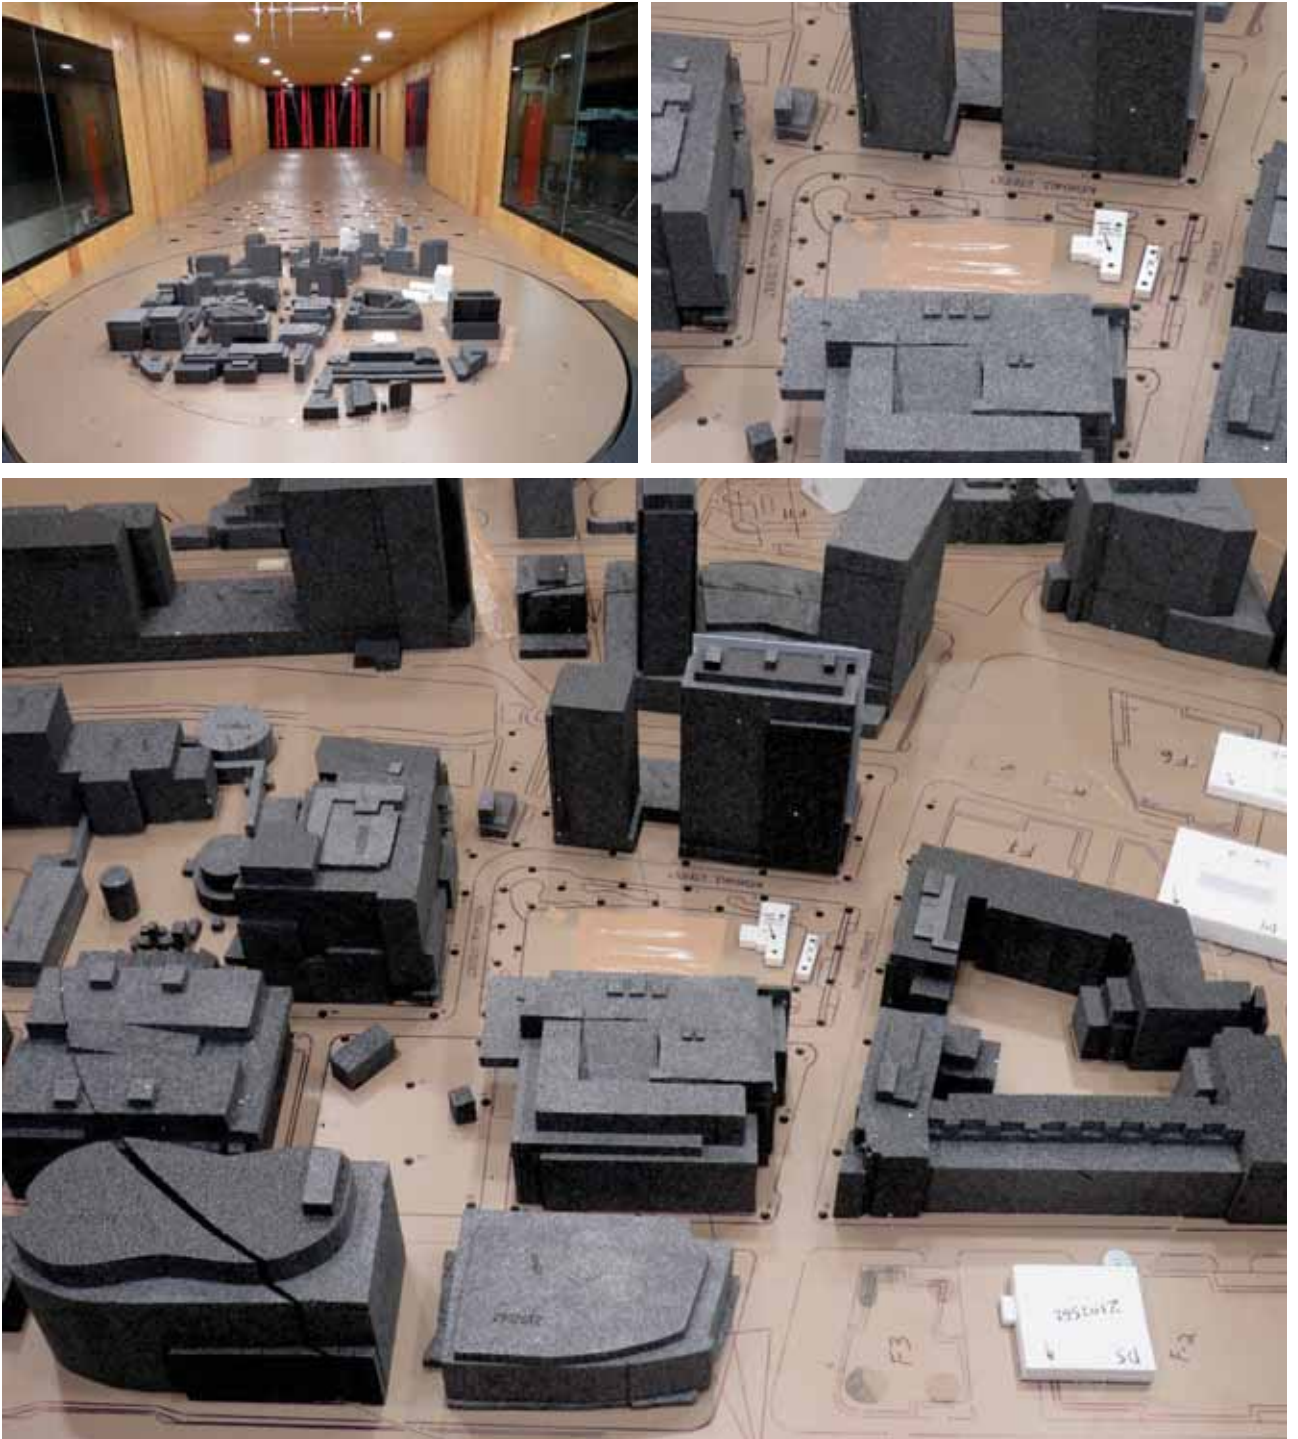
Image 2A: Wind Tunnel Study Model – No Build Configuration

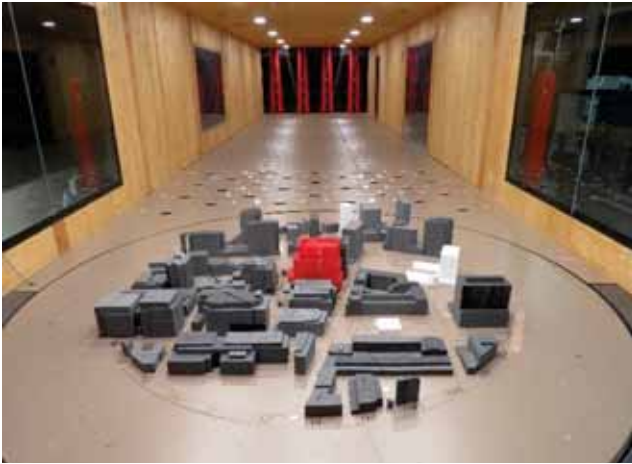
Image 2B: Wind Tunnel Study Model – Build Configuration

The objectives of the study were to assess the effect of the proposed development on local wind conditions in pedestrian areas on and around the study site and provide recommendations for minimizing adverse effects, if needed. This quantitative assessment was based on wind speed measurements on a scale model of the project and its surroundings in one of RWDI's boundary-layer wind tunnels. These measurements were combined with the local wind records and compared to the BPDA criteria for gauging wind comfort and safety in pedestrian areas. The assessment focused on critical pedestrian areas, including building entrances, public sidewalks, and grade-level outdoor seating spaces.

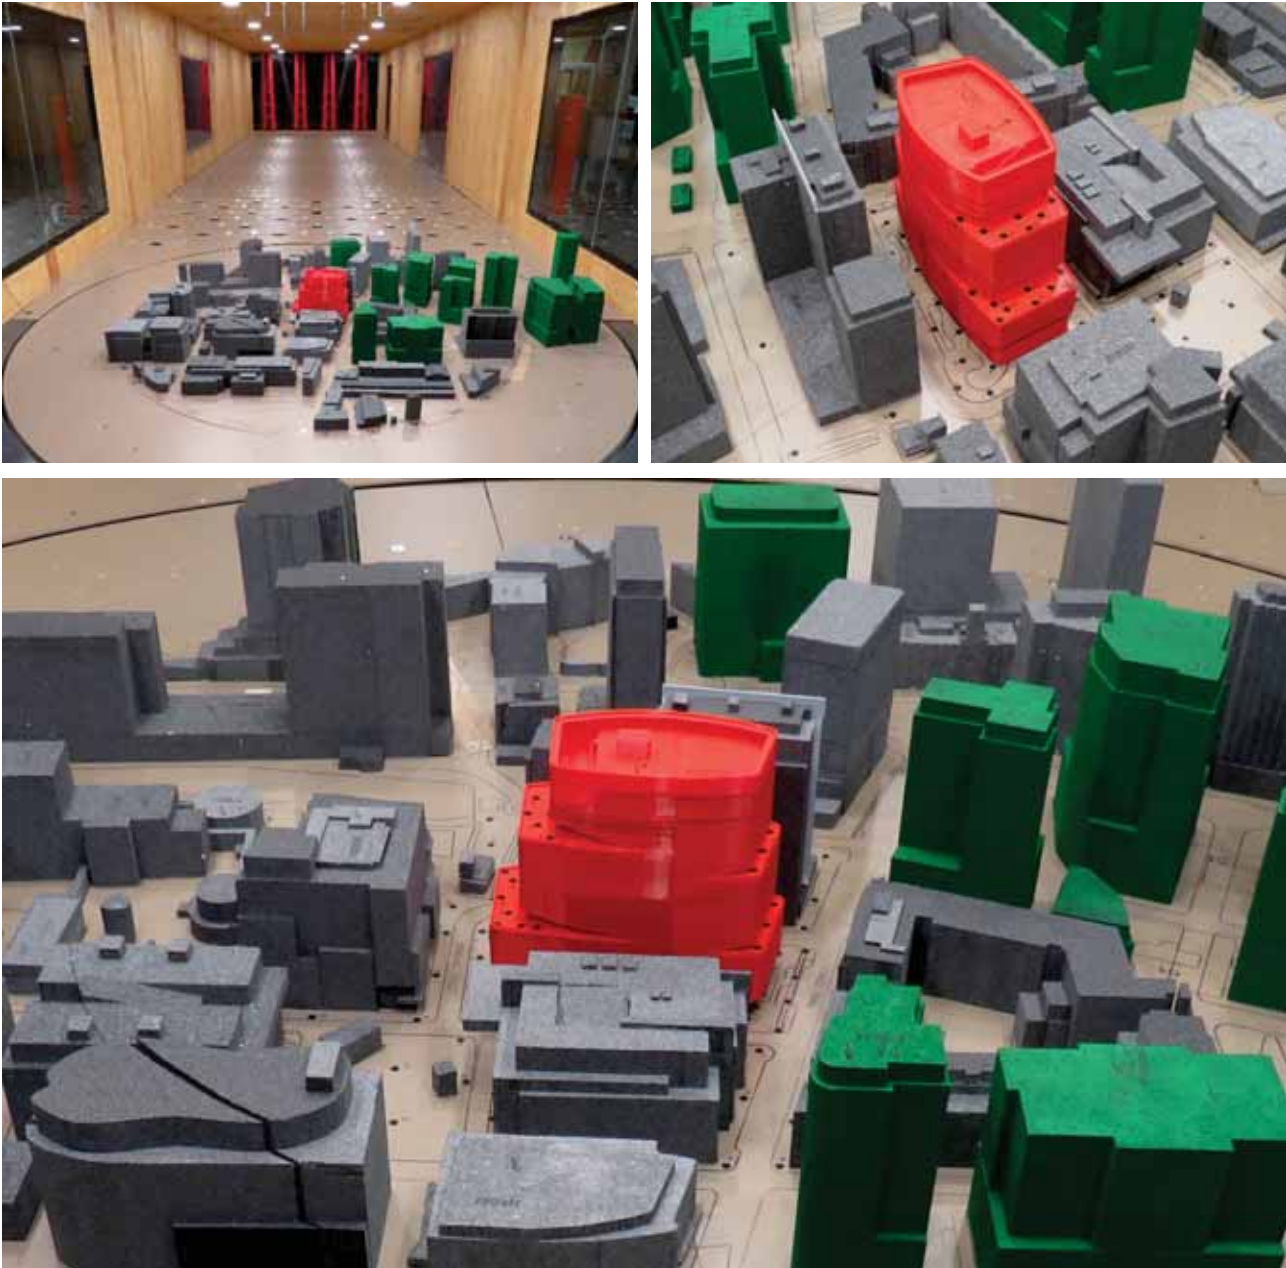
Image 2C: Wind Tunnel Study Model – Full Build Configuration

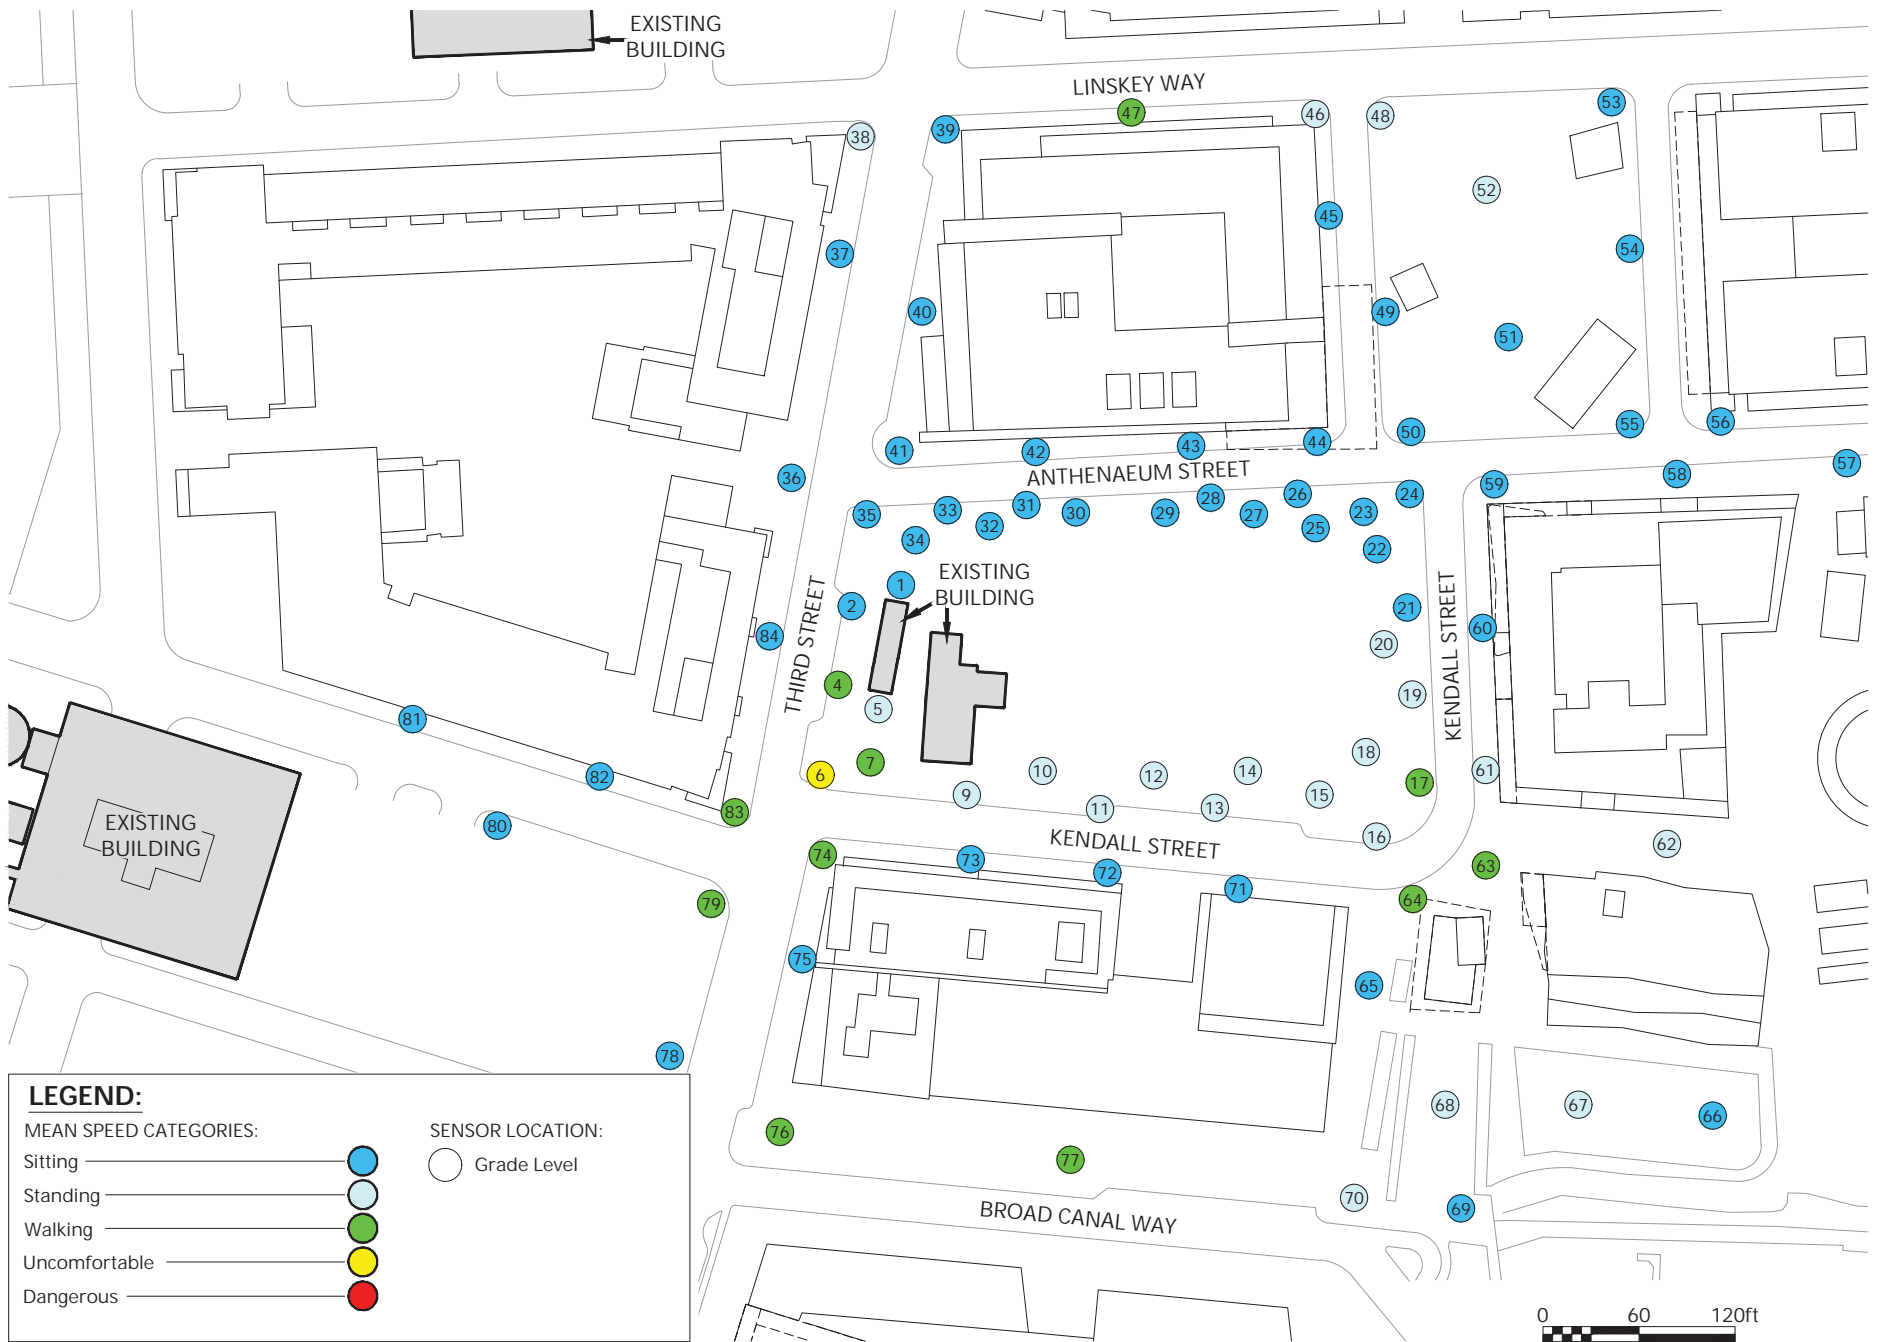
Pedestrian Wind Conditions - Mean Speed
 No Build
 Annual

- The annual mean wind speeds on the existing site (No Build configuration) are generally comfortable for the intended pedestrian use. Wind speeds that are uncomfortable for walking occur at the southwest corner of the project site. There are no areas with dangerous wind conditions on either an annual or seasonal basis.
