Out of Town News - Historic Restoration
08.01.16

CONCEPTUAL DESIGN STATUS AS OF: 08.01.2016

GPR INVESTIGATION OUT OF TOWN NEWS STAND CAMBRIDGE, MASSACHUSETTS

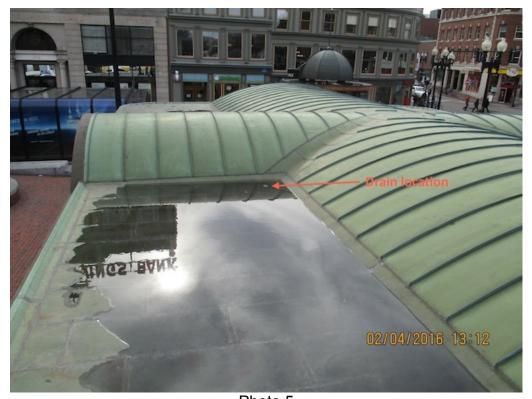
Photo 5
West elevation: Roof drains are located at the base of each valley. Three of four drains are obstructed.

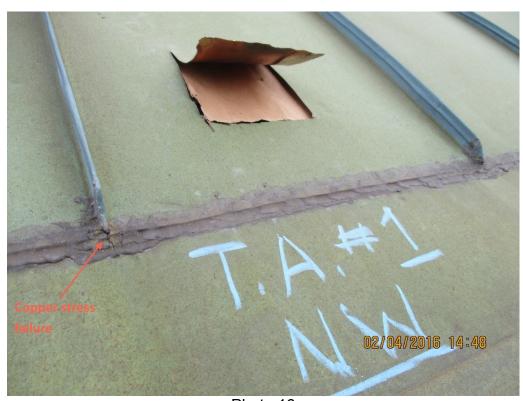
Photo 16
West elevation: Site of Test Area #1, standing seam copper.

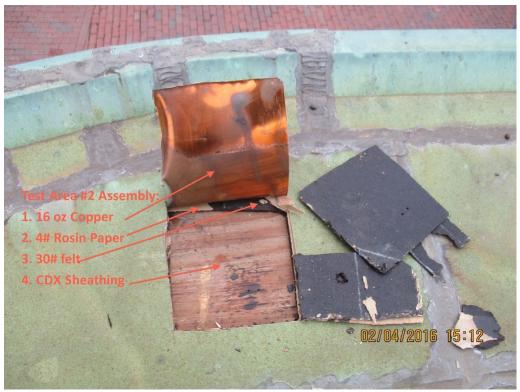
Photo 19 North elevation: Test Area #2 assembly.

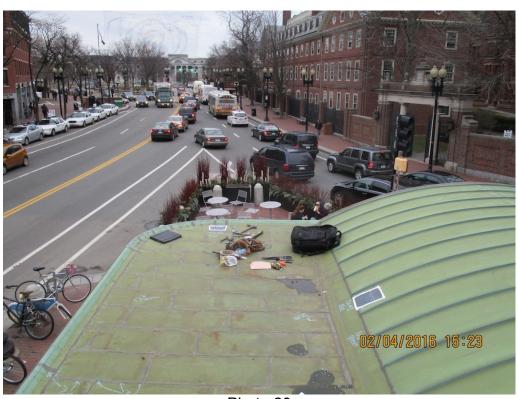
Multiple failed solder seams and several "stress fractures" within the copper panels were observed.

Photo 20
Northwest location Test Areas. Note marked locations of failed solder seams.

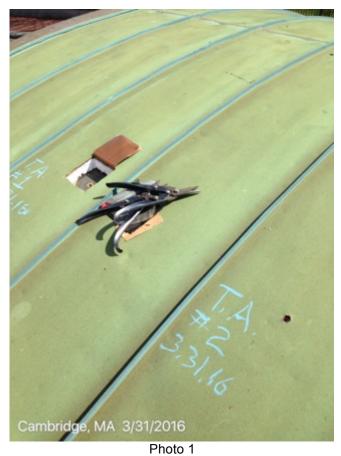
"Test Areas # 1 and #2, Northwest elevation. T.A. #1 is located above the soffit, while T.A. #2 is located above the interior ceiling.

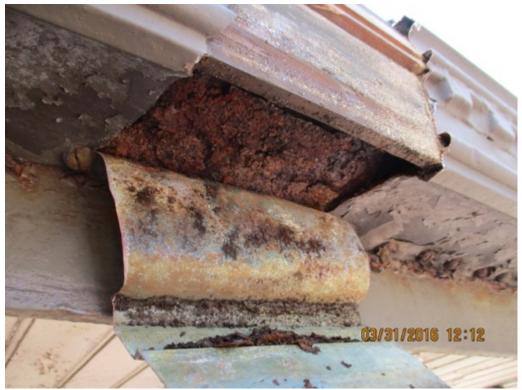
Photo 3
Cornice test area on the Northwest elevation.

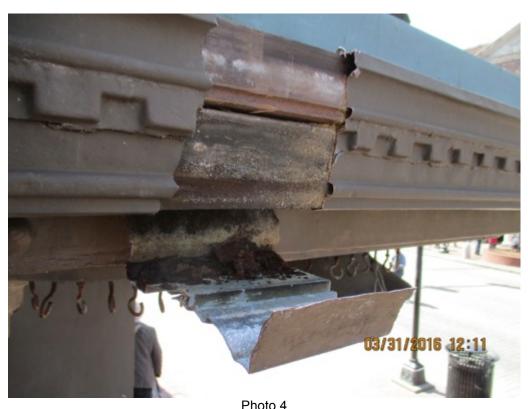
Photo 4
Cornice test cut. Note cedar support blocking and significant oxidization of copper cornice.

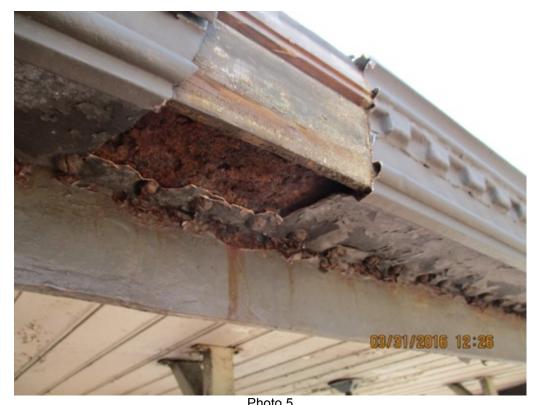
When the cornice assembly was exposed during the test cut in area #3, it was observed that the interior cornice assembly (wood blocking and steel framing) was saturated. It was also observed that the horizontal leg of the outer steel angle frame was significantly oxidized (see photo 5) due to the conditions of water infiltration, exacerbated by a dissimilar metals reaction between the steel and the copper cornice cover. The steel angle frame in this location has lost approximately 75% of its material thickness due to oxidization. No insulating materials were observed between the copper and steel frame. While the lead coating on the copper and paint layers help to mitigate the reaction between the copper and steel components, multiple steel rivets penetrate the lower copper cornice covering.

Photo 5
Cornice attachment point. Note substantial oxidization of the horizontal leg of the steel cornice angle. The steel has lost 75% of it's thickness in this location.
